# Technical Service Bulletin

## 48 Electric steering column adjustment not working, DTC B14BF01 is stored in the BCM 1

48 21 95 2062288/2 March 8, 2021. Supersedes Technical Service Bulletin Group 48 number 21-93 dated February 25, 2021 for reasons listed below.

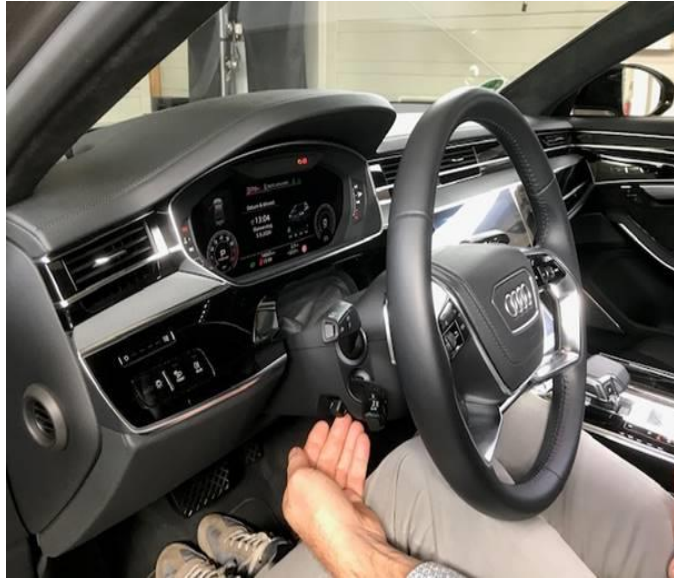
*Figure 1. 40 kg force pushing steering wheel upward.*

- Get into the vehicle and use your knees to push the steering wheel upward (a force of approx. 40 kg or 88 lbs is required), at the same time press the steering column adjustment switch upwards in the vertical adjustment direction (Figure 1).
- This will restore the function of the electric steering column adjustment.

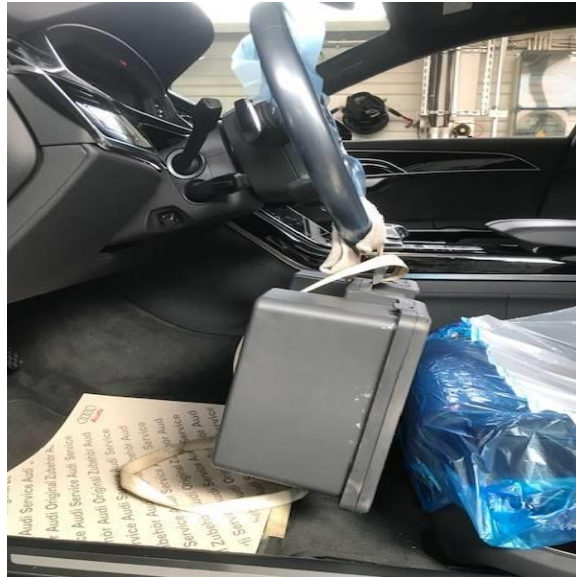
*Figure 2. Weight necessary for steering adjustment.*

6. Attach the tool kit to the steering wheel using a small securing strap (Figure 2). Take care not to damage the steering wheel.

We recommend placing a cleaning cloth underneath, as shown in Figure 2.

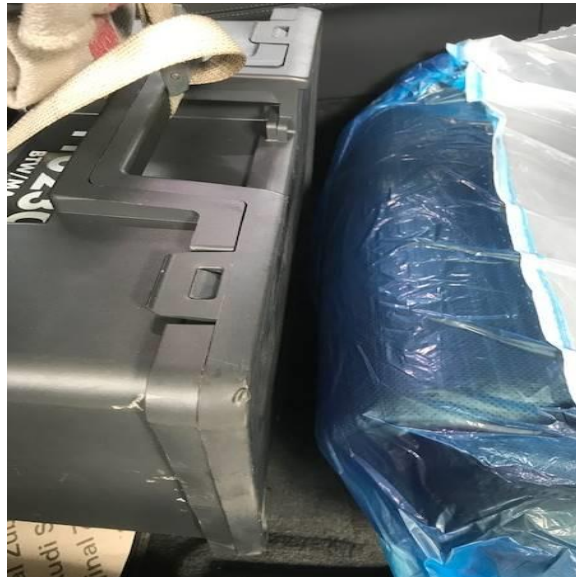
*Figure 3. Plastic foil protection for the seat.*

7. Apply plastic foil to make sure the tool kit cannot scrape against the seat (Figure 3).
