STAR ONLINE PUBLICATION

Case Number: S2018000007 REV. B

Symptom/Vehicle Issue: Diagnostic Trouble Code (DTC) P0299 – Turbocharger Underboost Additional Diagnostics

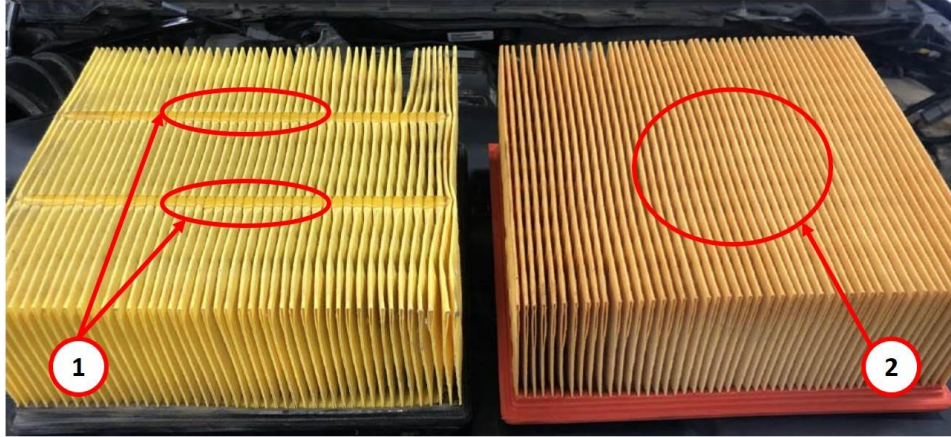
Figure 1

1. Remove, and inspect the engine air filter. Ensure that the air filter is clean, and not restricted.
2. Inspect the bottom of the air filter to see if it utilizes glue strips to separate the pleats. Newer design OEM replacement air filters, and some aftermarket filters utilize glue strips to separate the pleats. Please see ([Figure 1](#)). There have been reports that filters using this design can potentially cause this DTC. If the air filter installed on the vehicle utilizes these glue strips, swap it with one that is not equipped with them, and retest.

1. Glue Strips
2. No Glue Strips

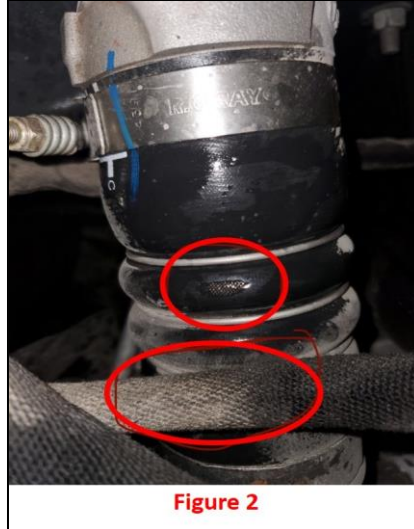
Figure 2

3. Ensure that the Charge Air Cooler (CAC) system is properly pressure tested per the steps outlined in Service Library Service Information Section 09 – Engine, 6.7L Diesel > Turbocharger System > Diagnosis and Testing – Leaks. While performing the CAC leak testing, pay close attention to the CAC boot connected to the turbo outlet for leaks caused by the wire harness rubbing through the boot. Please see (Figure 2).

4. If the boot is found damaged, replace as necessary, and retest the CAC system for any additional leaks. Repair as necessary.
5. Remove the EGR Crossover tube from the EGR valve, and inspect the EGR inlet to see if there are signs that the valve internal seat has begun to rotate. Please see (Figure 3). The EGR internal shaft should be completely visible when looking into the crossover tube inlet.

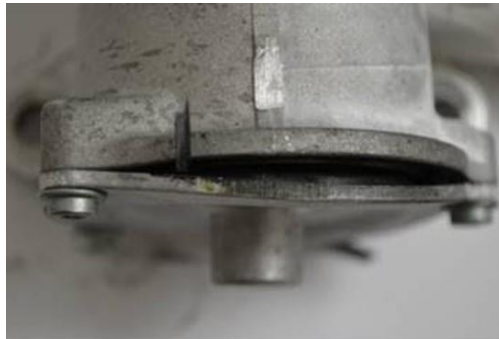
Figure 4

6. Thoroughly inspect the EGR valve end cap for signs of leaks (**Figure 4**). If found to be leaking, replace the EGR valve.
