# Technical Service Bulletin

Technical Service Bulletin: TSB210041

Leaking Air Compressor Coolant Line Grommets

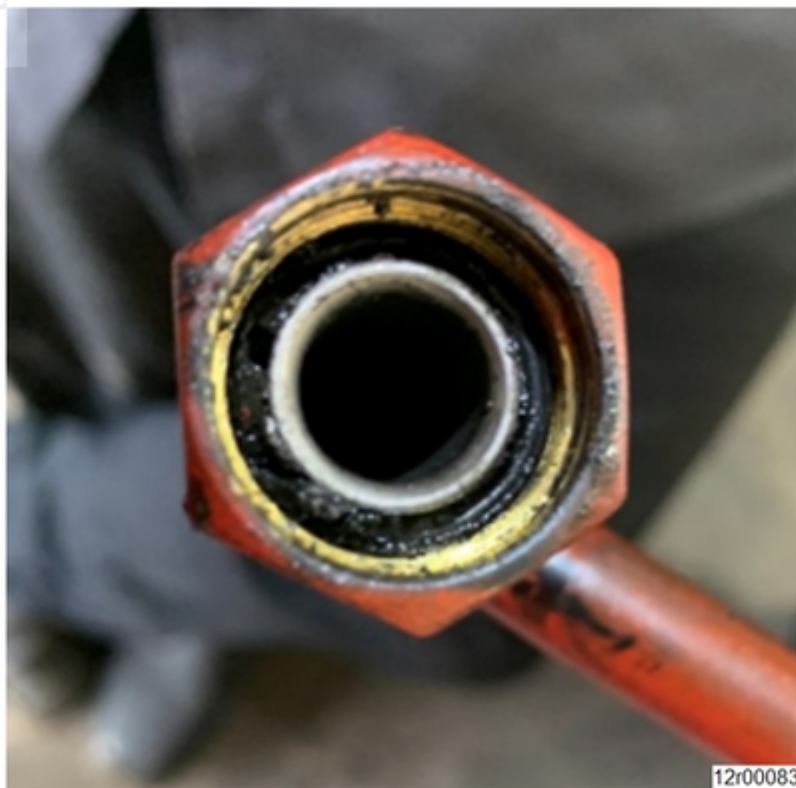
- Internal grommet is deteriorated and allowing passage of coolant around the grommet.

Figure 1, Example of Deteriorated Grommet.

- Remove both supply and return coolant lines between the engine cylinder block and the air compressor head. See corresponding Service Manual. Reference Procedure 012-004 in Section 12.
- Carefully inspect both ends of both lines.
- If the internal grommet is deteriorated; remove all existing grommet material from both sides of the line and replace with grommet, Part Number 3103015.
- Install both supply and return coolant lines connecting the engine cylinder block to the air compressor cylinder head utilizing existing service procedures.
