MIL ON With DTC P211904 - 2GR-FKS (6MT)

Market USA

YEAR(S)	MODEL(S)	ADDITIONAL INFORMATION
2016 - 2020	Tacoma

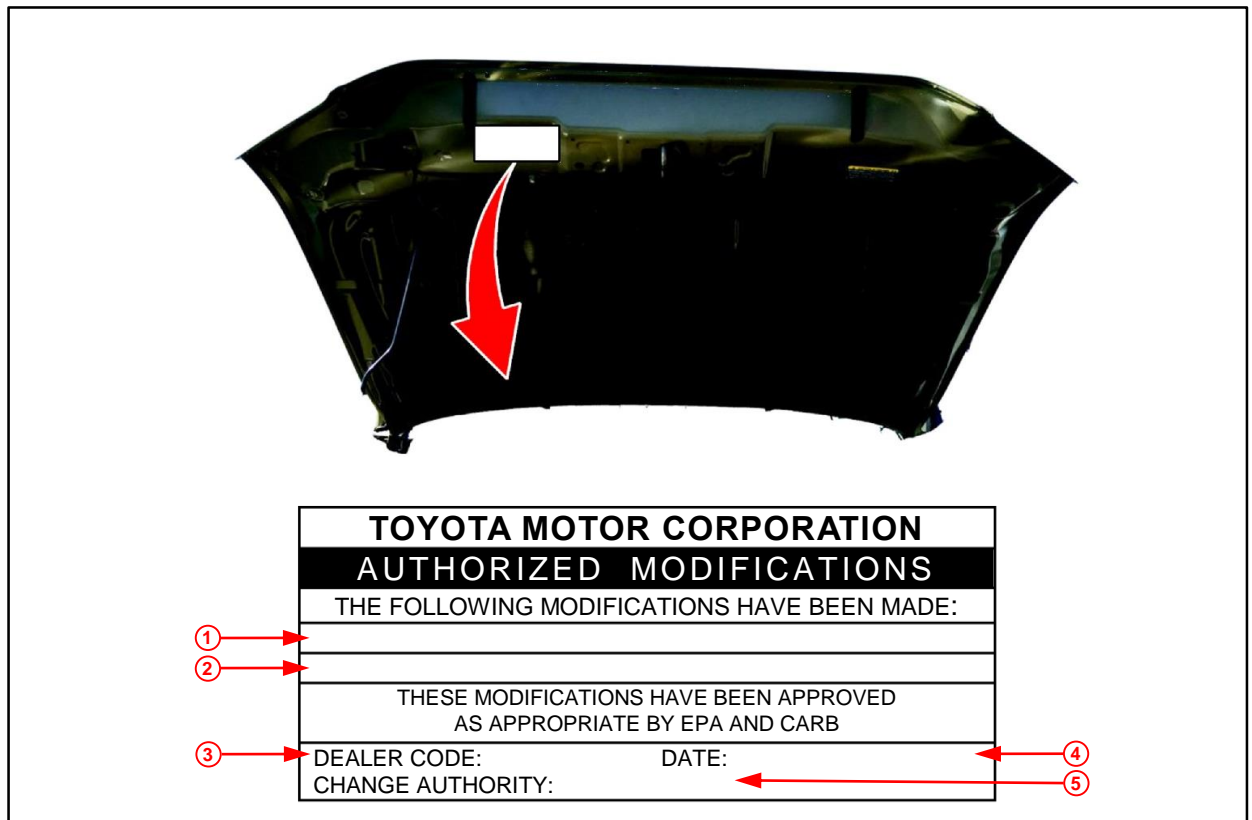
Figure 1. Location of Authorized Modifications Label on 2016 – 2020 Tacoma

- Use Techstream to confirm if the ECM (PCM) calibration has been updated and check for the Authorized Modifications Label affixed to the vehicle in the location shown below.

4. Prepare and install the Authorized Modifications Label.
 - A. Using a permanent marker, enter the following information on the label:
 - ECM (PCM) part number [*Refer to the **Parts Information** section for the **NEW PART NUMBER***].
 - Calibration ID(s) [*Refer to the **Calibration Information** section for the **NEW CALIBRATION ID***].
 - Dealer Code.
 - Repair Date.
 - Change Authority [***This bulletin number***].
 - B. Install the Authorized Modifications Label onto the vehicle at the location shown in Figure 1. The Authorized Modifications Label is available through the MDC, P/N 00451-00001-LBL.
5. Test-drive the vehicle to confirm proper operation.
