# Technical Service Bulletin

## 48 Squeaking noises from rubber boot of the intermediate steering shaft

48 21 96 2055733/2 March 16, 2021. Supersedes Technical Service Bulletin Group 48 number 19-80 dated July 26, 2019 for reasons listed below.

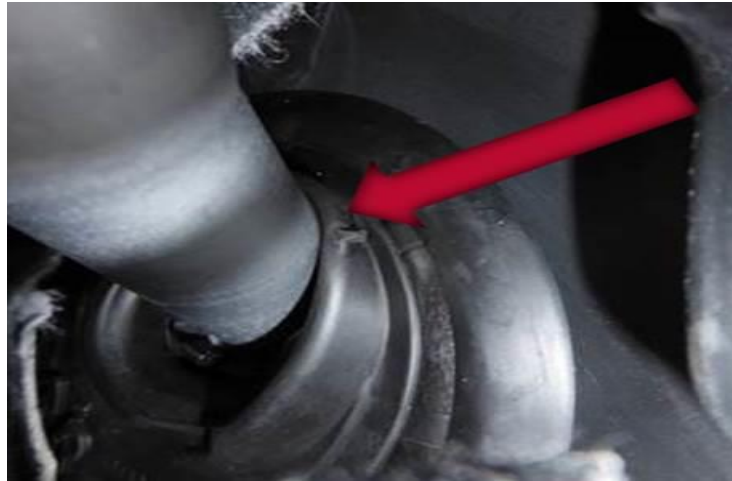
- The noise comes from the sealing sleeve/steering column opening on the bulkhead.
- The steering column adjustment is set in the lower range.
- The steering shaft rests on the cone of the sealing sleeve (Figure 1).

**Figure 1.** Steering shaft rests on the sealing sleeve (also known as sealing lip).

Incorrect positioning of the sealing sleeve (lip) in the bulkhead in connection with unfavorable tolerances of the components.

2. Loosen the rubber sealing sleeve (A) and push it upwards as far as possible and retighten (Figure 2).

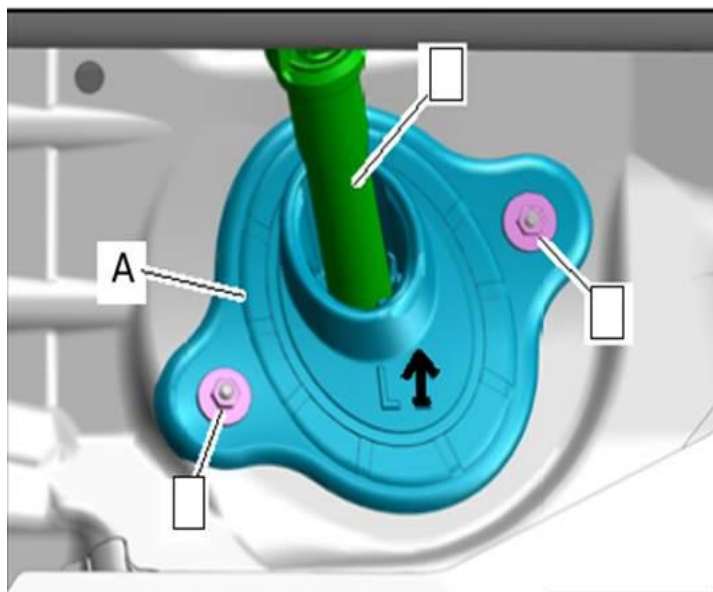
**Figure 2.** Sealing sleeve (also known as sealing lip).

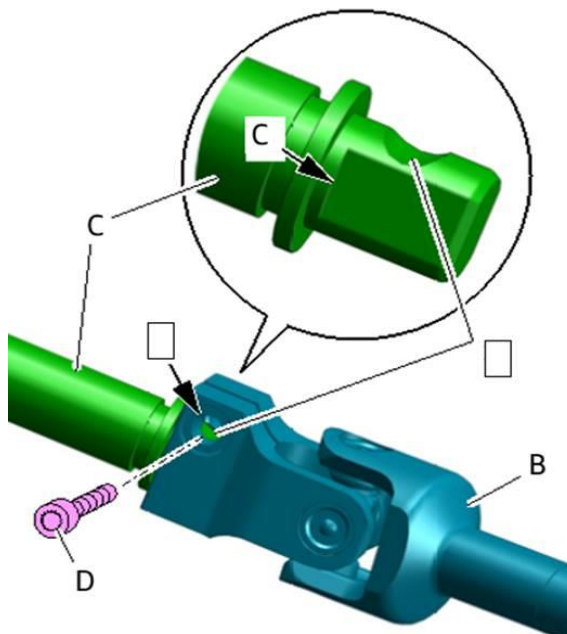
**Figure 3.** Steering column shaft and intermediate shaft connection.

3. Reinstall the steering intermediate shaft (B) to the steering column (C) and tighten with new bolts (D) (Figure 3).
