Technical Service Bulletin

96 High beam assist or traffic sign detection limited, DTC C12B3FD may be stored in the DAS control module

96 21 63 2059201/4 March 12, 2021. Supersedes Technical Service Bulletin Group 96 number 20-53 dated June 17, 2020 for reasons listed below.

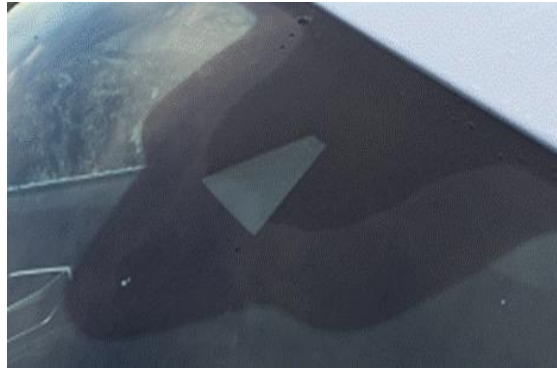
The viewing area of the front camera can be fogged up both on the inside and/or on the outside (Figures 1 - 2).

Figure 1. Viewing area fogged up from outside.

3. The customer cannot see this from the interior of the vehicle. Often it is enough to switch on the wiper system to fix the concern.
4. If the front camera is fogged up from the inside fairly often, it can help to remove its lens hood then to clean and dry the viewing area of the camera.

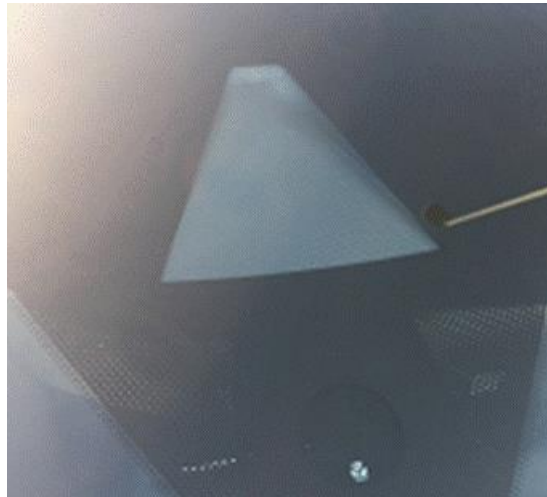
Figure 2. Viewing area fogged up from inside.
