REFERENCE:	Nova Bus Manuals
SECTION:	05: Rear Axle
RS N°:	MQR 7621-2254
EFFECTIVE IN PROD.:	LD39 (2020OC)

SUBJECT:	ZF Rear Axle AV133
JUSTIFICATION:	Quality issue identified by ZF on 20 screws used for rear axle flange shaft connection. The rework shall be done within next scheduled maintenance or service work.

## Torx screws potential issue at AV133 flange shaft connection

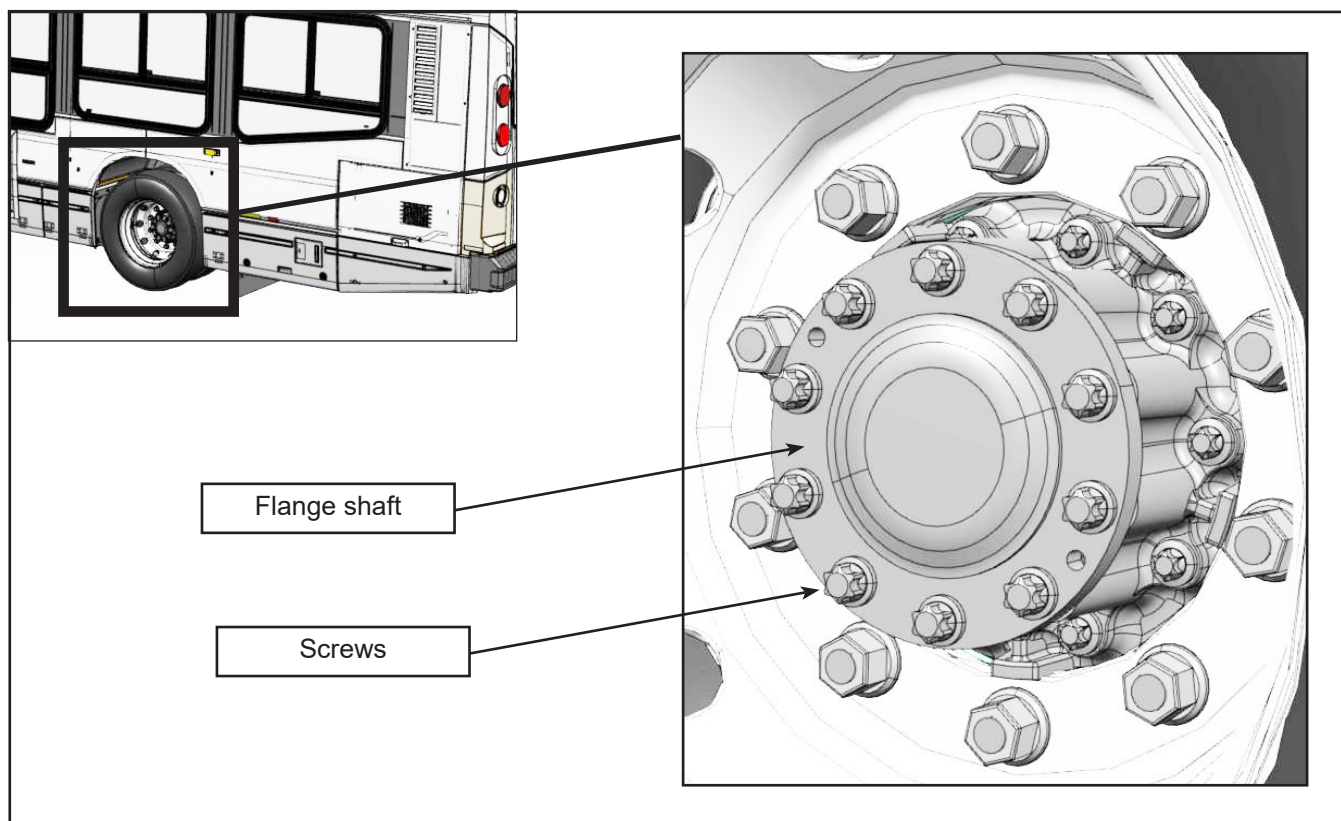
*Figure 1 - Flange shaft screws location*

- 1.1. Locate the 20 screws installed on flange shaft connection (Figure 1). There are 10 screws per wheel.

- 1.2. Loosen bolted connection of the flange shaft and remove the screws. **Note:** Do not pull flange shaft out of axle.
- 1.3. Install new Torx screws N8904440 and tighten to required torque of 325 ft-lb (440 N·m).
- 1.4. The vehicle can return in service. ❖
