## SERVICE BULLETIN

**APPLICABILITY:** 2020MY Legacy and Outback  
**SUBJECT:** Denso Gen 4 Cockpit One (CP1) Infotainment System Operating TIPS

**NUMBER:** 15-259-20R  
**DATE:** 02/19/20  
**REVISED:** 03/24/21

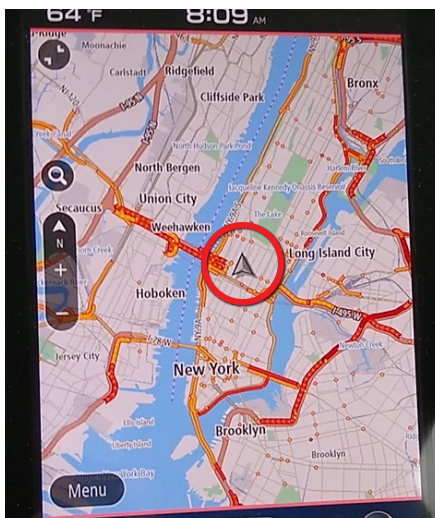
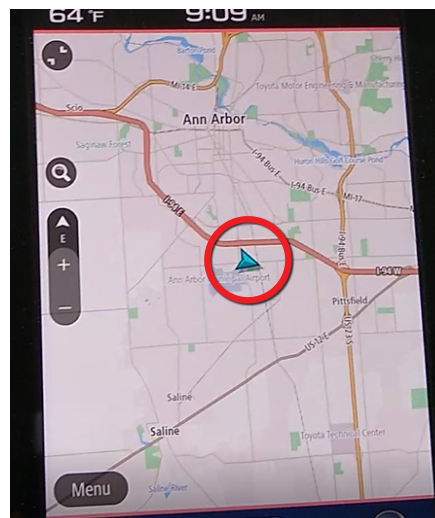
**CONDITION #2:** NAVI screen does not show the correct location.

It is possible during Delivery Mode for the NAVI GPS display to show Manhattan, NY location all the time. This is a default setting for GPS in this mode. Other indicators of Delivery Mode are:

Following Delivery Mode or Memory Initialization (map arrow is gray).

Normal Operation (map icon is blue/green).

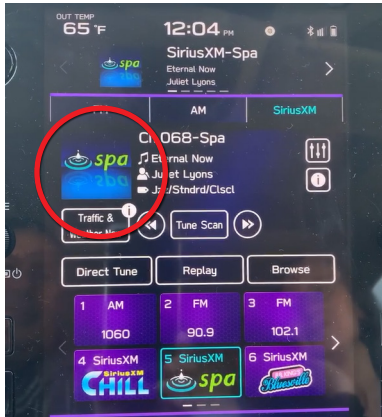
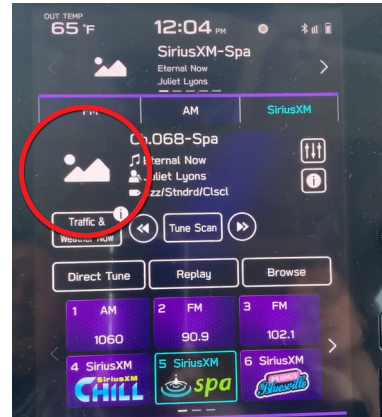
It is a normal operating characteristic for the SXM station artwork to disappear from the CP1 / Gen 4 Infotainment system display whenever the vehicle is in motion. Artwork is restored when the vehicle stops.

Artwork is displayed when stopped or parked.

Artwork is NOT displayed when moving.

Explain to customers questioning this condition that it is a normal operating characteristic intended to reduce distraction. Replacing the head unit will not change this characteristic.

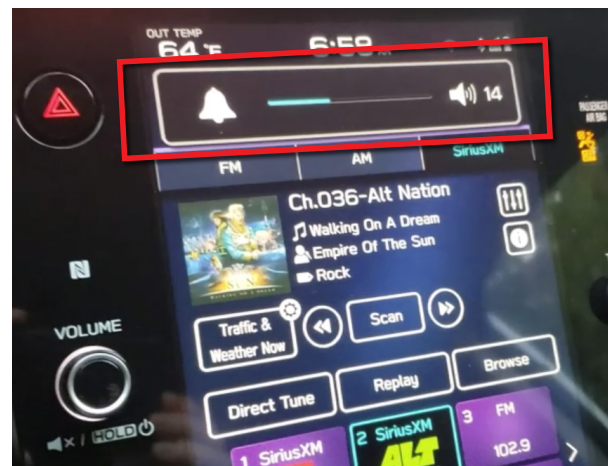
There are instances when using Android Auto, the audio volume cannot be adjusted intermittently even though notification of the adjustment by turning the volume control knob occurs as shown below on the display as shown here.

This condition occurs because Android Auto operation is being prioritized over the CP1 / Gen 4 Infotainment system.

This condition is temporary and will clear eventually. To expedite clearing and regain faster volume control for the audio source, there are some work arounds. One option is to relaunch Android Auto by disconnecting and reconnecting the phone to the CP1 / Gen 4 Infotainment system or, a short press of the Talk button on the steering wheel to start the native VR followed by saying “cancel” after the beep is heard. The procedure shown below copied from the Owner’s Manual regarding sound output can also be used.

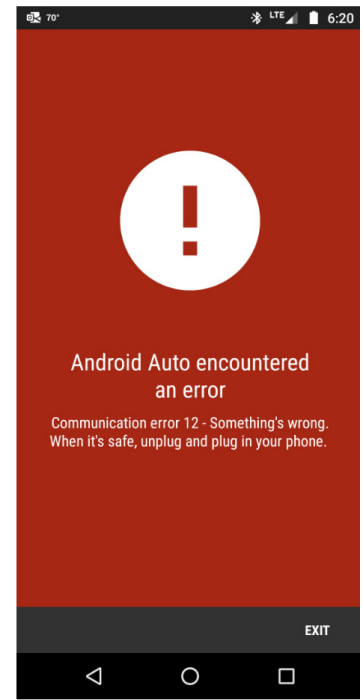
**CONDITION #9:** Android Auto connection failure is displayed.

When this message is displayed on the phone after connection to the CP1 / Gen 4 Infotainment system, the Android Auto application fails to launch. Investigation has shown the source of this error is on the phone side and can be resolved by re-synching communication by disconnecting and reconnecting the phone. The communication error number (12 shown in the example) is irrelevant.

When reviewing a similar issue, explain to the customer that replacing the head unit will not resolve this condition as it is not the root cause of the error. It is a good practice to confirm an undamaged, genuine cable is used to connect the phone as well as making sure the phone is set to accept connection with a new vehicle.

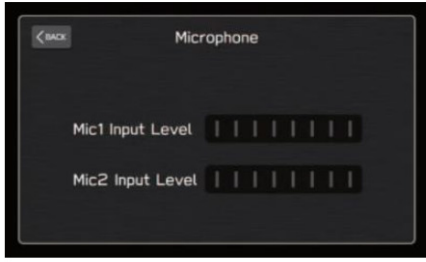
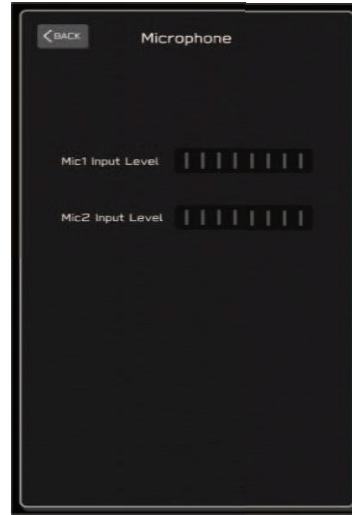
**CONDITION #15:** Microphone test anomaly

When performing the diagnostic checks for microphone operation using DIAGNOSTICS MODE (Dealership Mode/ Function Check/Microphone), the level gauge reading may appear weaker than expected or what may have been seen during prior testing. In some cases, a time lag or no or just one bar may be displayed when speaking into the microphone. This can occur both input levels and does not necessarily indicate a concern with the microphone.

There is a known bug with the RC2003 software update released in June 2020. See Appendix B in TSB **15-261-20R** to confirm if the software of the unit being repaired is impacted by this bug. This bug affects only the display of the microphone test and in no way impacts actual microphone operation.

With the microphone display being impacted, it is recommended to use other diagnostic methods. Alternatively, troubleshoot the microphone operation using the Voice Recognition feature to confirm the unit receives voice input correctly or, make a voice call. If concerns remain, perform continuity and voltage drop testing to confirm if a poor contact or connection may exist. Reference the applicable Service Manual for related wiring diagrams for the Cockpit Control Module and microphone wiring diagrams, with or without Telematics depending upon the vehicle.

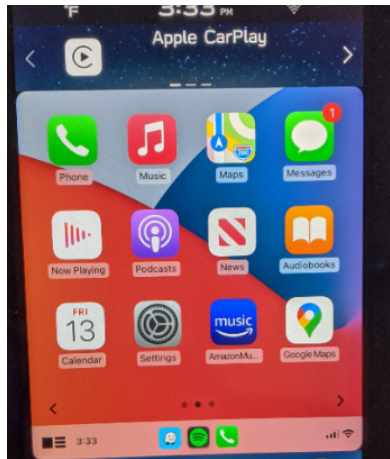
**Gen 4 Denso CP1 CID**

**CONDITION #18:** No Audio during CarPlay

A number of reports have been received stating the Audio Output (radio, CD, USB etc.) gets interrupted when the Apple CarPlay app is launched or a Navigation app (e.g. Waze) or audio streaming application is (e.g. TuneIn) is started from the Apple CarPlay environment.

This is a normal operating characteristic as the iPhone takes control. This may also occur when the phone is used for other purposes while CarPlay is active such as: texting, replying to e-mails or other phone-side actions.

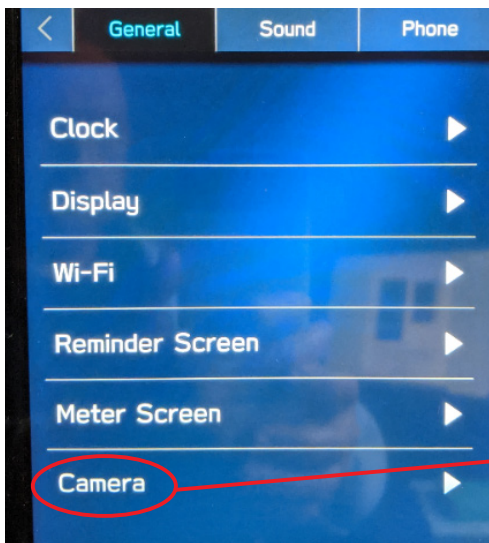
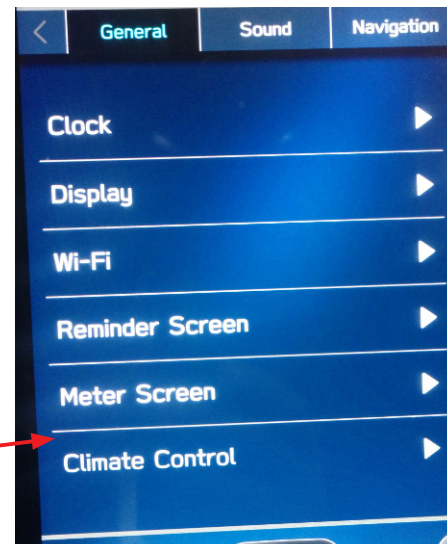
A report was received describing a missing “Camera” setting in Settings/General menu:

Camera setting PRESENT

Camera setting MISSING

After further investigation, it was determined to be a result of a needed process not being followed during replacement of the combination meter. The new combination meter was installed but not programmed properly by completing the required Variant Work. Always follow the applicable Service Manual instructions on STIS and confirm completion of all the necessary steps before condemning a possibly related system or hardware component. The Service Manual image below is an *example* of the VARIANT WORK procedure required for Combination Meter System replacement. Always follow the applicable procedure for the vehicle being repaired.

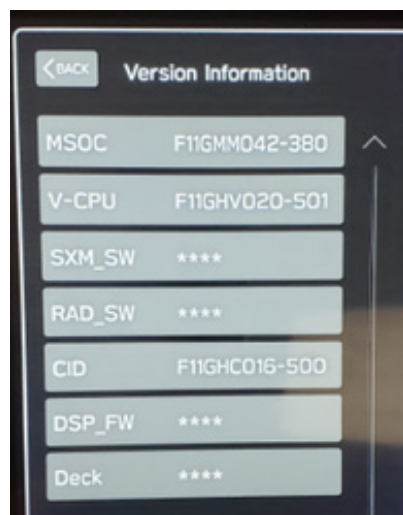
When you confirm CP1 system software version information, please assure the system has been running long enough to finish boot-up process. We don’t have a spec for how long to wait. Good practice might be to wait around 3 minutes. If you don’t wait long enough some versions would be missing or asterisk symbols (\*\*\*\*) as shown below.

By the way it is correct to see Deck version as asterisk symbols (\*\*\*\*), when CD Player is not installed. With that said please don’t confuse the case with no “RAD\_SW” version and “DSP\_FW” version displayed or showing asterisk symbols (\*\*\*\*), even after waiting long enough for the system to complete boot-up. That would a sign for the failed software update. For more details see Subarunet message **“Recall WRH-20 / WRI-20 Denso Gen 4 CP1 software update. Critical points to avoiding unnecessary hardware replacement”** posted January 5, 2021.
