JLRTB02012NAS4

**TECHNICAL BULLETIN**

'Gearbox Fault Detected' Displayed On The Instrument Panel Cluster (IPC)

MODEL:	MODEL YEAR:	VIN:	ASSEMBLY PLANT:
I-PACE (X590)	2019-2020	F60094-F80069	Graz (Austria)

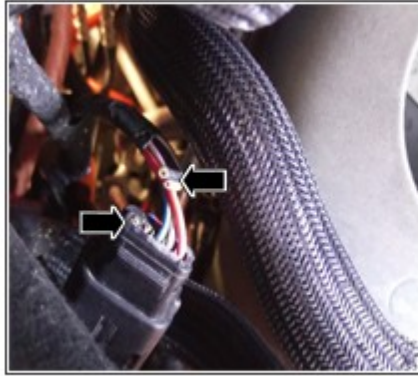
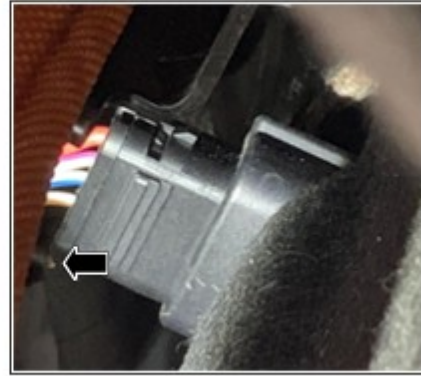
E256857

No retention to the front Electric Drive Unit (EDU) causing strain on the wiring going to the EDU parking lock actuator connector (C1YE113A).

- If the EDU parking lock actuator connector (C1YE113A) wiring is found to be damaged as per the illustration, **continue to step 2**.
- If no related repairs were identified **and** the customer concern is still present, **continue to step 2**.
- If any related repairs were identified **and** have been rectified **and** the customer concern is still present, **continue to step 2**.
- If any related repairs were identified **and** have been rectified **but** the customer concern is **not** present, **do not continue with this technical bulletin**.

- 
2. Remove the front compartment wiring harness (see TOPIx Workshop Manual section 418-02: Wiring Harnesses - Removal and Installation - Front Compartment Wiring Harness).
-

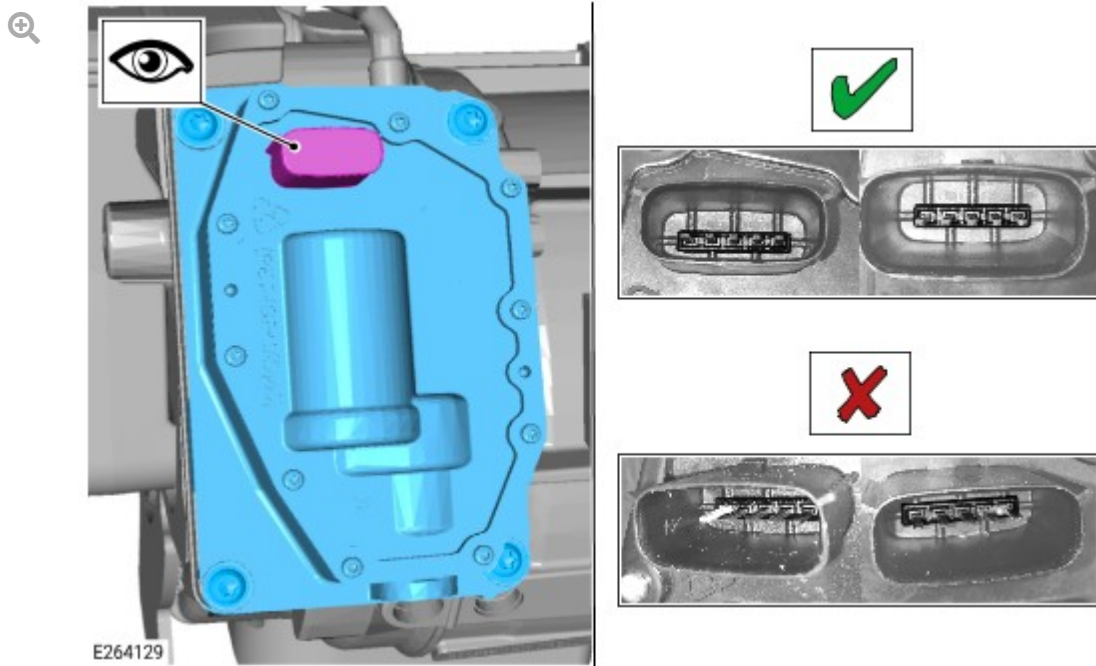
Inspect the electrical connector pins of the EDU parking lock actuator for signs of water ingress or corrosion.

- If signs of water ingress or corrosion **are not** present on the electrical connector pins of the EDU parking lock actuator, as shown in the image with a **GREEN '✓'**, the vehicle has passed the inspection.
  - **Continue to step 24.**
- If signs of water ingress or corrosion **are** present on the electrical connector pins of the EDU parking lock actuator, as shown in the images with a **RED 'X'**, the vehicle has failed the inspection.
  - **Continue to step 19.**

22. Renew the front EDU parking lock actuator (see TOPIx Workshop Manual section 601-01: Electrical Drive Unit - Removal and Installation - Electric Drive Unit Parking Lock Actuator).
