JLRTB02074NAS1  
**TECHNICAL BULLETIN**  
01 MAR 2021

Front Bumper Towing Eye Cover - Modification

MODEL:	MODEL YEAR:	VIN:	ASSEMBLY PLANT:
F-PACE (X761)	2021	663013-670434	Solihull

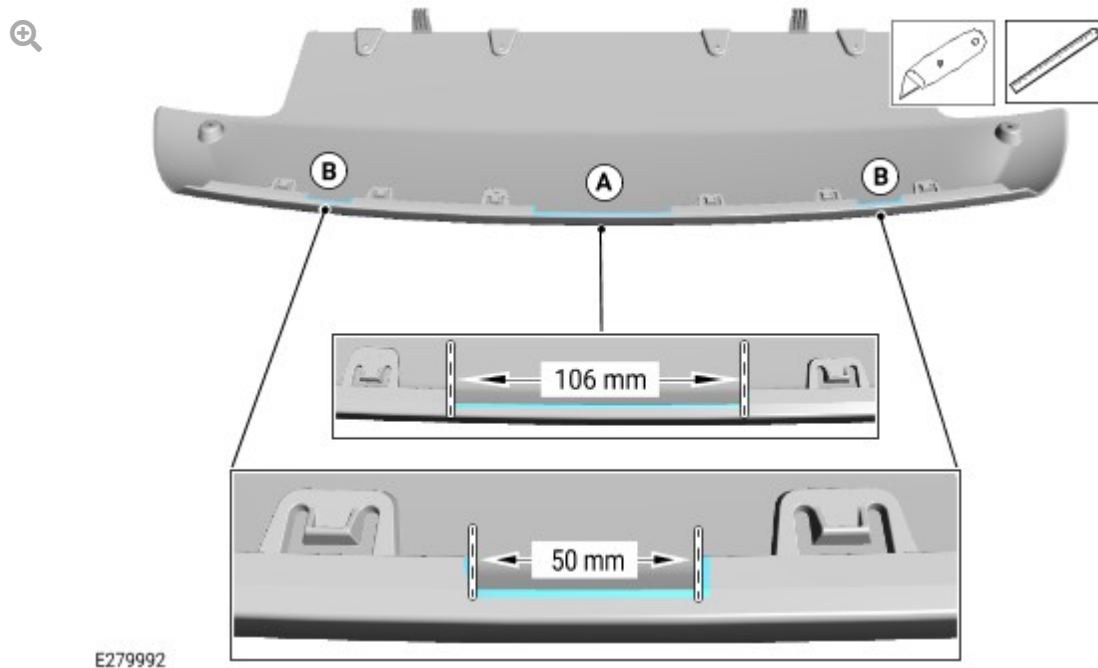
On vehicles with the 'Black Pack' trim option installed, a technician may have difficulty installing the front bumper towing eye cover during completion of the Pre-Delivery Inspection (PDI).

The towing eye cover has been manufactured away from the required specification. .

Do NOT increase the depth of the slotted area.

Using a suitable tool, modify the front towing eye cover, as shown in the illustration. Make sure an equal amount of material is removed from each side of the slotted area, which will allow the slotted area to remain central, between the fixing tabs.

- Slotted area marked 'A' - 106 mm wide.
- Slotted areas marked 'B' - 50 mm wide.
