David J. Johnson
 Director
 Service Engineering Operations
 Ford Customer Service Division

March 31, 2021

SUBJECT: NEW VEHICLE DEMONSTRATION / DELIVERY HOLD
Customer Satisfaction Program 21B03 - Supplement #1
 Certain 2020 Model Year Super Duty F250-F600 Vehicles Equipped with a 10R140
 Transmission - Number One Planetary and Ring Gear Assembly

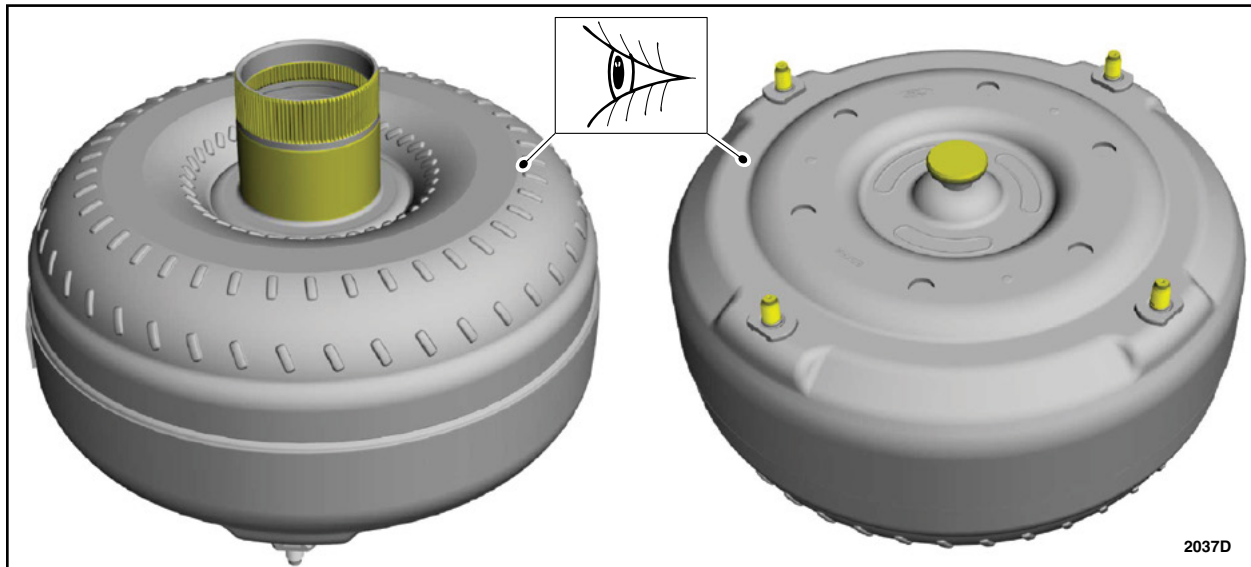
FIGURE 5

5. Inspect the torque converter. If you answer yes to any of the following questions a new or re-manufactured torque converter must be installed. See Figure 5.

- Does the sealing surface have a groove worn from the seal?
- Has a torque converter malfunction been determined based on complete diagnostic procedures?
- Is the torque converter stud or studs, threaded pads, impeller hub or bushing damaged?
- Is there evidence of water or antifreeze contamination?
- Does the torque converter exhibit external discoloration (due to overheating)?
 - Overheat discoloration would be a darker color with possible bluing.
 - Discoloration would be a different color than the rest of the torque converter.
