SIL 788

Service Information Letter

Units Affected: Certain LR7 aerial devices built on Freightliner M2-106 chassis from April 2016 through November 2019 (Verify that your unit serial number is affected by reviewing the attached list in this SIL or by accessing your fleet on connect.altec.com/login)

Bumper Support Bracket Inspection

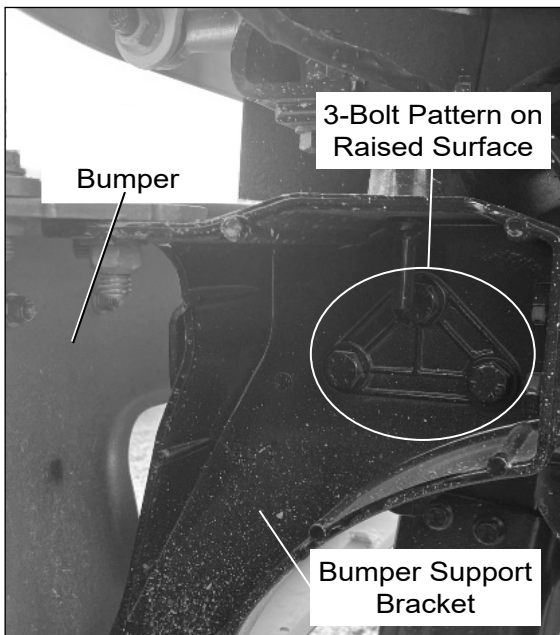
Figure 1 – Aluminum Bumper Support Bracket

Altec has discovered that the cast aluminum bumper support brackets used by Freightliner on some affected units have cracked in the field. This can cause a lack of proper support for the front bumper and the cab guard on the vehicle.

1. Position the unit on a level surface. Apply the parking brake and chock the wheels. Turn off the engine and remove the key from the ignition.
2. Using a flashlight if necessary, look into one of the front wheel wells at the bumper support bracket located behind the front bumper.
 - If the vertical side of the bumper support bracket has a raised molded surface around the triangular bolt pattern at the top, the bracket is an aluminum casting (refer to Figure 1).
 - If the vertical side of the bumper support bracket is flat around the triangular bolt pattern at the top, the bracket is a steel weldment (refer to Figure 2).

If the inspection confirms that the chassis has cast aluminum bumper support brackets, order the Steel Bumper Support Brackets Kit, part number 991243313, by calling 1-877-GOALTEC (1-877-462-5832). Install the kit no later than 60 days from the receipt of this SIL.

3. Review the results of step 2.
 - If the inspected bumper support bracket is aluminum, both bumper support brackets must be replaced no later than 60 days from the receipt of this SIL. Call 1-877-GO ALTEC (1-877-462-5832) to order the Steel Bumper Support Brackets Kit, part number 991243313. Return the unit to service. Install the kit as soon as it is received. Do not complete the Inspection Sheet at the end of this SIL.
 - If the inspected bumper support bracket is steel, no further action is required. Return the unit to service. Complete the Inspection Sheet at the end of this SIL and return it to Altec as specified.
