## Technical product information

<b>Topic</b>	Bentayga Speed - Phone, Media and Navigation screen showing as initialising permanently within the DIP
<b>Market area</b>	Russische Föderation (5RU),Australia E04 Bentley rest Asia and Australia (6E04),China 796 VW Import Comp. Ltd (Vico), Beijing (6796),Germany E02 Bentley rest Europe (6E02),Japan E03 Bentley Japan (6E03),Korea, (South) E08 Bentley South Korea (6E08),United Arab Emirates E06 Bentley Middle East and Africa (6E06),United Kingdom E01 Bentley UK (6E01),United States E05 Bentley USA and rest America (6E05)
<b>Brand</b>	Bentley
<b>Transaction No.</b>	2062549/2
<b>Level</b>	EH
<b>Status</b>	Approval
<b>Release date</b>

### Bentayga Speed

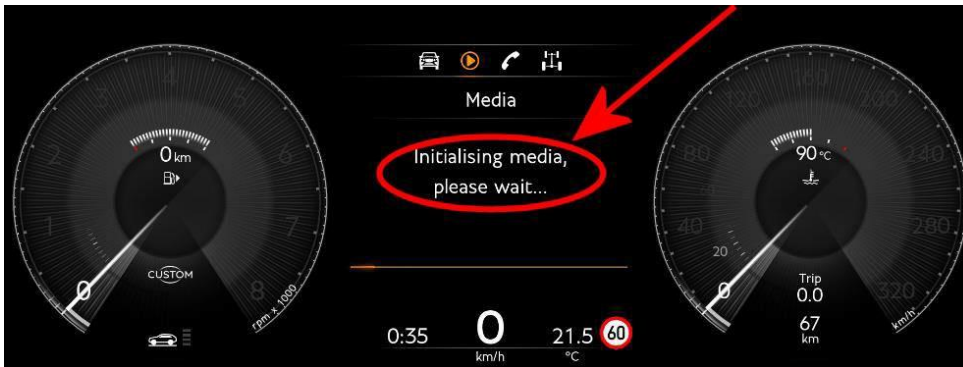
Figure 1

The Phone, Media and Navigation screen showing as initialising permanently within the DIP (Figure 1)

Software update for Address 0017 - Refer to the instructions within the Measure section
