# Tips&Tricks –Multistrada V4 Model Year 2021

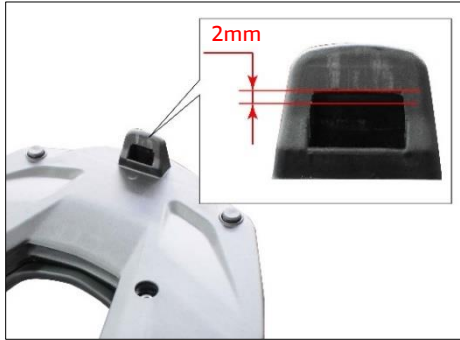
no.	Symptom	Subject	Photo	Notes and Indications - Corrective action
1	Issues during Top Case fixing to the plate	Top Case Kit Part no.96781531AA

<p>We have received some reports concerning the difficulty in securing the Top Case (Kit Part no.96781531AA) to the top plate Part no.8291M033A due to a machining error of the supplier. In particular, the locking tooth on the upper plate Part no.8291M033A shows a hole 2mm narrower than specified. To eliminate this defect, the locking tooth of the plate must be milled by <u>2mm in the upper area</u> using a flat file, as shown in the figure.</p>

<p>We inform you that the upper plates present inside the kits in stock have been restored.</p>
2	Anti-theft system kit Part no.96681081AA malfunction	Anti-theft system kit Part no.96681081AA

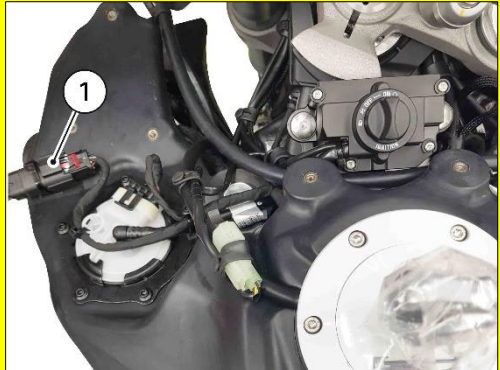
<p>We inform you that for the installation of the anti-theft system kit part no. 96681081AA, the <b>main wiring connector (1)</b> where to connect the anti-theft device, is positioned near the fuel pump flange, in the front left area of the fuel tank.</p>
