# Tips&Tricks –Multistrada V4 Model Year 2021

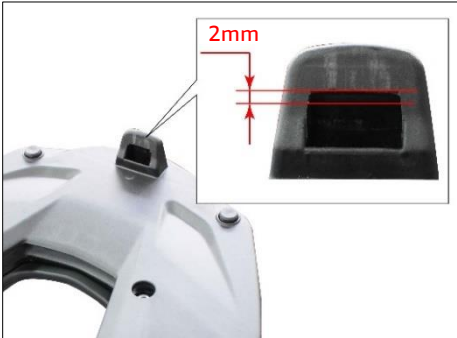
no.	Symptom	Subject	Photo	Notes and Indications - Corrective action
1	Issues during Top Case fixing to the plate	Top Case Kit Part no. 96781531AA

<p>We have received some reports concerning the difficulty in securing the Top Case (Kit Part no. 96781531AA) to the top plate Part no. 8291M033A due to a machining error of the supplier. In particular, the locking tooth on the upper plate Part no. 8291M033A shows a hole 2mm narrower than specified. To eliminate this defect, the locking tooth of the plate must be milled by <u>2mm in the upper area</u> using a flat file, as shown in the figure.</p> <p>We inform you that the upper plates present inside the kits in stock have been restored.</p>

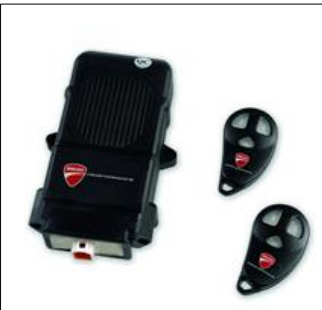
2	Anti-theft system kit Part no. 96681081AA malfunction	Anti-theft system kit Part no. 96681081AA

<p>After having installed the anti-theft system Kit Part no. 96681081AA and enabled it on the BBS control unit, some malfunctions may occur during activation due to a possible incorrect pin arrangement in the connector of the wiring branch supplied with the kit.</p>

<p>Follow the procedure described below:</p> <ol style="list-style-type: none"> <li>1) uncover <b>connector (A)</b> by moving <b>sheath (B)</b> backward;</li> <li>2) uncover the wiring by removing a portion of insulating tape to make operations easier;</li> <li>3) check the arrangement of <b>Pins 5</b> and <b>6</b> and the relevant color on the 8-pin connector. If the pin arrangement is not correct, extract them working from the front side with a needle inside the groove so as to lift the retainer and invert them.</li> <li>4) restore the cloth tape previously removed and the position of the protective <b>sheath (B)</b>.</li> </ol>

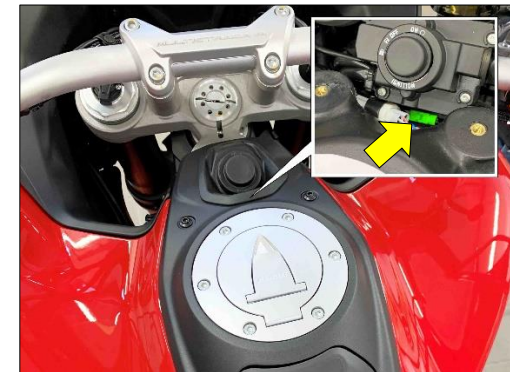
<p>We inform you that for the installation of the heated handgrip kit part no. 96680702A, the main wiring harness connectors where to connect the heated handgrips, are positioned below the ignition switch cover as shown in the figure.</p>

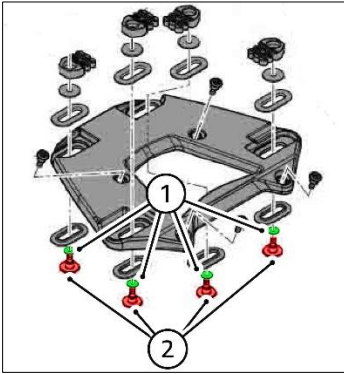
no.	Symptom	Subject	Photo	Notes and Indications - Corrective action
7	Possible incorrect operation of the swinging system - Top Case accessory kit part no. 96781531AA	Top Case Part no.96781531AA

<p>We inform you that the first Top Case accessory kits part no. 96781531AA delivered may not operate correctly with the swinging system, which may seem "too braked". To improve this condition, it is possible to insert <b>4 copper washers (1) part no. 85250231A</b> on the <b>4 screws (2)</b> retaining the bottom plate to the top one.</p> <p>For a better understanding of the assembly procedure of the Top Case accessory kit, a video has been made which can be viewed at the following link: <a href="https://youtu.be/DVEHKVvdKQI">https://youtu.be/DVEHKVvdKQI</a>.</p> <p>All Top Case kits in stock will be restored by February.</p>

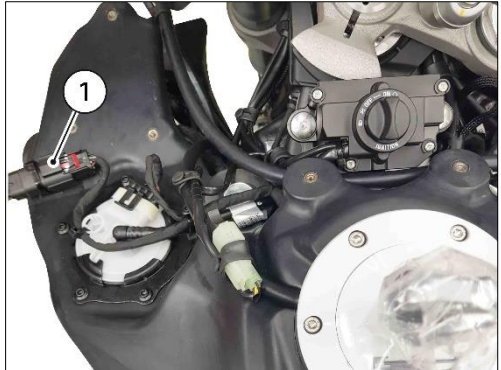
<p>We inform you that for the installation of the anti-theft system kit part no. 96681081AA, the <b>main wiring connector (1)</b> where to connect the anti-theft device, is positioned near the fuel pump flange, in the front left area of the fuel tank.</p>

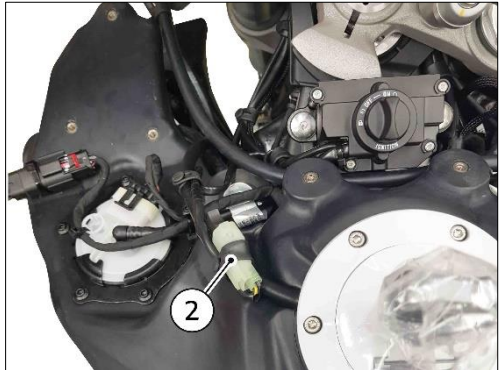
<p>We inform you that for the installation of the Hands Free fuel tank cap kit part no. 96681021AA, the <b>main wiring connector (2)</b> where to connect the Hand Free fuel tank cap, is positioned near the fuel pump flange, in the front left area of the fuel tank.</p>
