# Technical product information

<b>Topic</b>	Bentayga - Fuel Gauge - Guided Fault Finding DTC's B103E1B and/or B10581B evident within address 0046
<b>Market area</b>	Russische Föderation (5RU),Australia E04 Bentley rest Asia and Australia (6E04),China 796 VW Import Comp. Ltd (Vico), Beijing (6796),Germany E02 Bentley rest Europe (6E02),Japan E03 Bentley Japan (6E03),Korea, (South) E08 Bentley South Korea (6E08),United Arab Emirates E06 Bentley Middle East and Africa (6E06),United Kingdom E01 Bentley UK (6E01),United States E05 Bentley USA and rest America (6E05)
<b>Brand</b>	Bentley
<b>Transaction No.</b>	2060081/2
<b>Level</b>	EH
<b>Status</b>	Approval
<b>Release date</b>

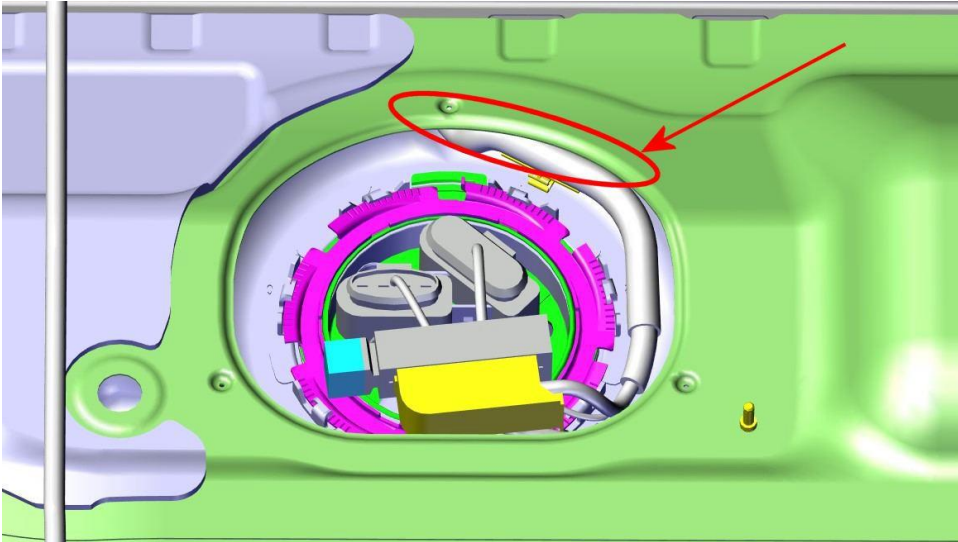
- Referring to Figure 5 – Conduct a check of the wiring harness to confirm if any damage is evident

Should any issues be found regarding wiring harness damage – The operative must raise a new DISS query or update the already existing query ensuring photographs of the issue and a description of the damage is included
