Classification:
DA17-033A

Reference:
ITB18-002A

2017 Q50 AND Q50 HYBRID; SONAR SYSTEM DOES NOT DISPLAY RED INDICATOR WHEN CLOSE TO OBJECT

APPLIED VEHICLES: 2017 Q50 (V37)
 2017 Q50 Hybrid (V37)

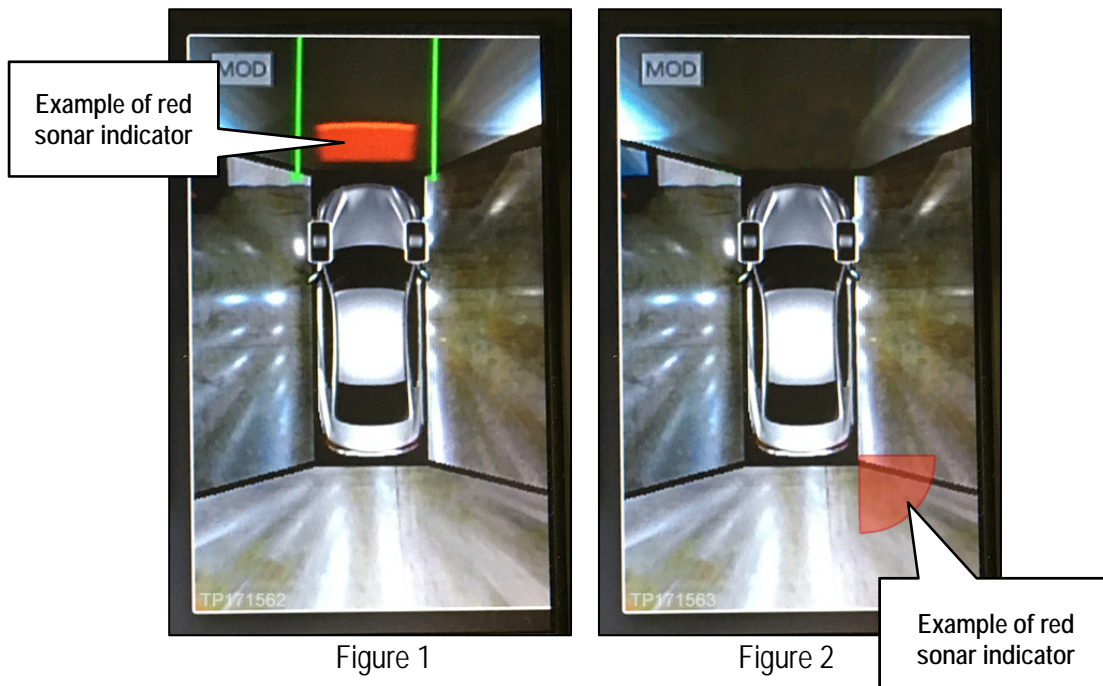
When a center or corner sonar sensor in an Applied Vehicle is close to an object while the sonar system is ON:

- The sonar indicator will appear on the display screen in green, then yellow, but does not change to red no matter how close the object is.

Perform the Service Procedure beginning on page 2 to configure the sonar system.
