Classification:  
 RS19-005A

Reference:  
 ITB19-024A

## DTC B00A0-00 STORED

<b>APPLIED VEHICLES:</b> 2009-2013 FX (S51) 2013 JX35 (L50) 2014-2021 Q50 (V37) 2014-2018 Q50 Hybrid (HV37) 2017-2021 Q60 (CV37) 2019-2021 QX50 (J55)	2011-2013 QX56 (Z62) 2014-2020 QX60 (L50) 2014-2017 QX60 Hybrid (L50H) 2014-2017 QX70 (S51) 2014-2021 QX80 (Z62)
--	--

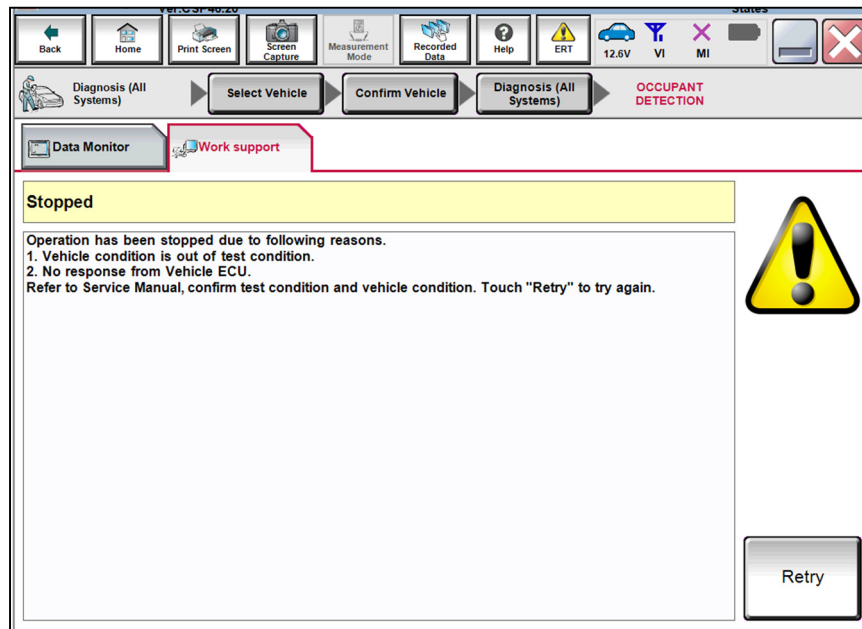
Figure 1

DTC B00A0-00 (OCCUPANT DETECTION SENSOR UNIT) is stored,

OCS zero point reset cannot be performed,

The following screen will display:

1. Check the Occupant Classification System (OCS) control unit using the ODS Analysis tool software.
  - Refer to **SERVICE PROCEDURE** on the next page.

2. Perform "75-zero RESET".
