# SERVICE BULLETIN

Classification: RS19-004A	Reference: NTB19-071A	Date: March 5, 2021
------------------------------	--------------------------	------------------------

## DTC B00A0-00 STORED

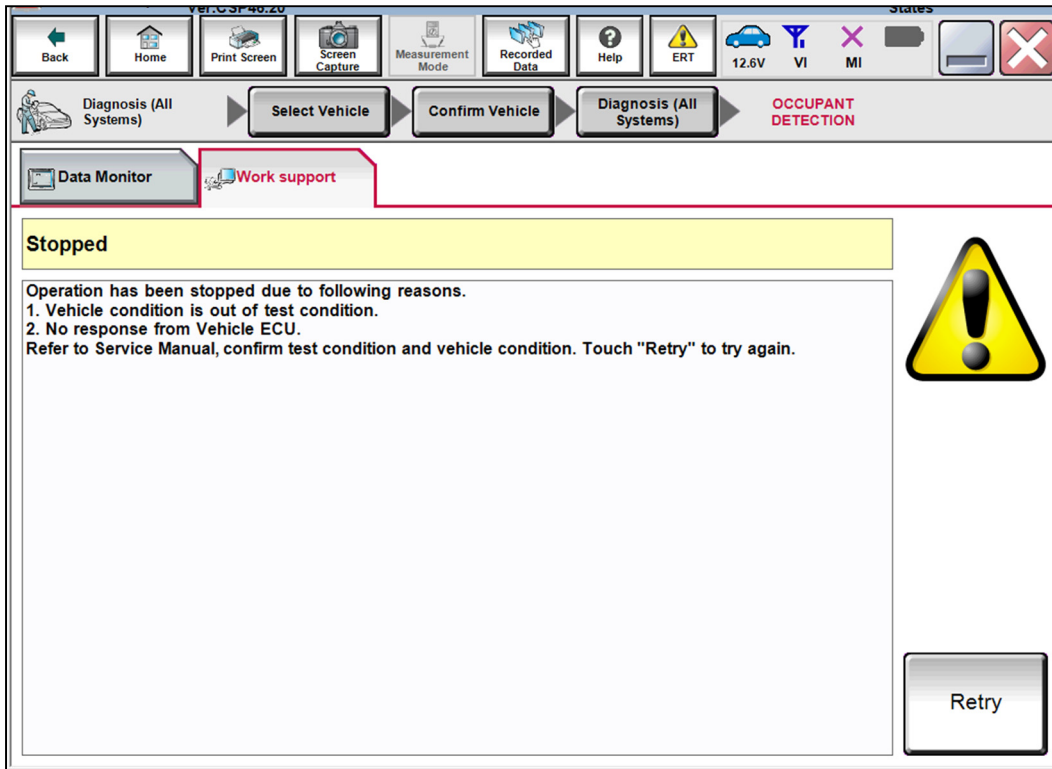
Figure 1

DTC B00A0-00 (OCCUPANT DETECTION SENSOR UNIT) is stored,

OCS zero point reset cannot be performed (continued on the next page)

The following screen displays:

1. Check the Occupant Classification System (OCS) control unit using the ODS Analysis tool software.
  - Refer to **SERVICE PROCEDURE** on page 3.

**HINT:** "OCS" also may be referred to as "ODS".
2. Perform "75-zero RESET".

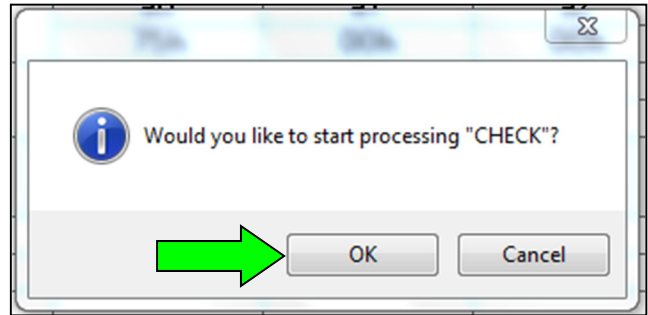
Figure 6

12. Check for code 75h to show under **CURRENT FAILURE CODE**.

- If code 75h shows under **CURRENT FAILURE CODE**, go to step 13.
- If code 75h does NOT show under **CURRENT FAILURE CODE**, STOP HERE. This bulletin does not apply. Refer to ASIST and the ESM for further diagnostic assistance.

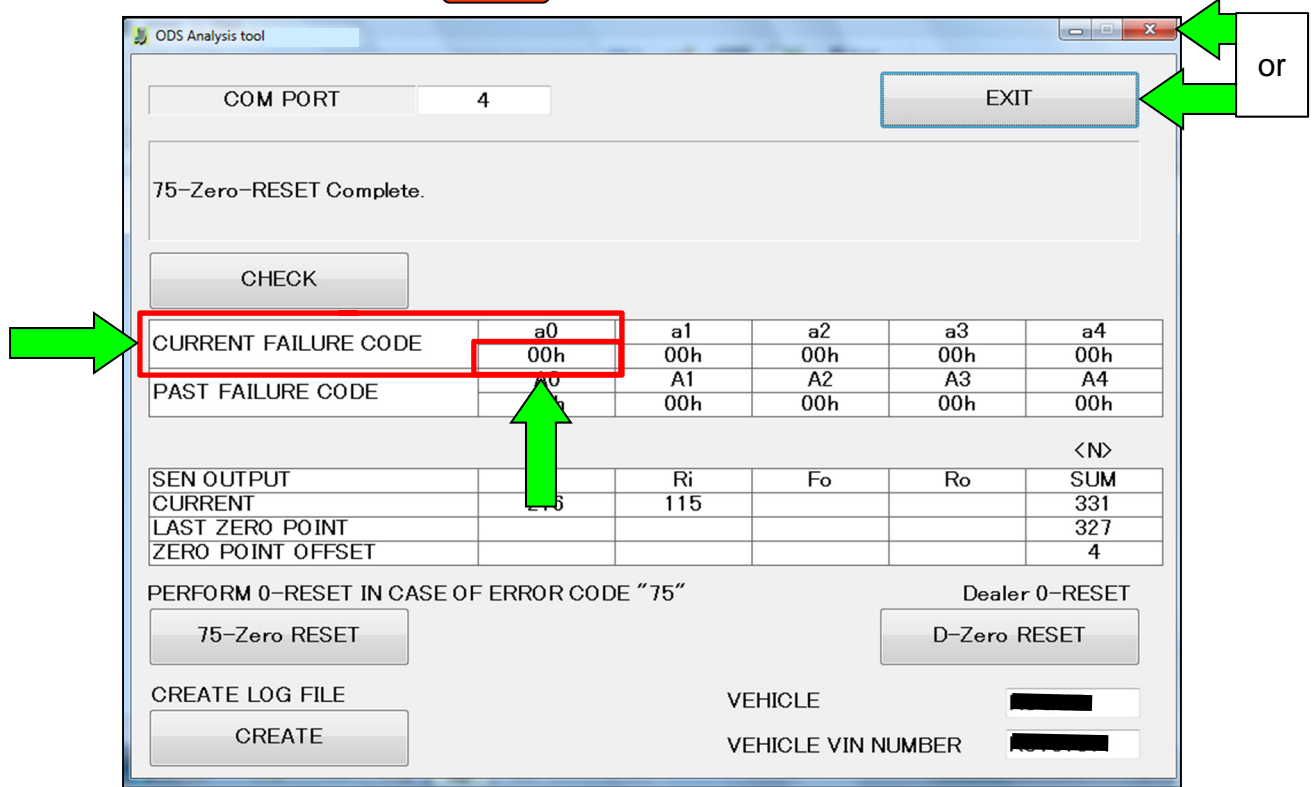
17. When the screen in Figure 10 displays, the 75-zero reset process is complete.
  - Verify code 75h is not displayed under **CURRENT FAILURE CODE**.
18. Select either **EXIT** or the

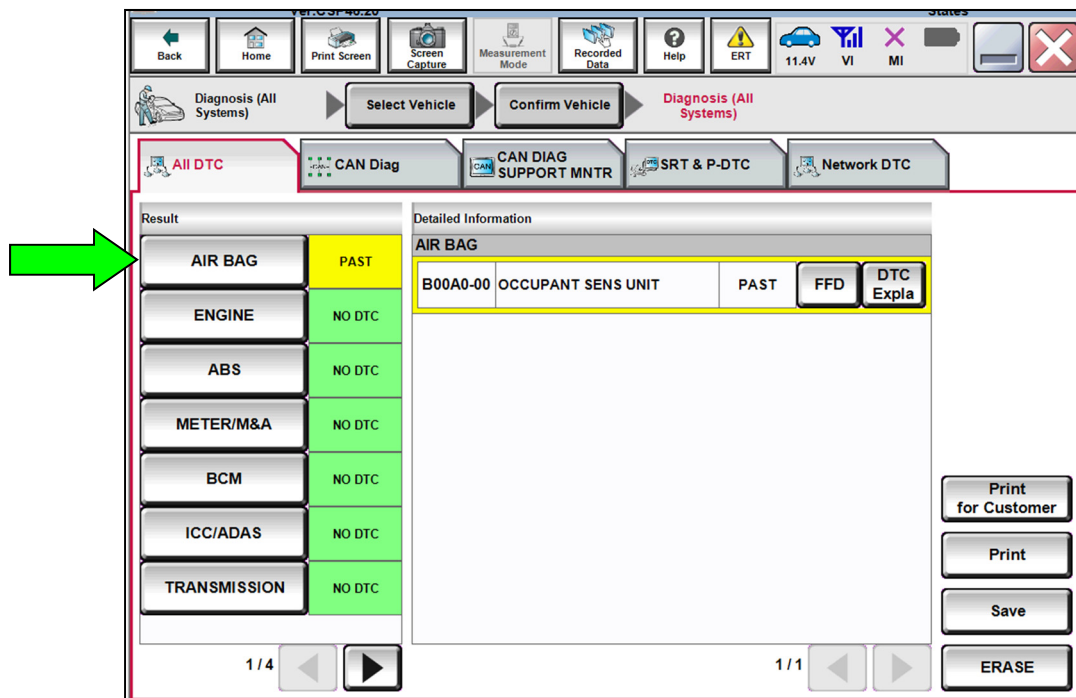
Figure 13

- DTC B00A0-00 should be the only DTC displayed.

24. Select **ERASE**.

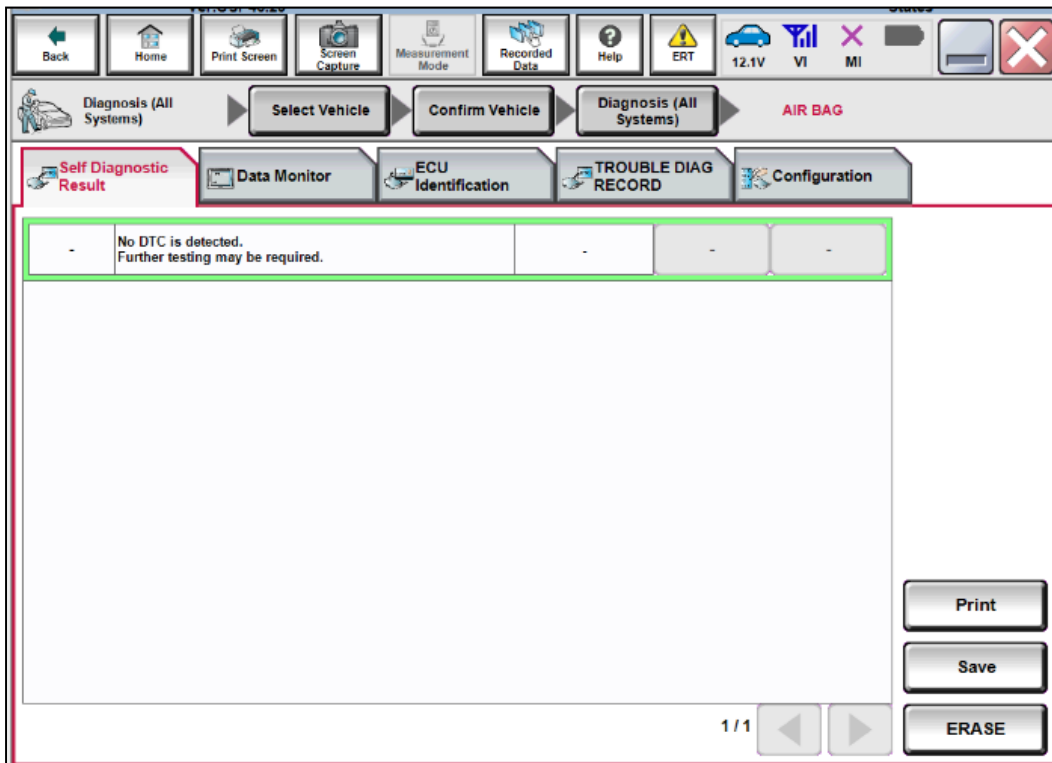
- After selecting **Close**, the screen in Figure 17 should display (the DTC is erased).
