# SERVICE BULLETIN

Classification: AN20-008E	Reference: NTB20-016E	Date: March 4, 2021
------------------------------	--------------------------	------------------------

## RADIO INTERMITTENTLY REBOOTS DURING AUDIO PLAYBACK VIA BLUETOOTH CONNECTED IPHONE

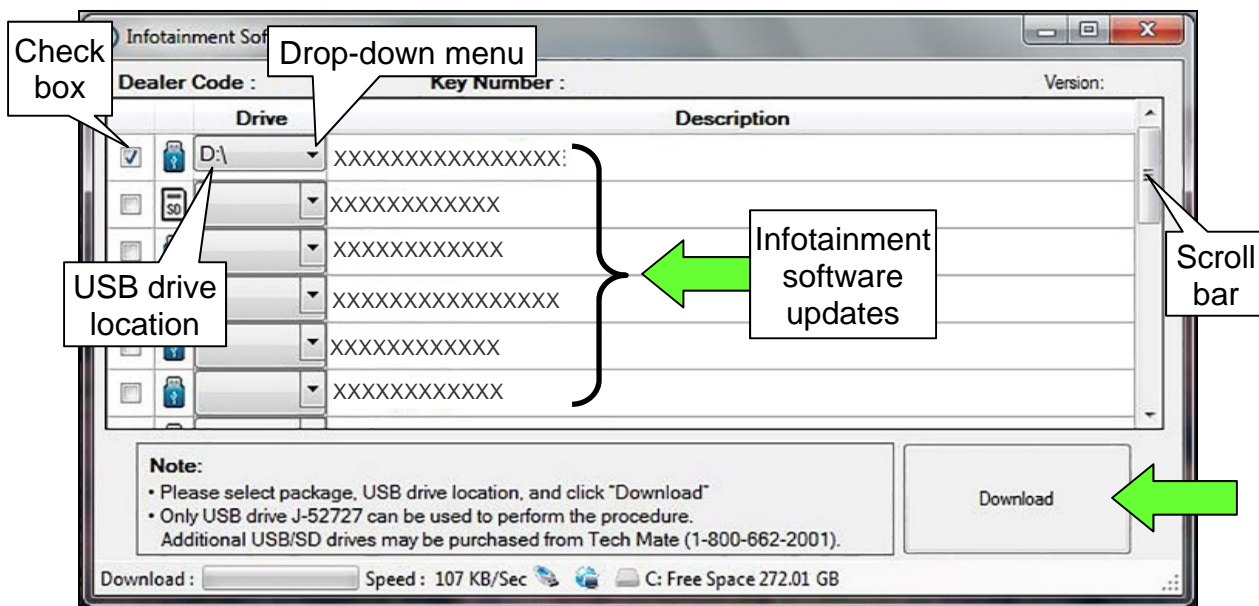
Figure 8

**NOTICE** To avoid damage to the vehicle, ensure the correct update software package is selected. Failure to select the correct update software package may result in needing to replace the AV control unit.

10. Select the check box next to the correct update software package (Figure 8).

- Locate update file #1 (LD001) and update file #2 (see **Table A** above).
- Only 1 update will be loaded at a time, starting with update #1 (LD001).

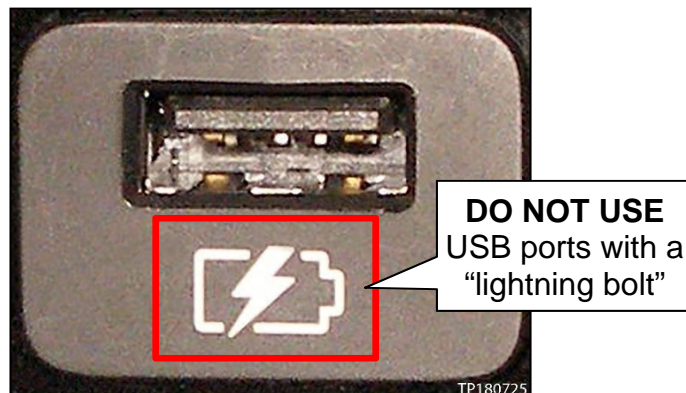
Figure 12

**NOTICE** Do not insert the USB drive into a charging port (Figure 12). If used, the update software and/or USB drive may become damaged. Only insert the USB drive in a USB media port.
