Preliminary Information

PIT5825 Vibration Type Noise Heard at Highway Speeds

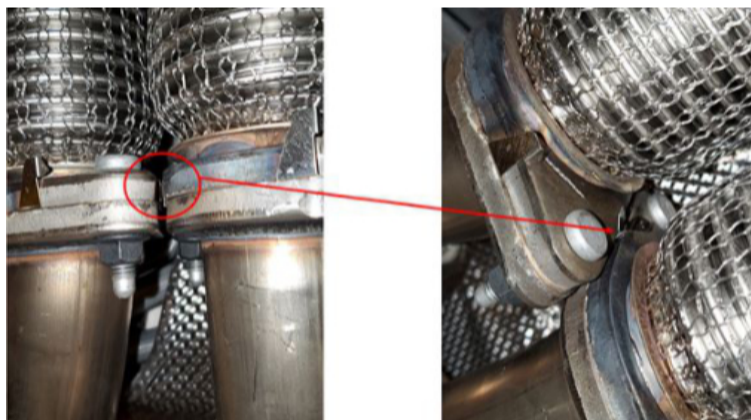
Involved Region or Country	North America
Additional Options (RPO)	LGX
Condition	Vibration type noise at highway speeds heard under the vehicle.
Cause	Some of the metal gasket tabs between the front exhaust and muffler are not fully crimped, exhibiting some spring-back, allowing for them to touch at certain speeds / rpms

With a small punch or chisel and hammer bend/crimp the tabs on the exhaust gasket in further to prevent any spring-back and provide increased clearance between the two tabs to correct the noise.
