# Preliminary Information

## PIP5794 Diagnostic Tips For Engine Related Shudder Concerns

Involved Region or Country	North America
Condition	Vehicle may exhibit a shudder while driving that may be mistaken for a transmission related concern
Cause	Camshaft Actuator System

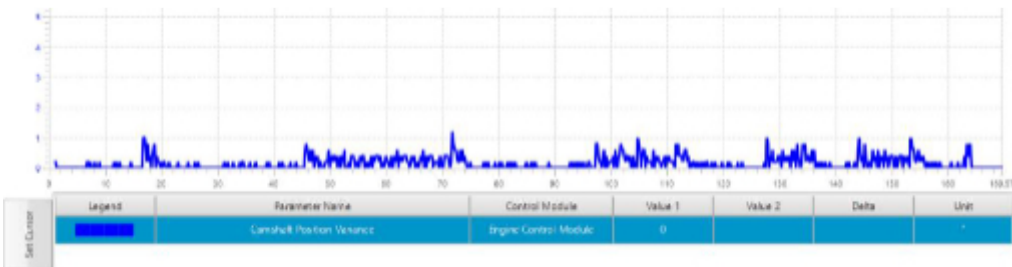
Normal operation (variance under 4 degrees):

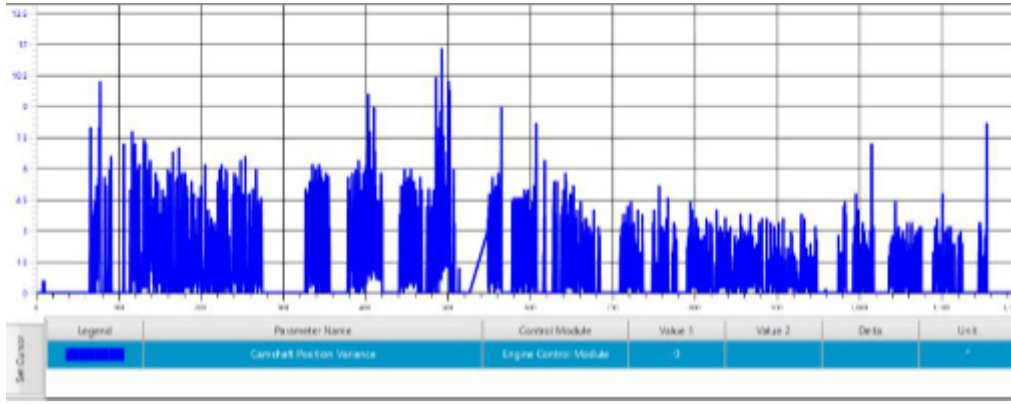
Any variance exceeding 3-4 degrees could potentially cause a noticeable shudder concern and should be diagnosed further (DTCs may or may not be present).

Fault in camshaft actuator system (variance over 4 degrees):
