Technical Journal

Blown fuse, compressor - air suspension

| REF NO: ISSUING DEPARTMENT: TJ 31423.18.1 Technical Service | | CAR MARKET: United States and Canada | |
| 3 US 7 | PARTNER: '510 Volvo Car USA | ISSUE DATE: 2021-02-25 | STATUS DATE: 2021-03-03 |

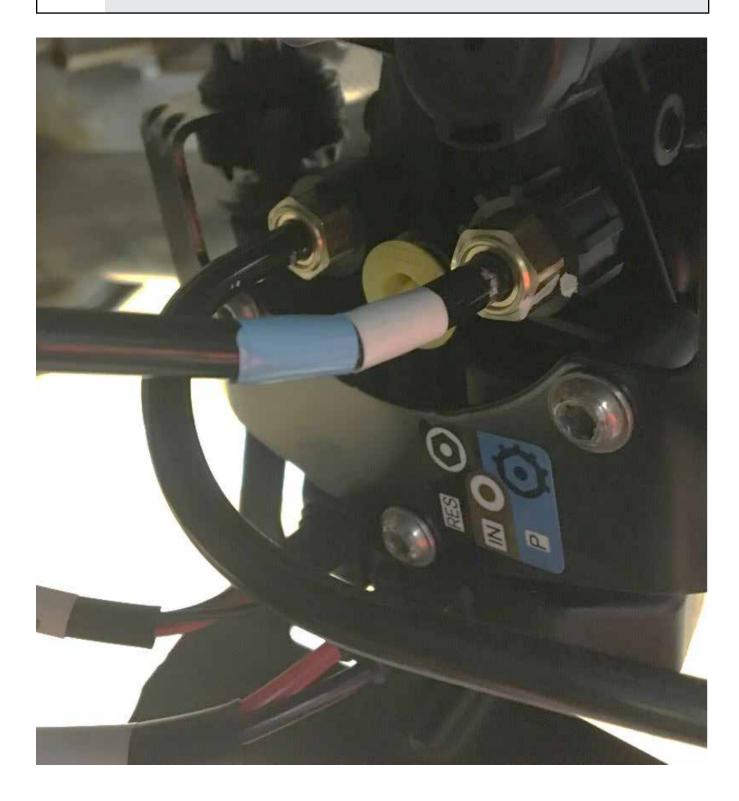
| File Name | File Size |
|---|---|
| Air suspension hoses to compressor.JPG | 0.0679 MB |

Note. Pay attention to which hose is connected to where on the compressor. See attached picture, <u>Air suspension hoses to compressor.jpg</u>.

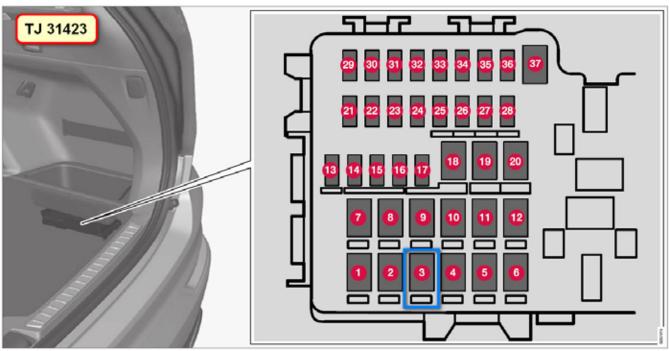
| File Name | File Size |
|---|---|
| TJ 31423 - 2.jpg | 0.1334 MB |

Improved compressors have been introduced in production in Torslanda (VCT) 19w48 and planned to be introduced in Daqing (VCDQ) 20w08 and Chengdu (VCCD), Malaysia (VCMM) 20w11. Note: The concerned fuse is located in the cargo area right side under the storage compartment, fuse number 3, refer to picture TJ 31423 - 2.jpg.

- Replace the compressor fuse 40A, PN 31346535
- Replace the compressor relay, PN 30765045
