## STAR Case

**Case Number:** S1723000001 Rev C

**Symptom/Vehicle Issue:** Left Hand Drivers Side Mirror Takes Longer to Defrost Or Clear Than Right Side Passenger

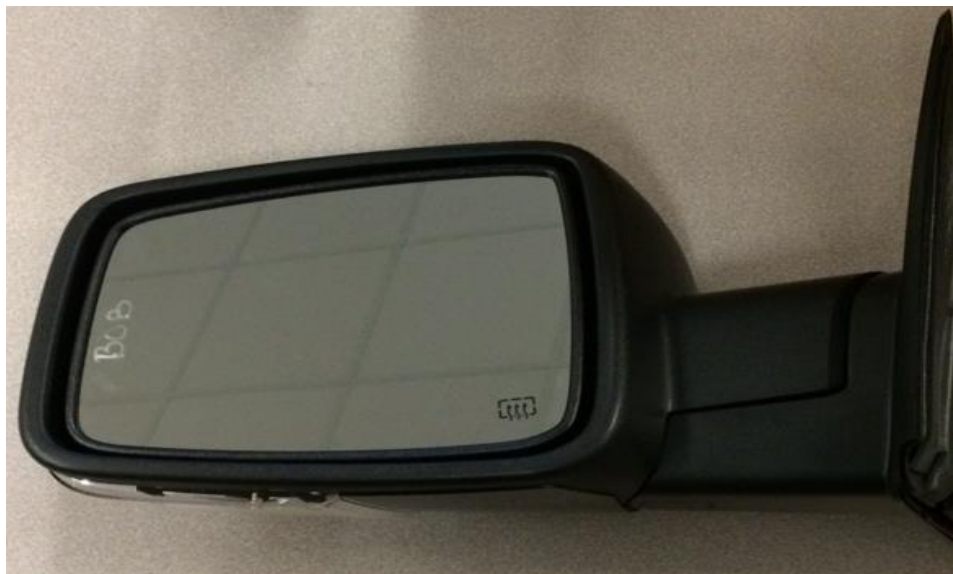
**Discussion:** The driver's side or left side door mirror is an ElectroChromic (EC) dimming mirror. The passenger side is not an EC mirror. Having the EC coating on the driver's side mirror does lengthen the time it will take to defrost or clear the mirror when compared to the right side. This is a normal condition and not a part failure. Replacing the mirror(s) will not correct this.
