NUMBER: 08-045-21

UGQ Radio Enhancements

2018	(JL)	Jeep Wrangler
2020	(JL)	Jeep Wrangler

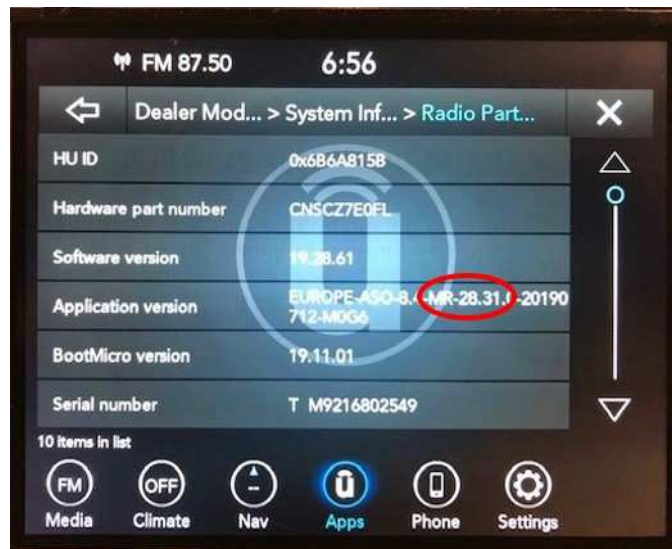
Fig. 1

Radio Software Level Screen

1. Verify the radio software version. Radio must be in Dealer Mode to verify by following these steps:
 - a. Push and hold the front defrost, driver temperature up and temperature down buttons simultaneously until the 'Dealer Mode' screen appears (approximately seven seconds). Release buttons.
 - b. Select "Radio Part Information". The software version will be listed next to "Application Version" (Fig. 1) .

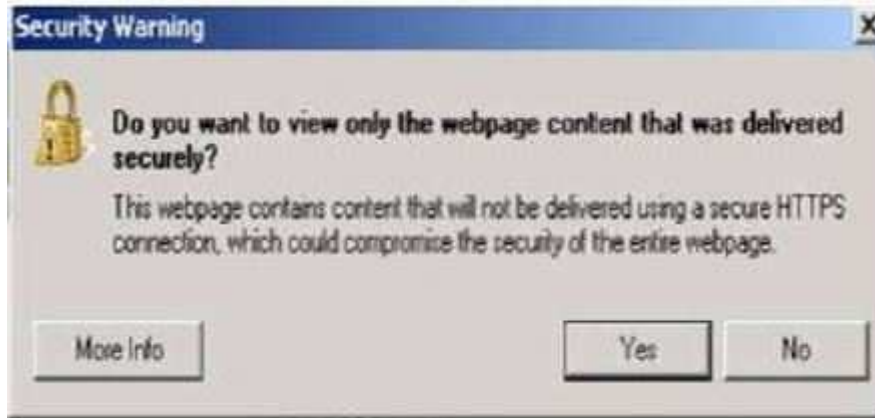
Fig. 2
Pop-Up Security Message

1. Has a **16GB** USB flash drive been created?
 - YES>>> Proceed to [Step 9](#).
 - NO>>> Proceed to [Step 2](#).
2. Go to DealerCONNECT>Service>Uconnect Command Center>Uconnect>More Information >Dealer software downloads to download the files.
3. If a security message appears “Do you want to view only the web page content that was delivered securely?” ([Fig. 2](#)) . Press “No” to continue.

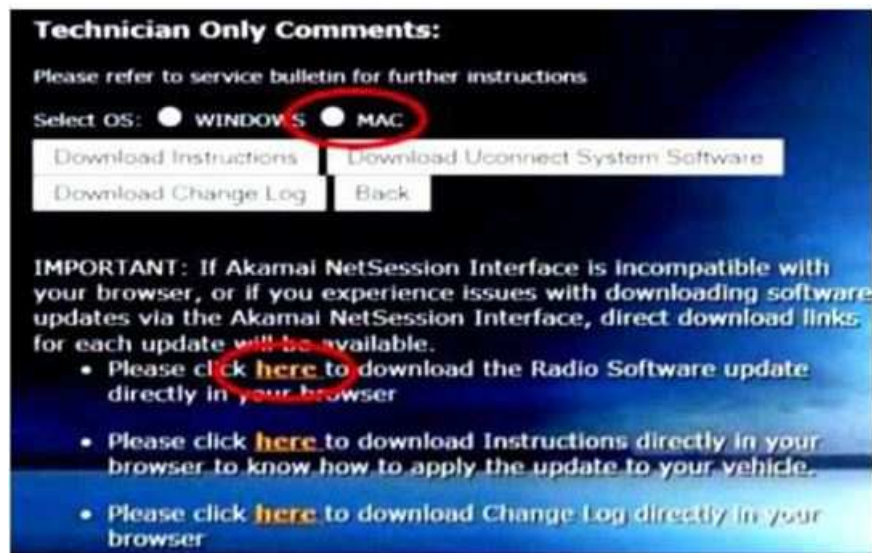
Fig. 3

MAC Download Steps

5. Download the software update file to your local PC's desktop. Make sure to select the "MAC" radial button for all downloads (Fig. 3) .

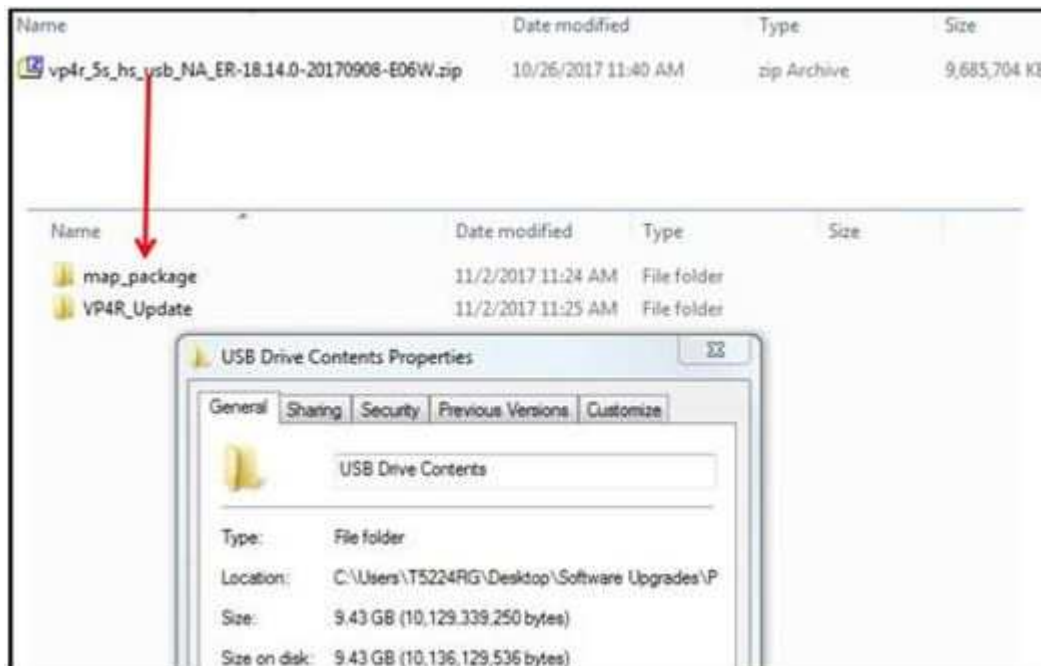
Fig. 4

Files/Folders In The USB Flash Drive

7. Unzip all the files to the root folder of USB flash drive. Files should not be within a zip folder. Your USB files should look like (Fig. 4) when you open it, displaying multiple files/folders.

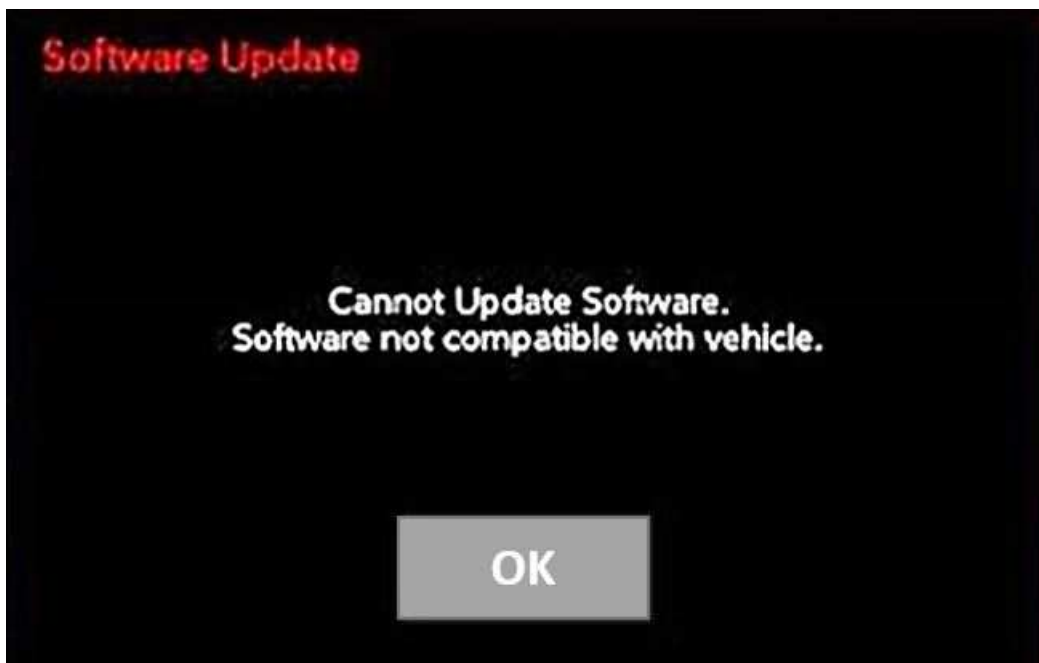
Fig. 5
Software Not Compatible

10. If the screen in (Fig. 5) is displayed, the USB flash drive was not set up correctly. Use a top name brand USB flash drive and create a new USB flash drive. Start the update again.

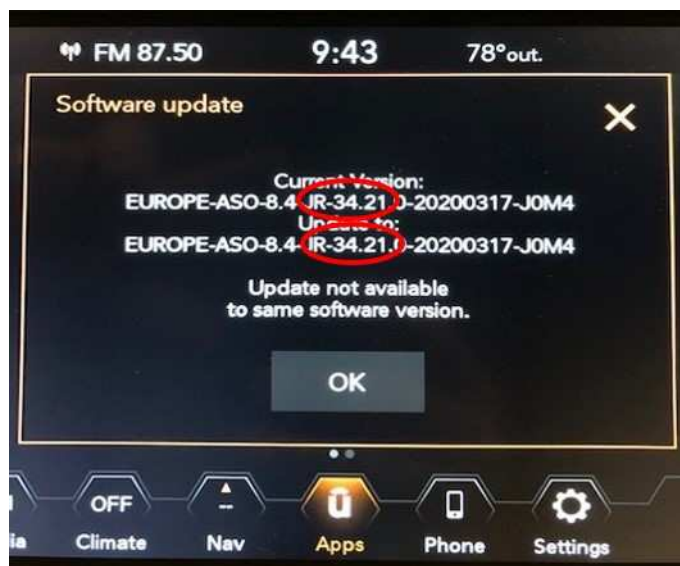
Fig. 6
Screen Displayed When Radio Software Level Is Up To Date

11. If the radio software is up to date, the screen in (Fig. 6) will be displayed. Press "OK" and remove the USB flash drive.
