<b>Technical Service Bulletin:</b> TSB190165	<b>Released Date:</b> 02-Mar-2021
<b>Soot or Ice Deposits in the Intake Air Connection and Fault Codes: 1866, 3361, 3382, 3383, 3389, 7233 and/or 4729</b>

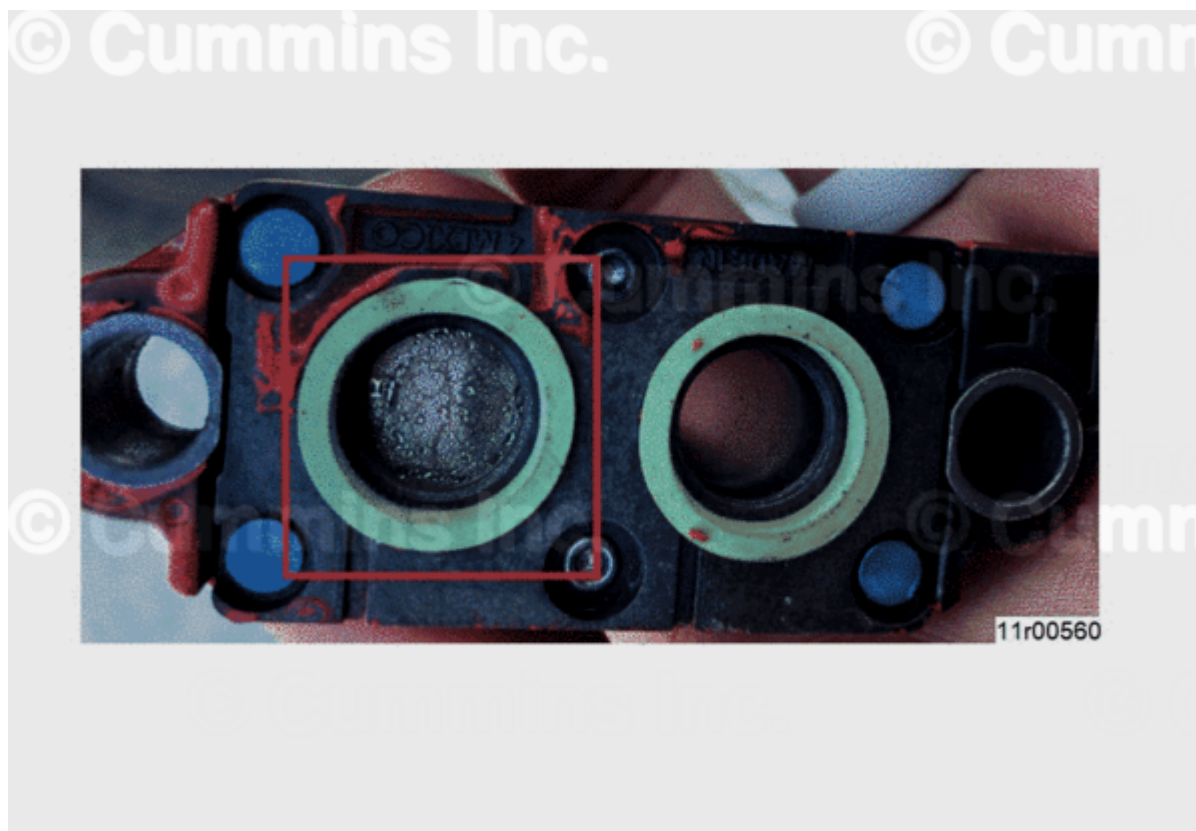
- Soot deposits in the intake air connection exhaust gas recirculation (EGR) differential pressure horizontal and vertical ports are present and have affected EGR flow measurements.
- Icing/condensation in the intake air connection exhaust gas recirculation (EGR) differential pressure sensor or horizontal and vertical ports are present and have affected EGR flow measurements.
  - Icing may **not** be present at the time of the repair, but presence of condensation/water droplets in the EGR Differential Pressure sensor indicates that icing of the sensor is the root cause of this issue.

Figure 1, Condensation on the EGR Differential Pressure Sensor.

- If soot is found, gently wipe away with a clean towel. Be sure not to apply too much pressure on the sensor elements, as they can become damaged.
  - If ice or condensation is found (See Figure 1 below), gently wipe away with a clean towel. Be sure **not** to apply too much pressure on the sensor elements, as they can become damaged.
