NUMBER
231 (Rev 1, 04/28/2021)

TECHNICAL SERVICE BULLETIN

**FRONT VIEW CAMERA REPLACEMENT
FOR DTC C160449 & C160649**

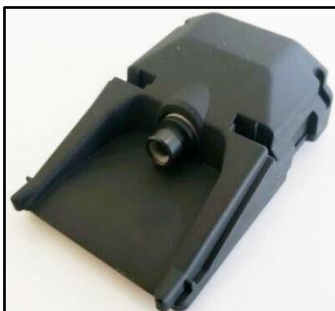
This bulletin provides information on the inspection and replacement of the front camera on some vehicles listed below. Due to an internal control chip concern inside the camera, the vehicle may exhibit an MIL on with DTC C160449 and/or C160649. Certain systems may become temporarily disabled during occurrences: Smart Cruise Control (SCC), Lane Keep Assistance (LKA), Lane Departure Warning (LDW), Forward Collision-Avoidance Assist (FCA), Forward Collision Warning (FCW) and/or Driver Attention Warning (DAW). Follow the procedure outlined in this publication to diagnose and replace the front view camera assembly.

Front View Camera
(image is representative only)
