# Technical Service Bulletin

## 40 Clacking noise from front upper suspension or the bushings are torn

40 21 24 2016453/4 April 21, 2021. Supersedes Technical Service Bulletin Group 40 number 10-08 dated July 15, 2010 for reasons listed below.

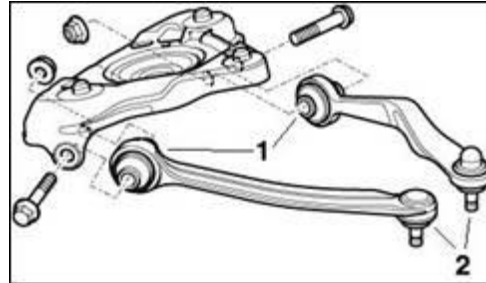
Visually inspect the front suspension upper link rubber bushing (Figure 1) on all four upper links for damaged bushings. Confirm wear as shown in Figures 2-5:

**Figure 1.** Inner bushing (Position1).

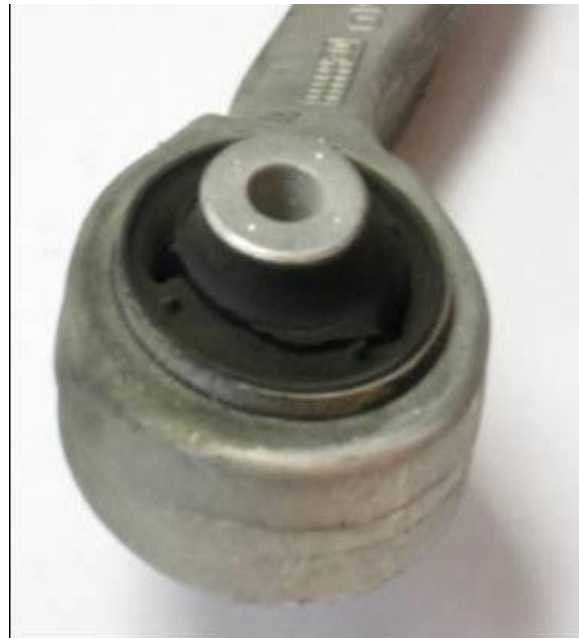
1. The rubber is clearly cracked, as in Figure 2.

**Figure 2.** A bushing with cracked rubber.

If the rubber is clearly cracked (Figure 2) or the bushing insert is displaced (Figures 3 - 4), **replace all four of the rubber bushings** according to Elsa at Repair Manual: *Chassis >> Suspension, Wheels, Steering >> Front Axle >> Suspension Strut and Control Arm.*

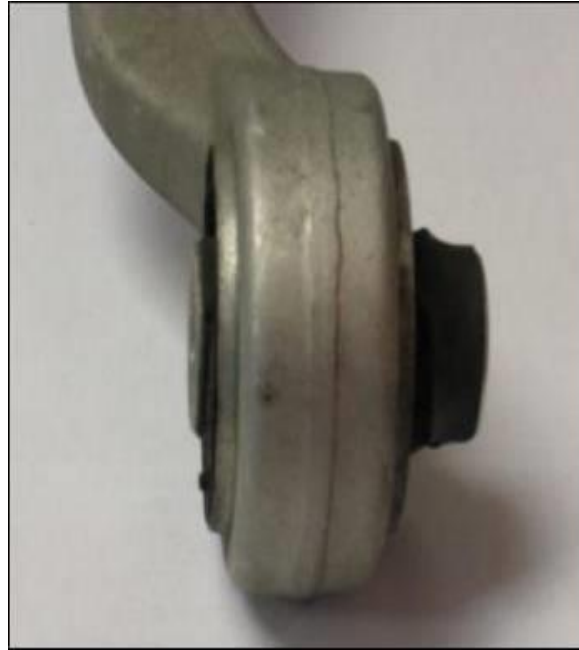
2. The bushing insert is displaced due to a complete rip in the bushing, as shown in Figures 3 - 4.

At any stage of deterioration the link is always captured and will not result in reduced vehicle stability.

**Figure 3.** A bushing with a displaced insert.

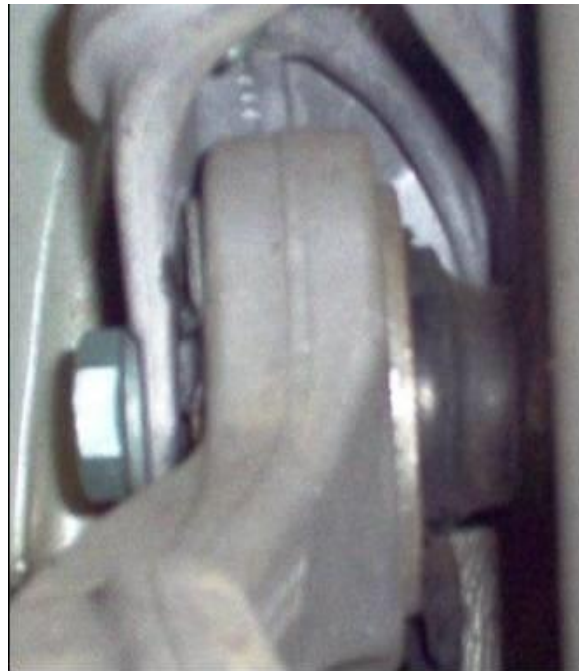
**Figure 4.** A bushing with a displaced insert, shown installed in the vehicle.

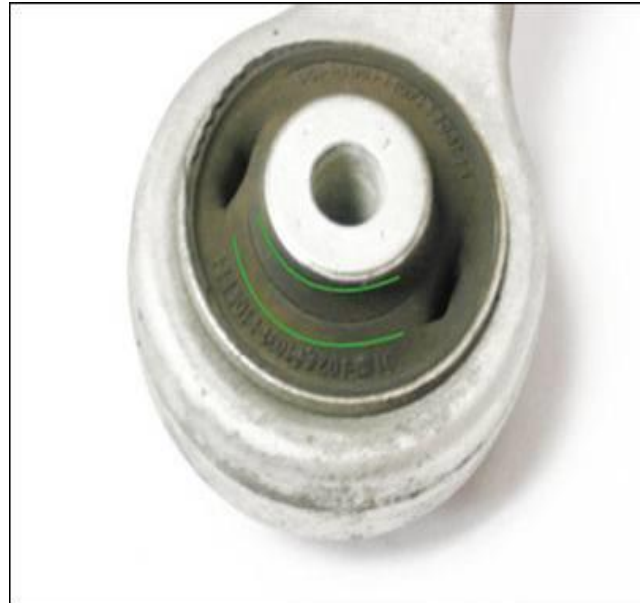
3. The bushing insert has a hairline crack in the surface, as shown between the green lines in Figure 5.

**Figure 5.** A bushing with a hairline crack. This is an acceptable amount of wear.

A hairline crack in the surface (Figure 5) **does not require the bushing to be replaced.**
