# Service Bulletin

Bulletin No.: 19-NA-220

**Subject: Loss of Propulsion, Malfunction Indicator Lamp (MIL) Illuminated - DTC P0A3F and/or P1B03 Set**

Brand:	Model:	Model Year:		VIN:		Engine:	Transmission:
		from	to	from	to		
Chevrolet	Bolt EV	2017	2021	—	—	—	—

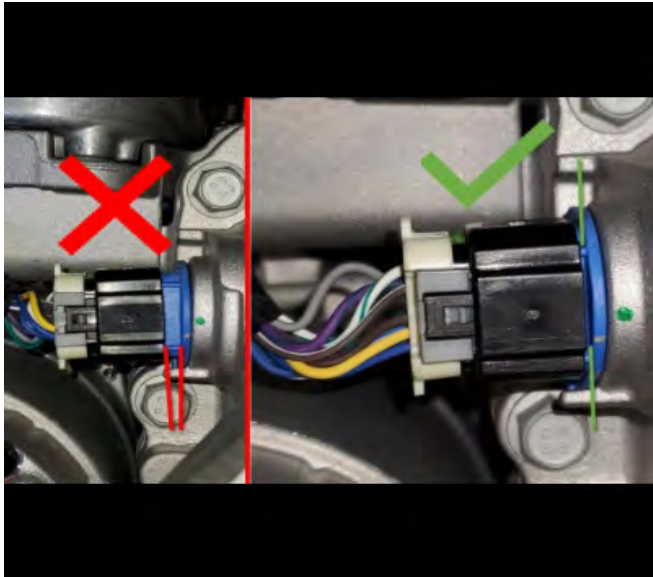
5518453

Ensure that the connector is fully seated.

<b>Correction</b>	<p>Replace the Engine Harness.</p> <p>Due to the sensitivity of resolver (motor position sensor) circuits, replacing the connector with a terminated lead is not permitted per SI document ID 4583435. These diagnostic codes result in a loss of propulsion event on the vehicle.</p> <p>Exercise care when connecting the new harness to X2 on the transmission by aligning the connector bodies and not attempt to install at an angle.</p>

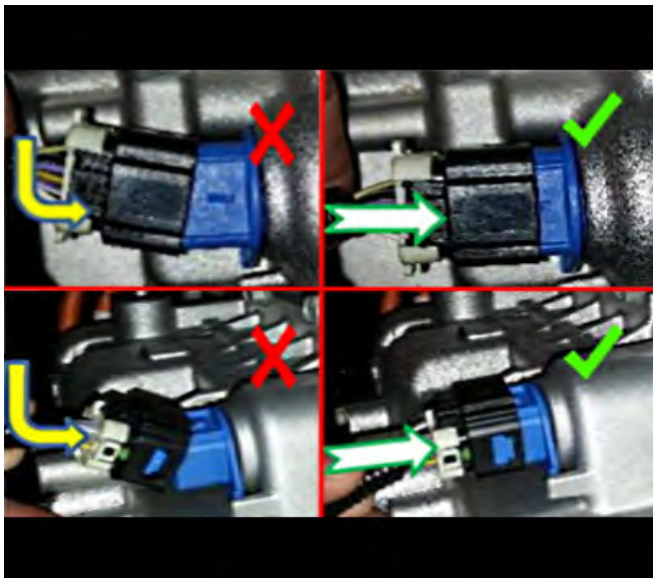
5409322

Showing both proper and improper alignment of the X2 connector.

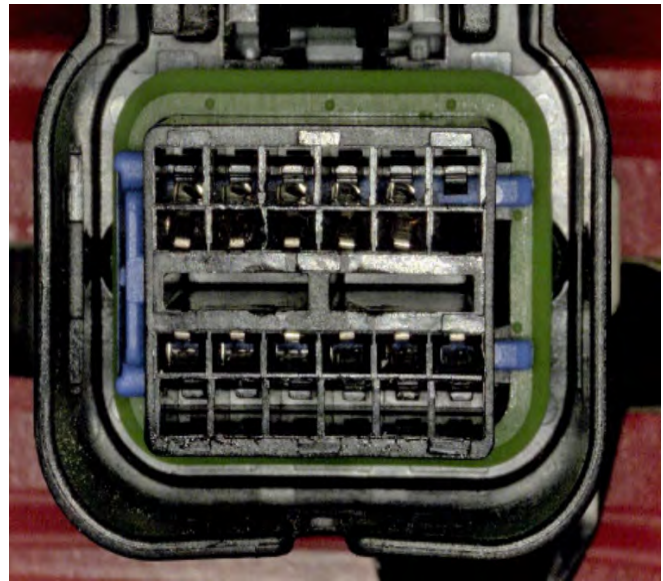
5409321

Example case of damaged terminals. Terminals do not need to have visible damage to set DTCs P0A3F and P1B03.
