# Service Bulletin

Bulletin No.: 20-NA-047

**Subject: Front or Rear Crankshaft Oil Leak, Malfunction Indicator Lamp (MIL) Illuminated - DTC P1101 Set**

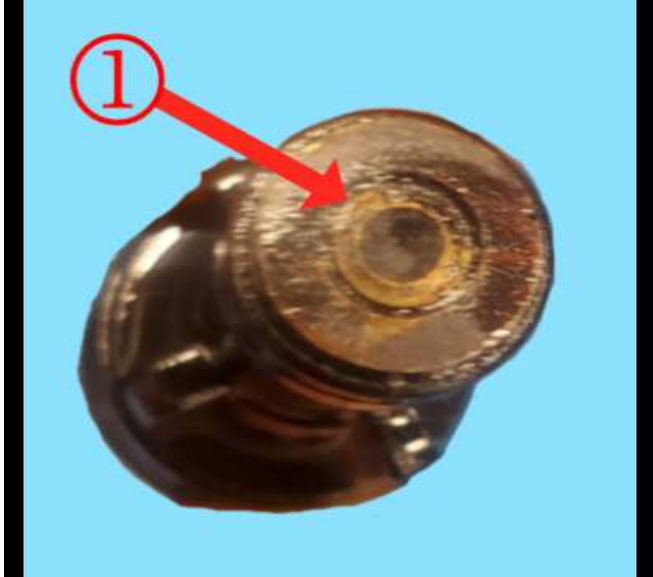
5513764

If diagnosing for oil leaks and/or DTC P1101 with no engine oil leaks and excessive positive crankcase pressure exists, an obstructed PCV orifice (1) would be suspect requiring a PCV orifice replacement.

Remove the camshaft cover and remove the PCV orifice and inspect for blockage. Replace the orifice as necessary along with the camshaft cover gaskets. Make sure the camshaft cover does not have any blockages in the PCV passages.
