Technical Service Bulletin

91 MIB2 High: Phone/Audi connect telephone and online services do not work

91 21 94 2051613/3 April 29, 2021. Supersedes Technical Service Bulletin Group 91 number 18-08 dated August 24, 2018 for reasons listed below.

Model(s)	Year	VIN Range	Vehicle-Specific Equipment
A6, A7, TT, and R8	2015 - 2019	All	MIB2
A4, Q7	2017	All	MIB2

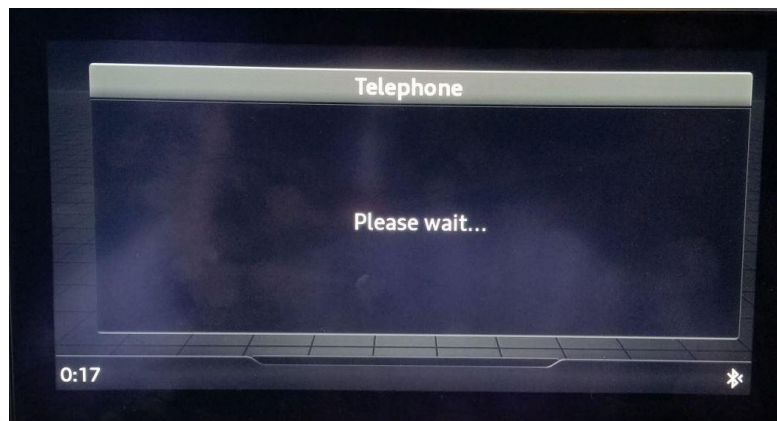
- The message "Please wait ..." is **permanently** shown in the phone menu. Therefore a mobile device cannot be used in the hands-free Bluetooth mode. This message is still shown after the vehicle sleep cycle.

Figure 1. Message shown permanently in phone menu.

The phone module is not initialized and therefore is not recognized in the infotainment control module.

- Check the SIM card reader with a flashlight and magnifying glass or photo for broken or damaged pins. If the card reader is damaged, replace the main unit.
- Remove the fuse for the information electronics control module for at least 30 minutes. If the fault is still permanently present, continue with the TSB. Otherwise, the issue has been resolved.
- Review the *Required Parts and Tools* section of this bulletin.
- Obtain the telephone module retrofit kit listed in the *Required Parts and Tools* section of this bulletin (if required).
- Obtain the software matching the customer's vehicle according to the *Required Parts and Tools* section of this bulletin.

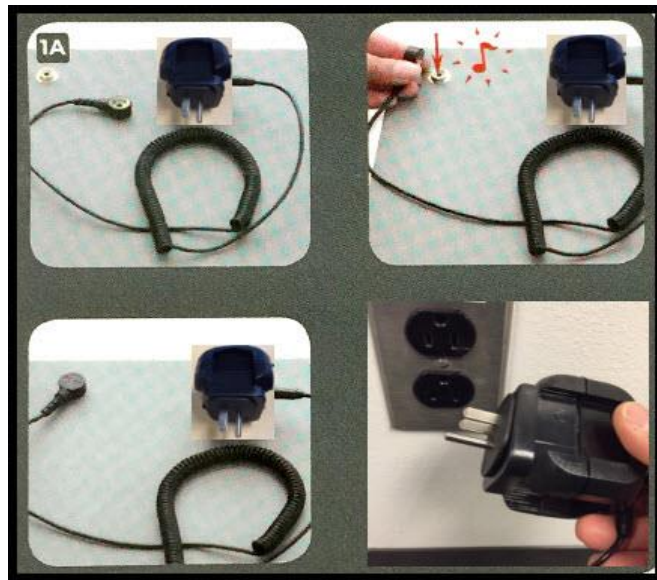
Figure 2. VAS6613 ESD work surface grounding plug.

3. Place the ESD anti-static mat onto the surface. Ensure that all three grounding straps are securely strapped to the ESD mat.
4. Ground the ESD mat by plugging the 110V grounding strap into a wall socket or power strip (Figure 2). If a power strip is used, it must be plugged into a grounded wall outlet (see attached user instructions for VAS6613 titled "VAS6613 ESD Workspace Guide.pdf").

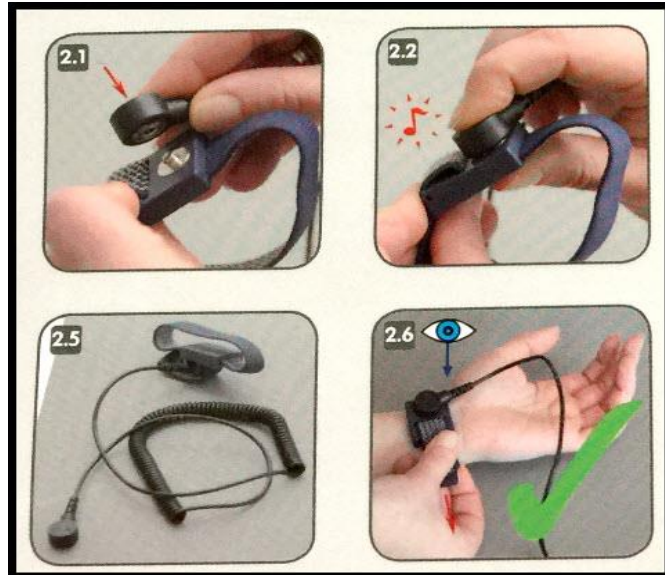
Figure 3. VAS6613 ESD work surface grounding wrist strap.

5. Ground yourself by placing the elastic strap around your wrist. Make sure it is securely touching your skin. It cannot be loose-fitting or over your shirt cuff (Figure 3).

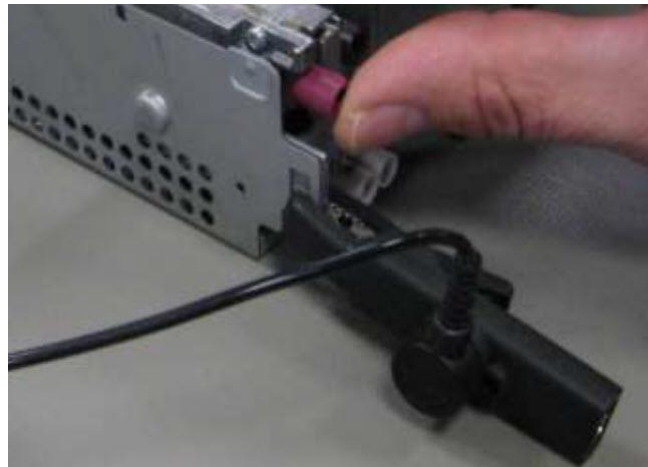
Figure 4. VAS6613 ESD work surface grounding device clip.

6. Ground the MIB main unit by placing an alligator clip on the back, ensuring that it makes contact with the metal housing of the main unit. The most secure location is at the bottom of the metal bracket (Figure 4).

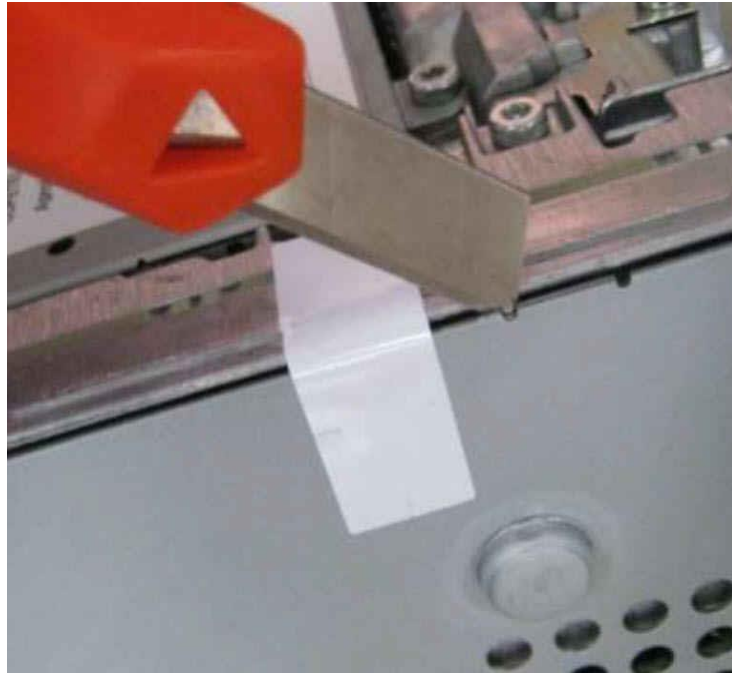
Figure 5. Break the white warranty seal.

- Break the white warranty seal on the back of the main unit (Figure 5).

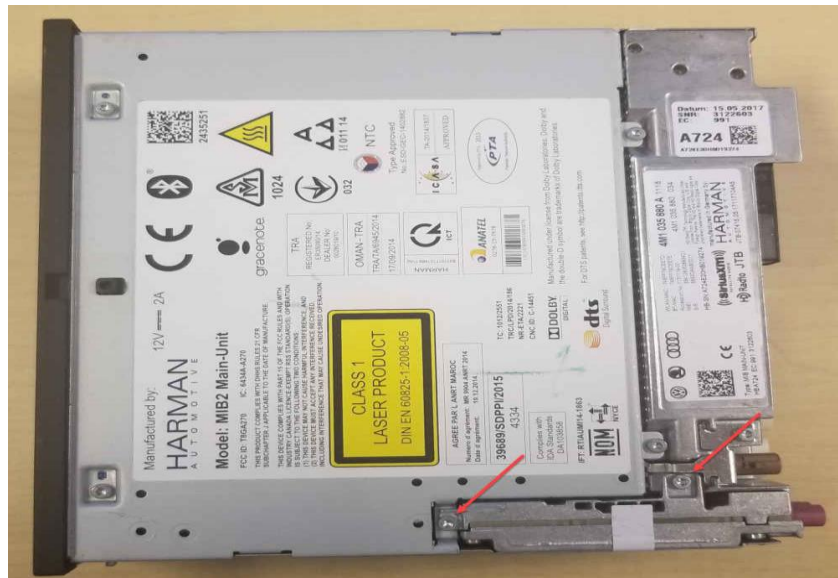
Figure 6. Telephone module retaining screws indicated by the red arrow.

- On the top of the main unit, remove the two retaining screws that hold the telephone module in place (Figure 6).

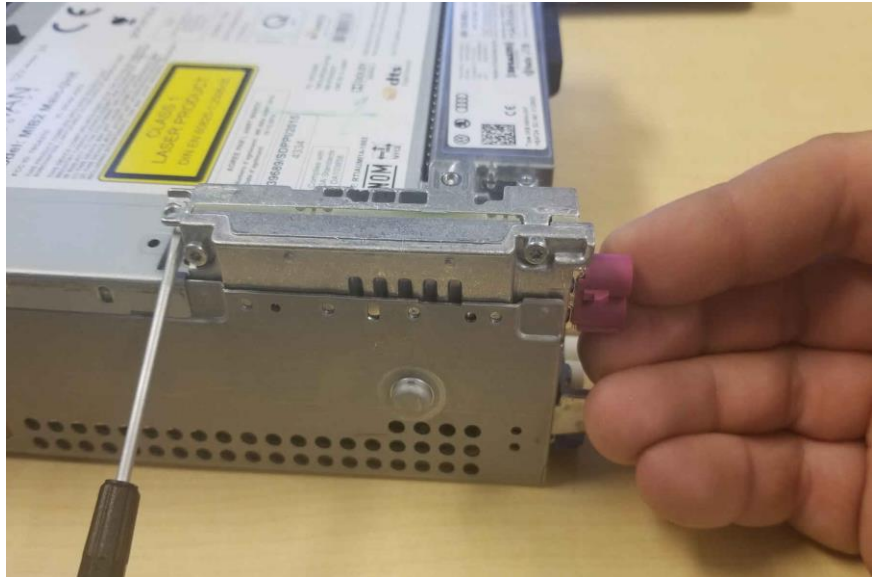
Figure 7. Lift up on both ends of the telephone module.

10. Carefully lift up the telephone module, using both ends as points of contact when pulling up. Use a flathead screwdriver to lift the forward flange (Figure 7). The module is held in place with a computer socket-type attachment and will release when enough force is used.

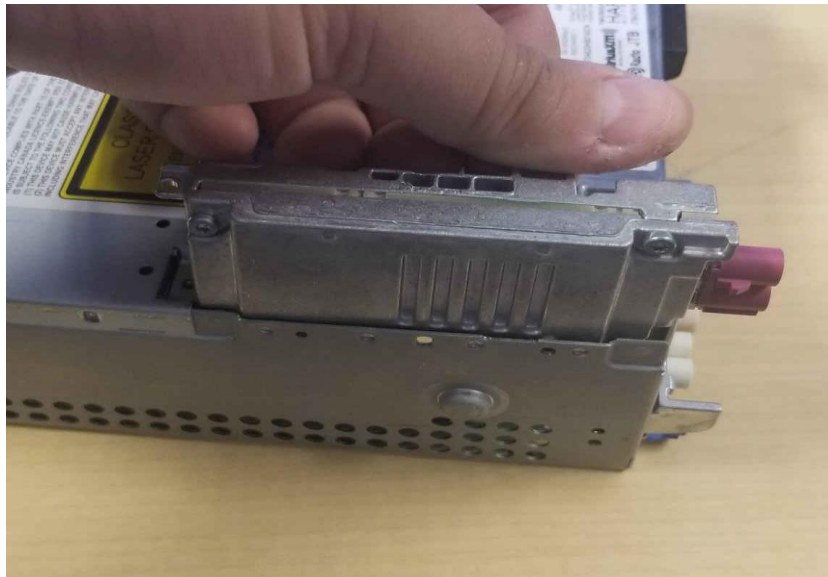
Figure 8. Do not press down using the purple FAKRA connector.

11. Place the new telephone module into the socket, making sure it is level before snapping it into place. Use both ends of the telephone module when pressing it into place. Do not press down using the purple FAKRA connector (Figure 9).

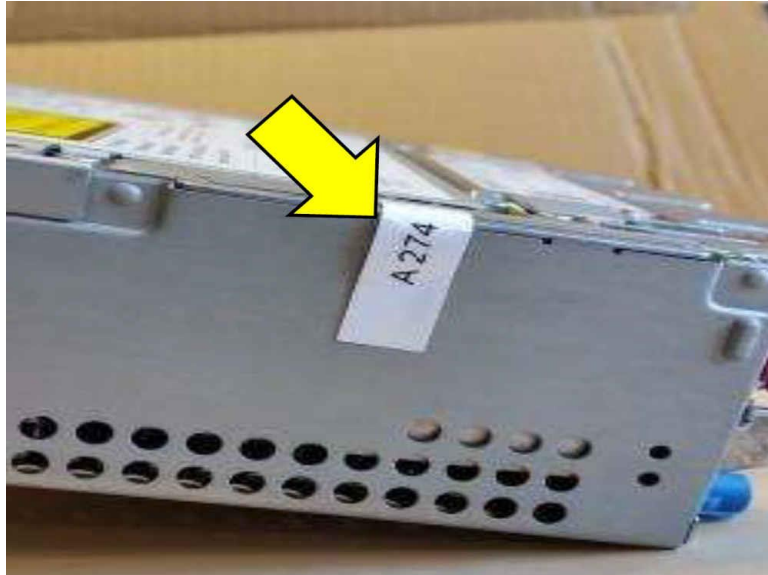
Figure 9. Place the new warranty seal over the location indicated by the yellow arrow.

13. Place the new warranty seal from the retrofit kit over the original warranty seal (Figure 9).
