**Location:** Powertrain Transmission – Rear Axle

**Topic:** Clutch oil leak between the clutch and gearbox casings

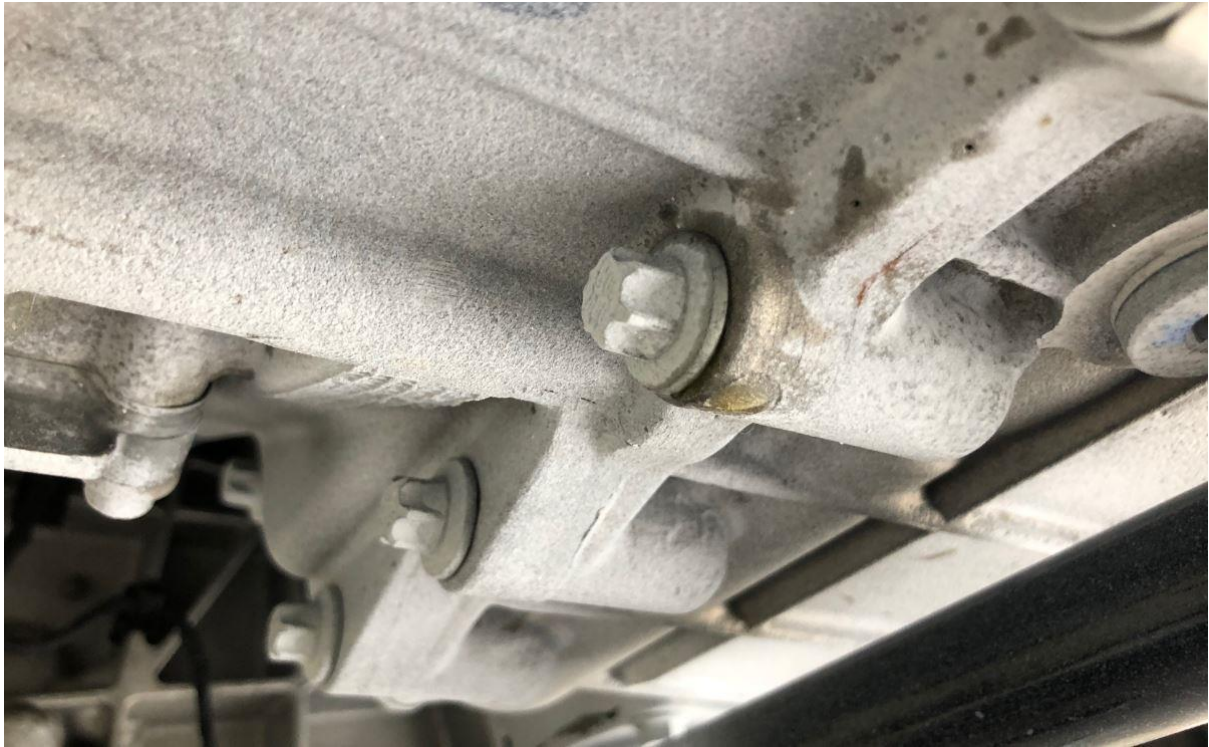
If a leak between the clutch and gearbox housing has been identified (as shown in the image below), follow the steps included in this document before considering replacing the transmission.

**Note:** A leak between the clutch and transmission casings may be due to porosity in the threaded holes.

1. Capture images of the area with the leak
2. Clean up and dry the transmission
3. Apply leak detector spray in the area that has previously leaked
4. Bring vehicle to operating temperature (test drive if necessary)
5. Inspect the transmission to confirm the source of the leak (if still present)
6. Capture new images of the leak
7. If the leak is confirmed that is between the two casings, proceed to the next step. If no further leaks have appeared no further action is required.
