**Vehicles Affected:** All Models

**Location:** Chassis - Steering

**Topic:** Oil residue at steering rack rubber boot

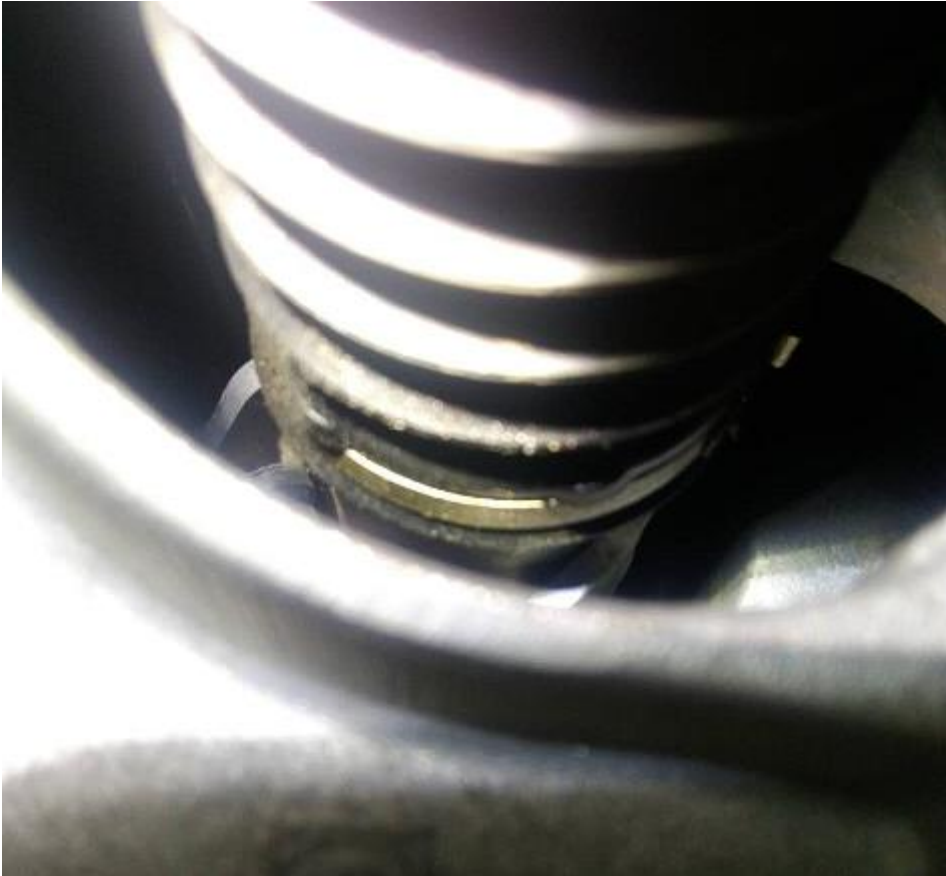
If during inspection oil residue is found around the end of the steering rack rubber boot (picture in the attachments section), do NOT replace the steering rack unless the following are confirmed;

If none of the above are valid, the oil residue around the steering rack rubber boot is grease that is used during assembly at the manufacturer and not power steering fluid. Therefore the operation of the power steering system is not affected.

Clean the oil residue and operate the steering from lock to lock for 10 times. Re-check the area and release the car if no power steering fluid leak is present.

- If power steering fluid has leaked the fluid level would be low and evidence of fluid will be present under the steering rack. In this event, proceed and replace the steering rack.
