Location: Body BIW - Floors

Topic: Wind noise

Condition: Primarily at high speed

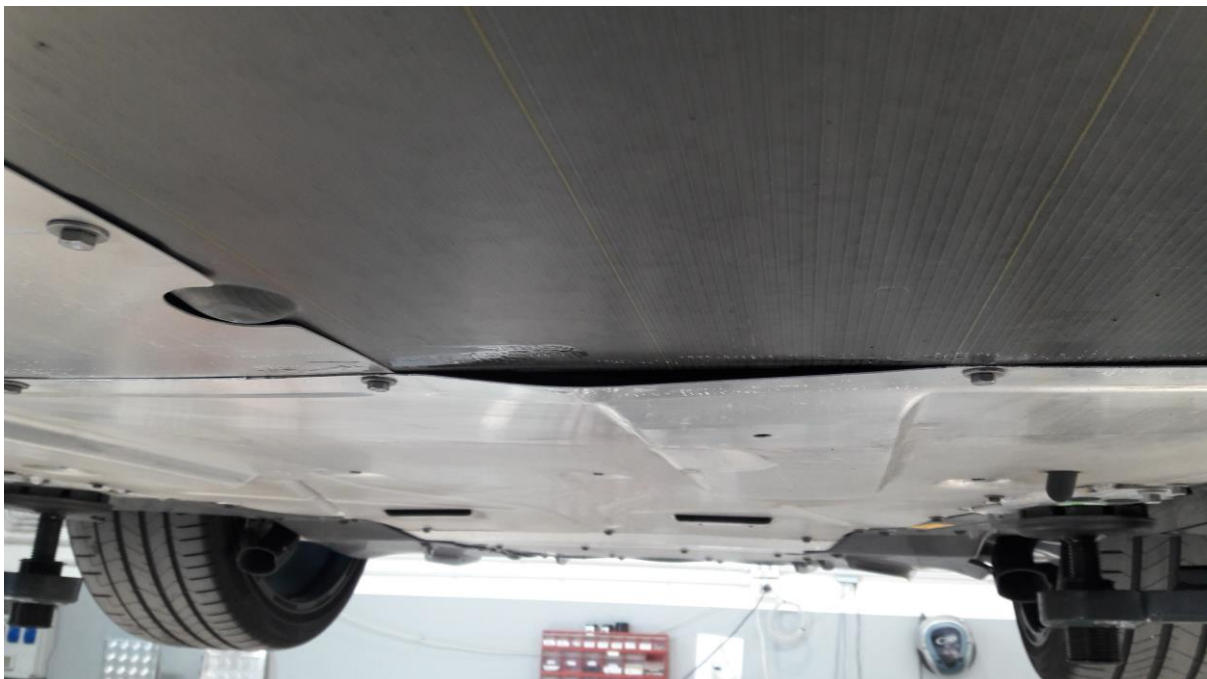
In the event of a customer complaint for wind noise and/or vibration when driving at high speed, raise the vehicle on the lift and inspect the engine floor.

If the floor is distorted as shown in the picture below, remove the floor and repair the deformed area of the floor.
