## Product Update: 2016-20 HR-V Software Update and CVT Inspection

### AFFECTED VEHICLES

Year	Model	Trim Level	VIN Range
2016-20	HR-V (CVT models only)	ALL	Check the iN VIN status for eligibility.

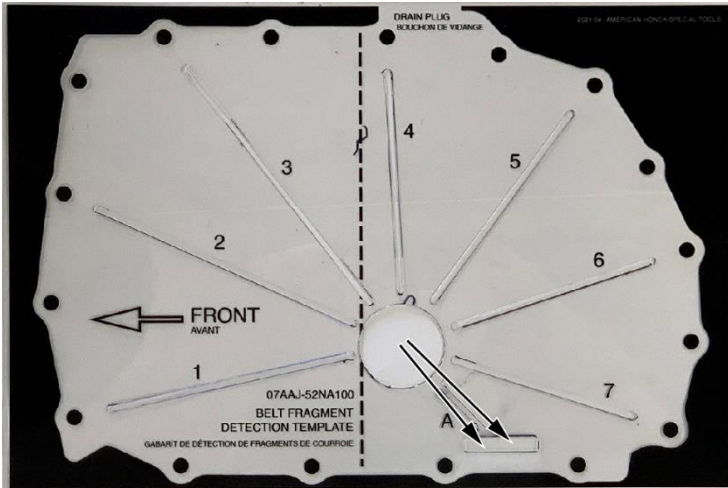
- After tracing all 7 lines from the outside to the inspection area, let go of the magnet to see if it sticks in place. If the magnet sticks to the oil pan in the inspection area there is a problem with the transmission, go to service bulletin 21-047, *Warranty Extension 2016 - 20 HR-V CVT Premature Belt Deterioration*. If the magnet does not stick to the oil pan, go to the next step.
- Place the magnet in the inspection area and slowly trace the "A" lines with the magnet to the lower right-side magnet shown on the oil pan (see image below). This is done to move any metal contaminates too small to hold the test magnet to the internal transmission magnet. Inspection is complete.
