Technical product information

Topic	Engine overheating - Warning on the DIP - V8 Kovomo
Market area	Bentley: worldwide (2WBE)
Brand	Bentley
Transaction No.	2061369/2
Level	EH
Status	Approval
Release date

Bentayga - New Continental GT/C and New Flying Spur

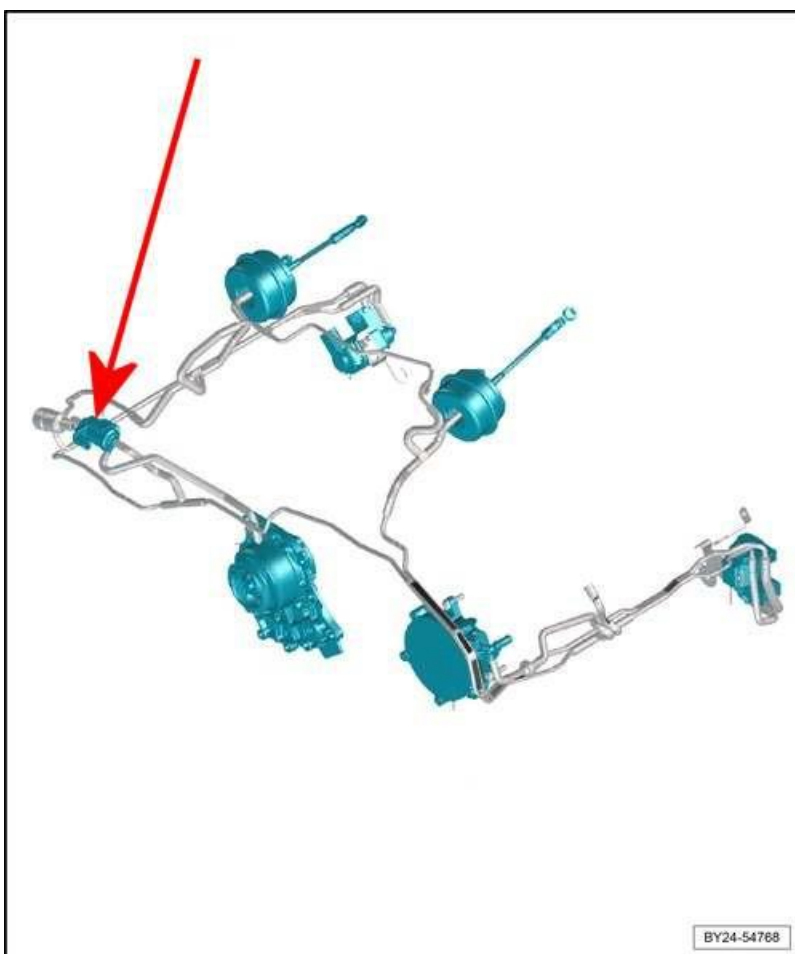
Figure 1 Shows the Bentayga Solenoid (Arrow)

When the solenoid is at fault (sticking open) the vacuum supply is constant, this allows the sleeve to stay in position around the impellor which leads to the symptoms described within the Customer statement/Workshop findings section of this TPI

1) Check and confirm the solenoid valve is sticking open and supplying a constant vacuum

2) The gain access to the solenoid - Remove the right hand engine side cover – Rep.Gr 10

- Disconnect the vacuum hoses and electrical connection
- Replace the solenoid
- Reconnect the vacuum hoses and electrical connection
- Refit the right hand engine cover

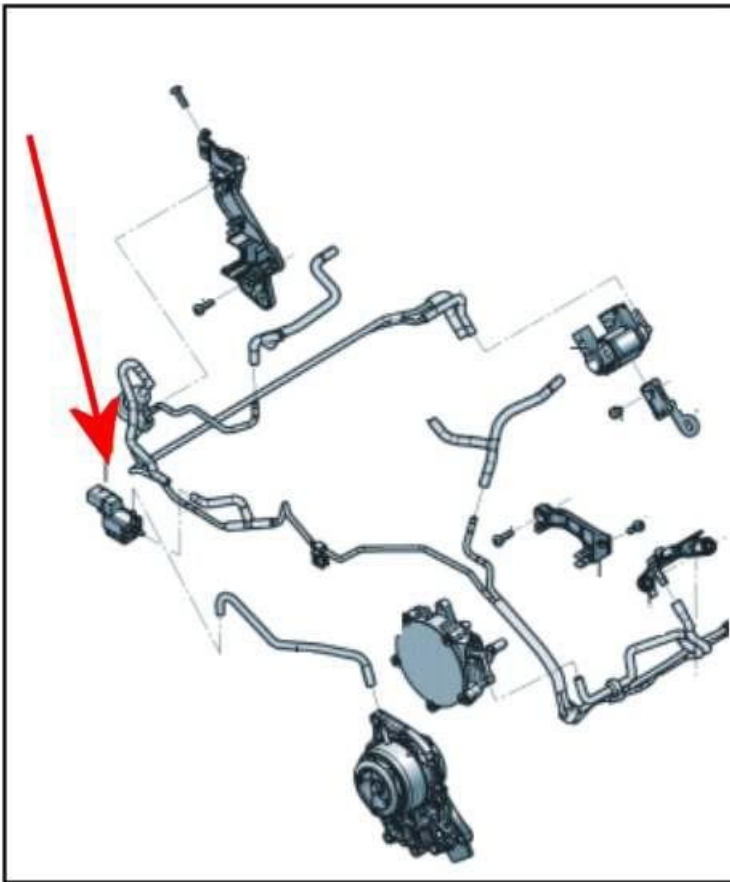
Figure 2 Shows the New Continental GT/ GTC and Flying Spur solenoid (Arrow)
