Location: Electrical - Window Lift

Topic: Window Anti-Trap poor behaviour

Condition: When raising window or closing door the window's Anti-Trap feature is enabled

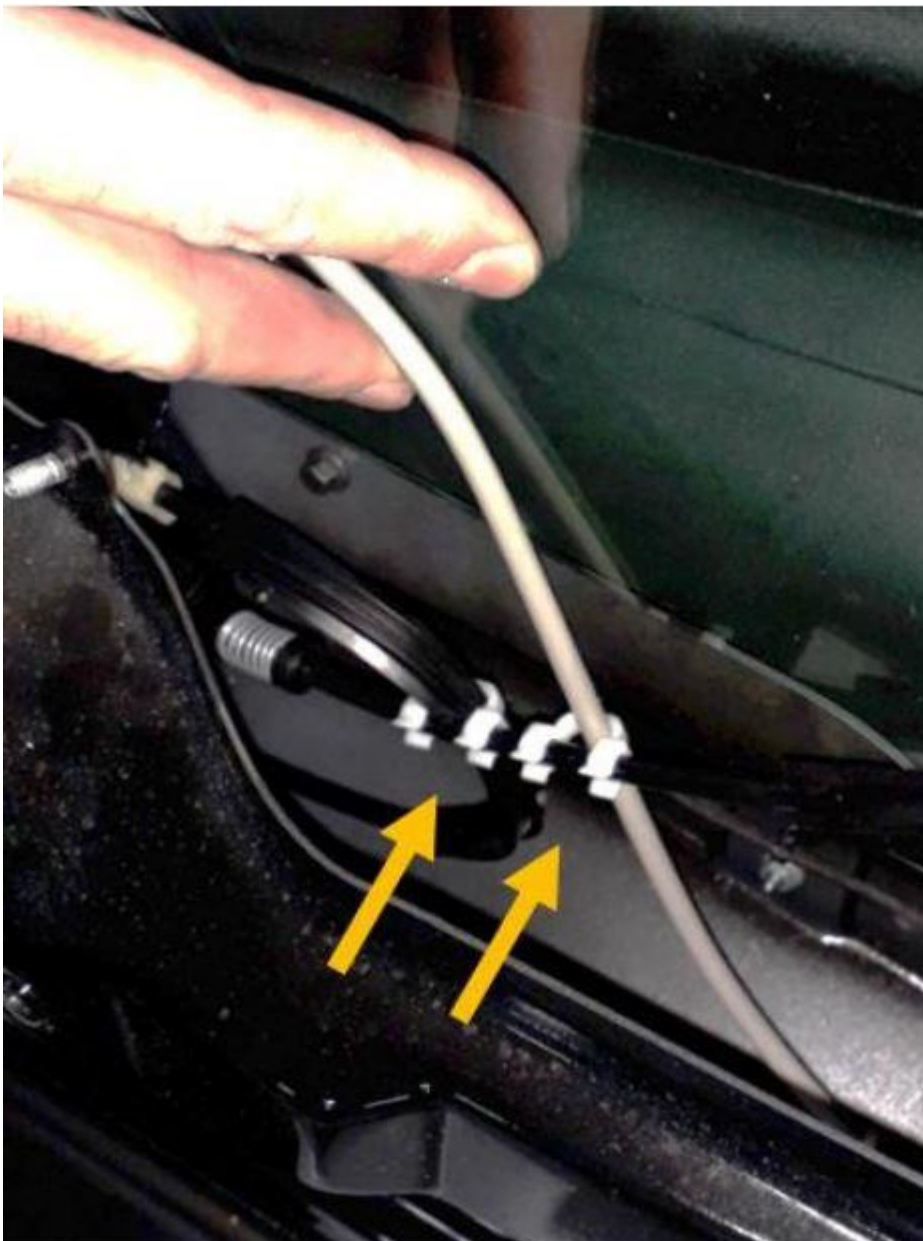
If window anti-trap is still encountered, the securing of the drive cables should be checked. If they are not secured, or secured using a cable tie, the motion of the window regulator will not be uniform during raising and the speed will slow. This will encourage premature anti-trap intervention. Please use part 00RB250 X2 and install as illustrated in the picture below.
