# SERVICE BULLETIN

Classification: AN20-009D	Reference: NTB20-029D	Date: April 21, 2021
------------------------------	--------------------------	-------------------------

## TELEMATICS (IVC) SERVICE INFORMATION

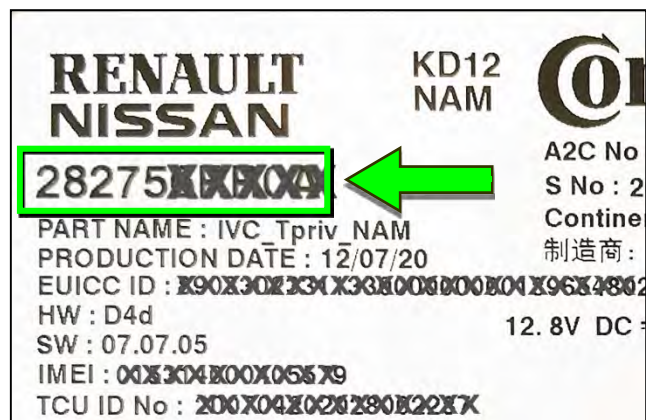
Figure 7

12. Write down the part number listed on the new / replacement TCU (Figure 7).

13. Install the new / replacement TCU into the vehicle.

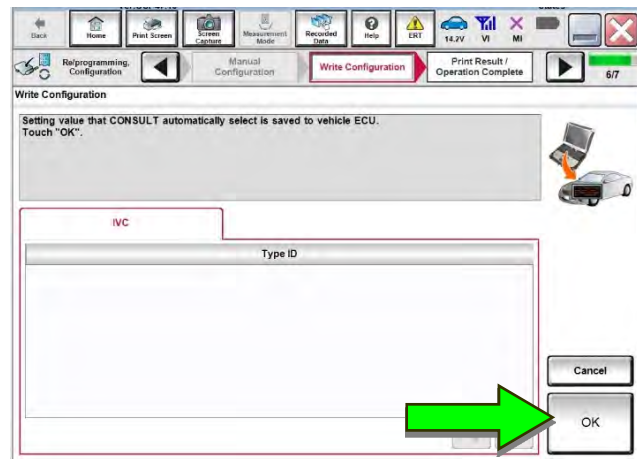
Figure 16

**NOTE:** If C-III plus automatically selects the Type ID, there will be no options shown under **Type ID** (see Figure 16). Skip to step 27.

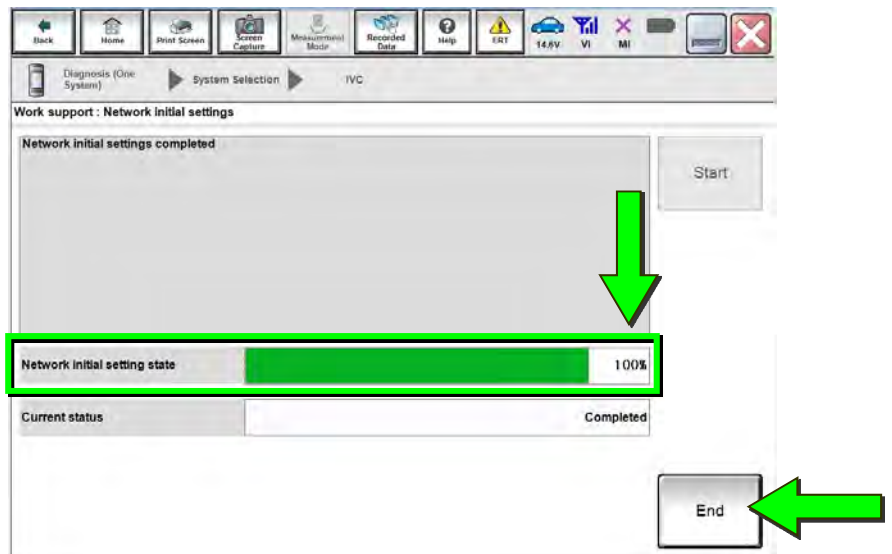
Figure 25

39. Check the **Network initial setting state** field (Figure 25).

- If the result is **100%**:
  - a. Confirm “**Completed**” displays in the **Current status** field.
  - b. Select **End**.
  - c. Skip to **Intelligent Key Registration** on page 18.

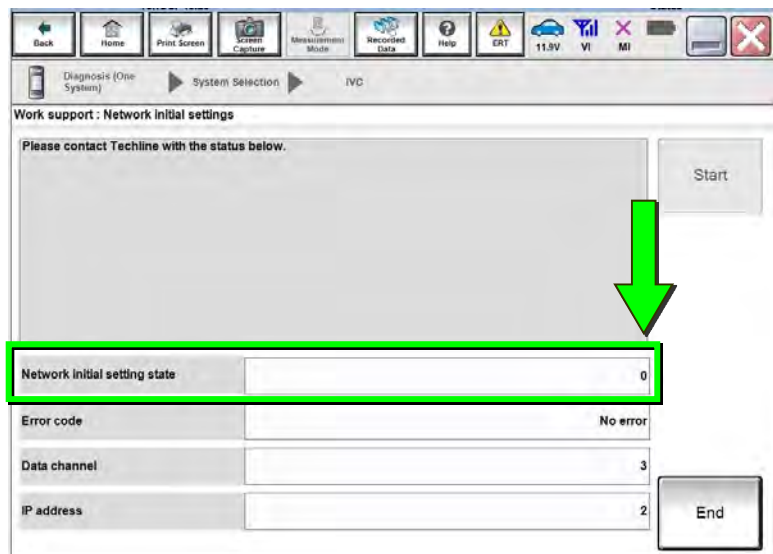
Figure 26

- If the result is **0**:
  - a. Confirm the VIN is written correctly.
  - b. Skip to **Verify Telematics Function (if needed)**, beginning on page 15.

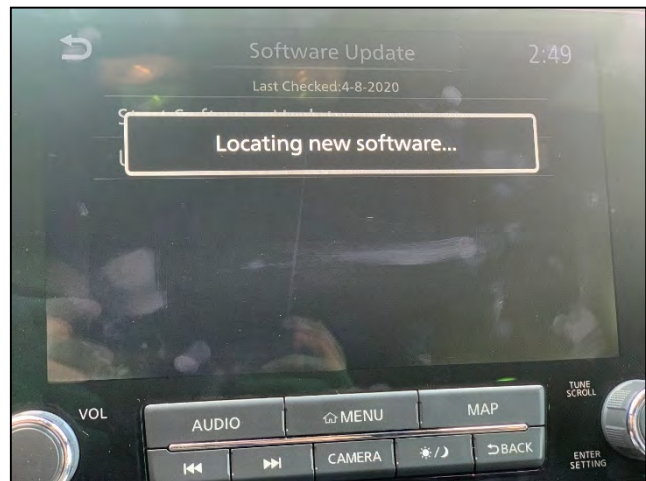
Figure 31

- **Locating new software** should display as shown in Figure 31.

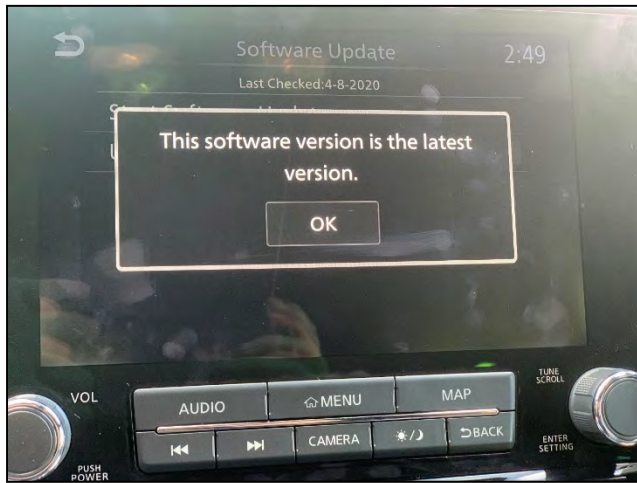
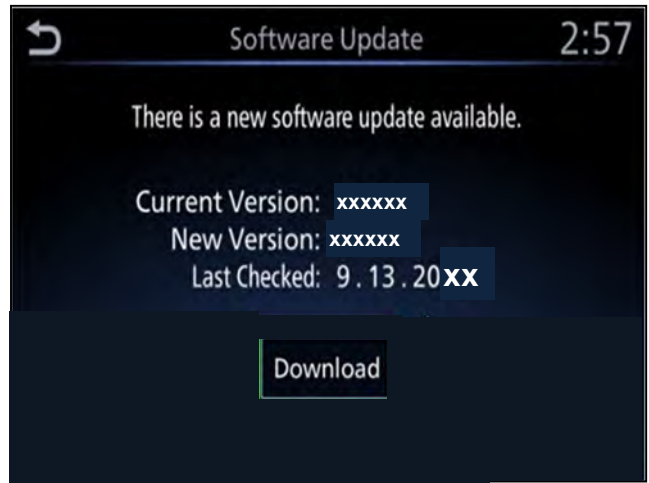
49. To confirm telematics functionality, ensure the screen in either Figure 32 or Figure 33, above, is displayed.

- If the screen matches Figure 32 or Figure 33, the procedure is complete.

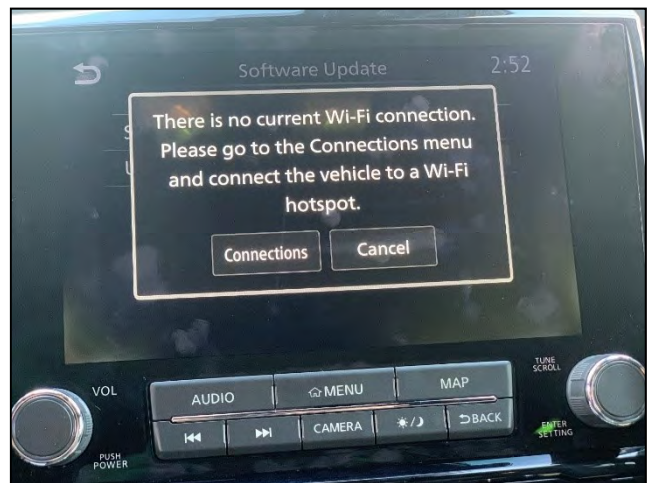
- If the screen matches Figure 34, (“**There is no current WI-FI connection**”) perform steps 40-49 again.

- If Figure 34 displays after performing steps 40-49 two times, wait 24 hours and then perform steps 40-49 a third time.

- If Figure 34 displays after the third attempt, contact the Nissan Owner Services call center at (855) 426-6628, between the hours of 8am and 7pm Central Standard Time (CST), Monday through Friday.
