Technical Service Bulletin

SUBJECT: ENGINE DOES NOT START DUE TO SOFTWARE COMMUNICATION ERROR BETWEEN OSS-ECU/ KOS-ECU		No: TSB-21-54A-001	
		DATE: April 2021	
		MODEL: See Below	
CIRCULATE TO:	<input type="checkbox"/> GENERAL MANAGER	<input checked="" type="checkbox"/> PARTS MANAGER	<input checked="" type="checkbox"/> TECHNICIAN
<input checked="" type="checkbox"/> SERVICE ADVISOR	<input checked="" type="checkbox"/> SERVICE MANAGER	<input checked="" type="checkbox"/> WARRANTY PROCESSOR	<input type="checkbox"/> SALES MANAGER

2011 - 2021 Outlander Sport / RVR (equipped with OSS / KOS)

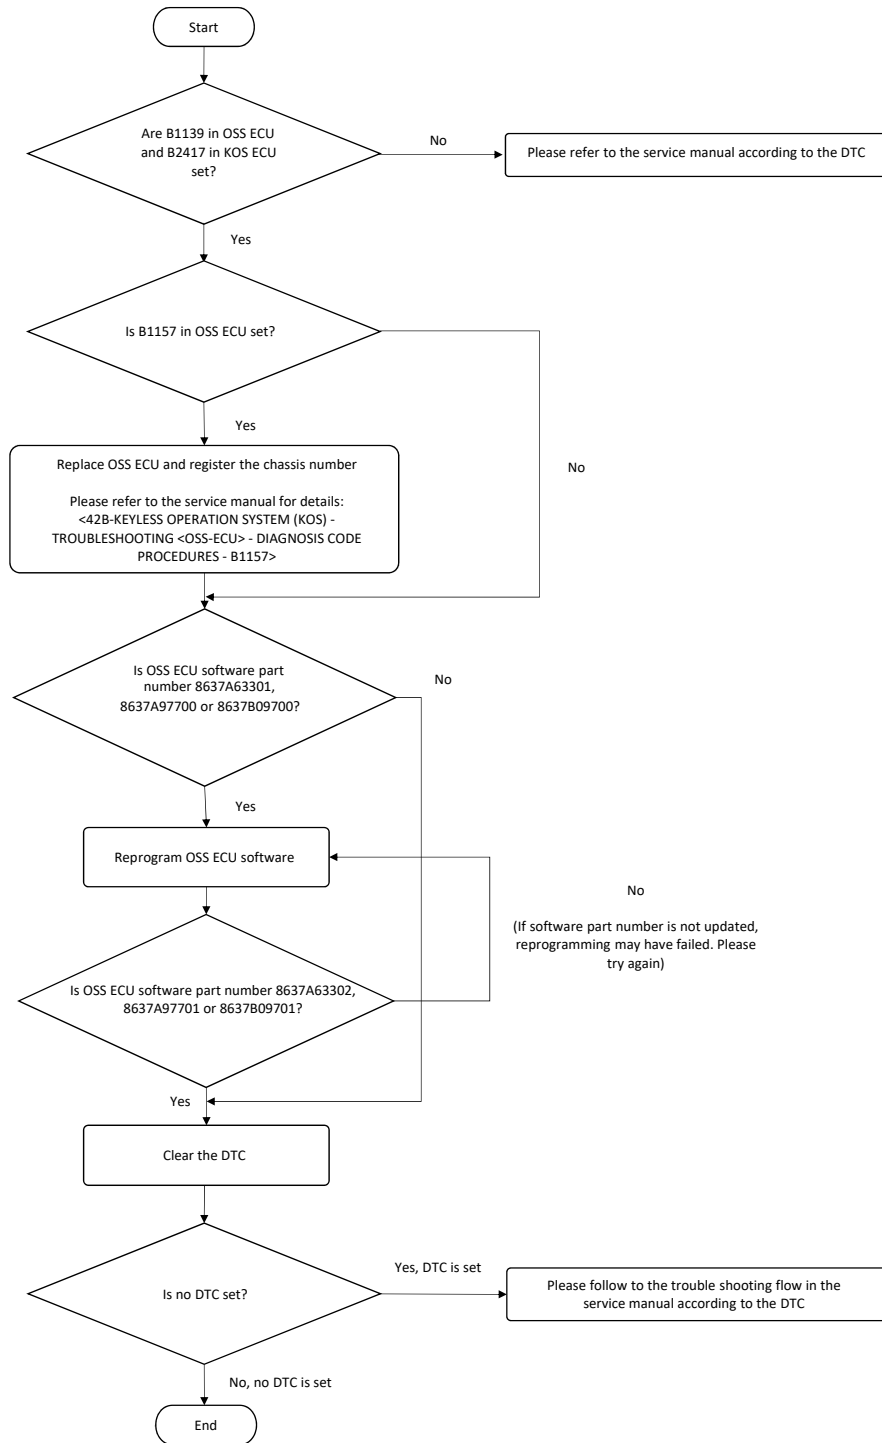
Outlander Sport OSS-ECU Troubleshooting

- When pressing the One-Touch Start System button (OSS), the engine will not start and a warning message "immobilizer system service required" will appear on the multi information display with the following DTCs:
 - B2417 - OSS authenticate error OSS
 - B1139 - KOS authenticate timeout
 - B1136 - Stop light switch

- When "both the B2417 and B1139 DTCs" **or** all three B2417, B1139, and B1136 DTCs" are detected; reprogram the software of the OSS-ECU with the countermeasure software.
- When DTC "B1157"* is detected **along with** B2417, B1139, and B1136; replace the OSS-ECU with a new one in accordance with the workshop manual.
