April 16, 2021

To: All Mitsubishi Service and Parts Managers

Subject: 2022 Outlander Hood Flutter Adjustment Special Customer Satisfaction Campaign

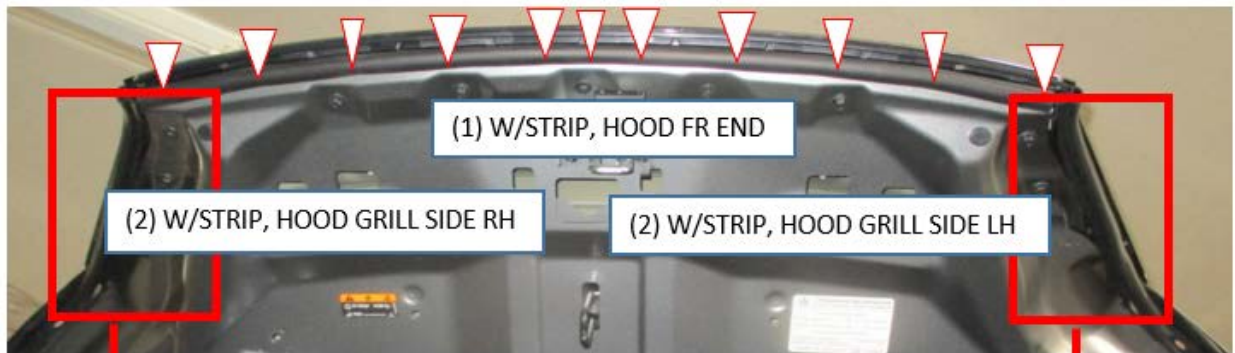
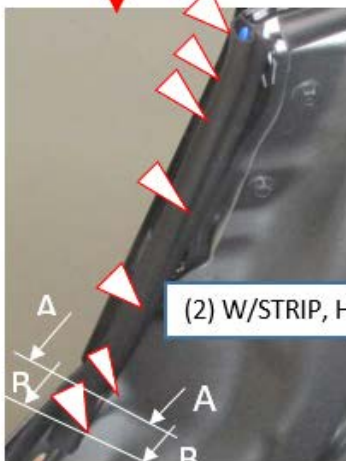
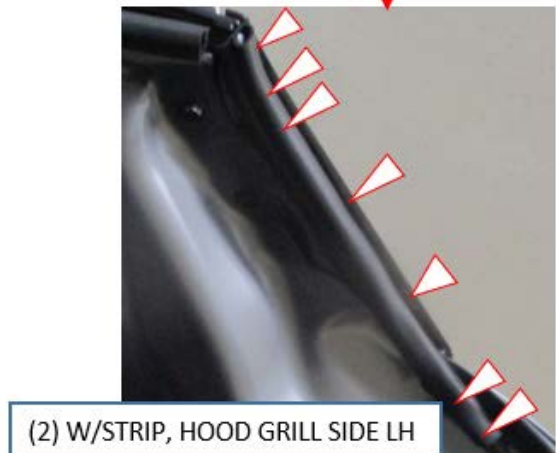
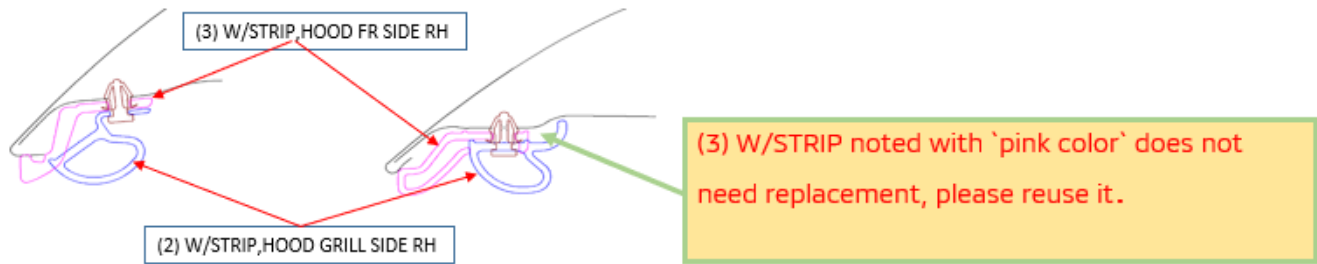
Please use the following procedure on all 2022 Outlander vehicles (EXCLUDING ES MODELS) - currently in your inventory and those that will be arriving at your dealership in April - to install countermeasure weather-strips to resolve a hood flutter centered around air intrusion to the engine compartment. This procedure is in addition to TSB-21-42A-001 and will ensure that the wind intrusion is minimized.

1. Remove the Weather-strip, Hood Front End (1) which is secured by 11 clips and remove the Weather-strip, Hood Grill Sides LH/RH (2), each secured by 7 clips.
