AN17-010B

ITB17-015B

March 16, 2021

## NAVIGATION SYSTEM REBOOTS WHEN SXM TRAFFIC IS ENABLED

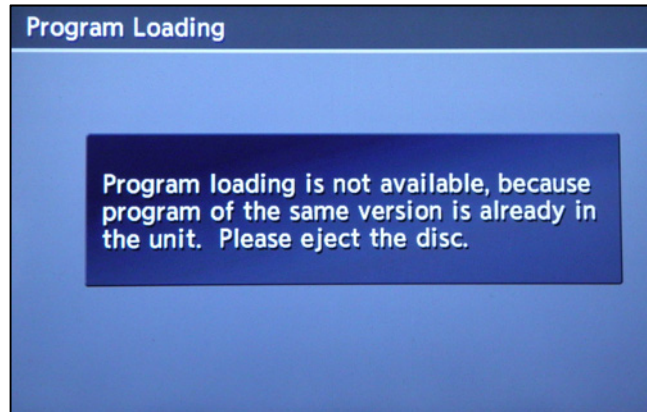
- If the screen in Figure 5 is displayed:
  - Remove the DVD from the CD slot.
  - Proceed to step 15 on page 7.
