SERVICE BULLETIN

Classification: AT21-003	Reference: NTB21-023	Date: March 16, 2021
-----------------------------	-------------------------	-------------------------

2021 ROGUE; DTC P0780 STORED IN THE TCM

APPLIED VEHICLES: 2021 Rogue (T33)

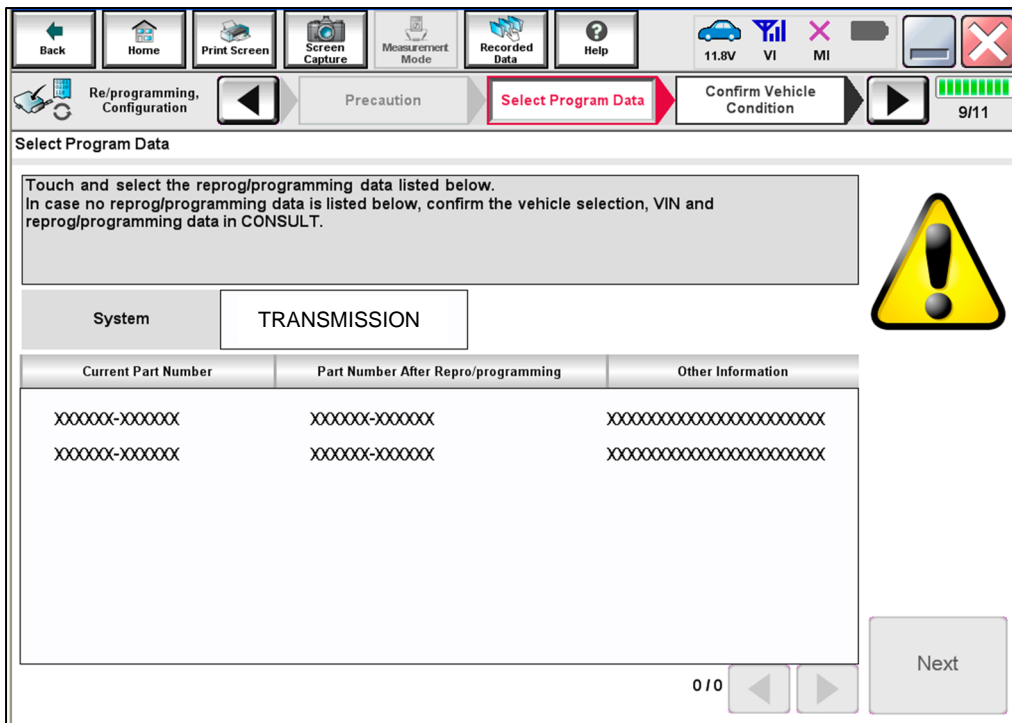
NOTE: In some cases, more than one new P/N for reprogramming is available.

- If more than one new P/N is available, the screen in Figure 11 displays.
- Select and use the reprogramming option that does **not** have the message “Caution! Use ONLY with NTBXX-XXX”.
- If you get this screen and it is blank (no reprogramming listed), it means there is no reprogramming available for this vehicle. Skip to step 25 on page 13.
