# SERVICE BULLETIN

Classification: AT21-003A	Reference: NTB21-023A	Date: March 19, 2021
------------------------------	--------------------------	-------------------------

## 2021 ROGUE; DTC P0780 STORED IN THE TCM

**APPLIED VEHICLES:** 2021 Rogue (T33)

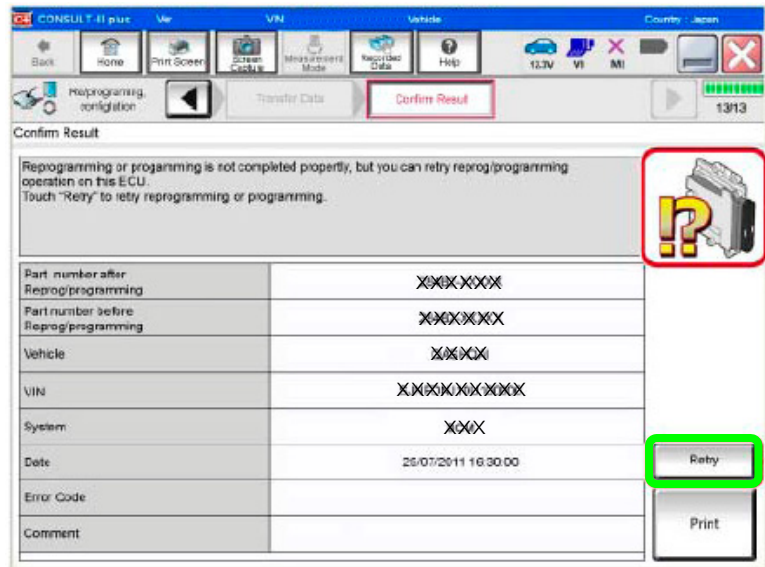
Figure 15

If reprogramming does not complete and the “!?” icon displays as shown in Figure 15:

- Check battery voltage (12.0 V – 15.5 V).
- Ignition is ON, engine is OFF.
- External Bluetooth® devices are OFF.
- All electrical loads are OFF.
- Select retry and follow the on screen instructions.
- “Retry” may not go through on first attempt and can be selected more than once.

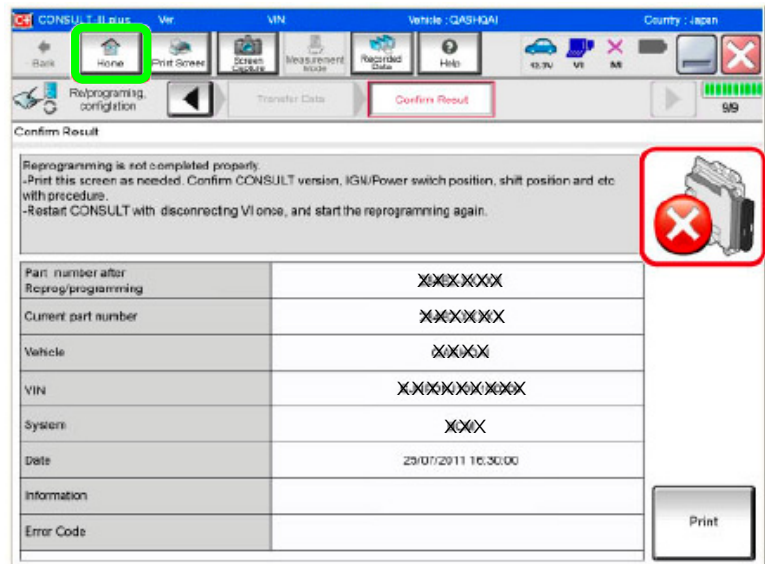
Figure 16

If reprogramming does not complete and the “X” icon displays as shown in Figure 16:

- Check battery voltage (12.0 V – 15.5 V).
- CONSULT A/C adapter is plugged in.
- Ignition is ON, engine is OFF.
- Transmission is in Park.
- All C-III plus / VI cables are securely connected.
- All C-III plus updates are installed.
- Select Home, and restart the reprogram procedure from the beginning.
