SERVICE BULLETIN

KS13-052B
 NTB13-109B
 March 12, 2021

2013-2015 ALTIMA AND PATHFINDER; ONE OR BOTH INTELLIGENT KEYS LOST PRIOR TO CUSTOMER DELIVERY

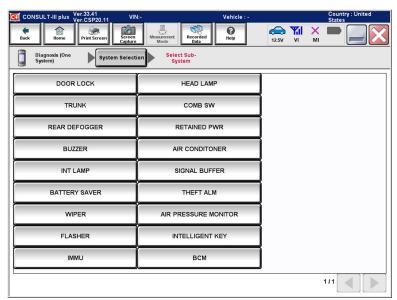
- If the screen in Figure 5 displays, the BCM is not in Transit Mode.
 - a) Select Home.
 - b) Replace the lost Intelligent Keys.
 - c) Register both replacement Intelligent Keys using CONSULT-III (C-III) plus.
 - d) Once successfully registered, this procedure is complete.
- If an error message indicates the ECU cannot be detected (see Figure 6), the BCM is in Transit Mode.
 - a) Replace the BCM.
 - Replace the lost Intelligent Keys and have the new ones available before proceeding to the next step.
 - c) Contact TECH LINE for Intelligent Key registration procedure guidance.
