Service Bulletin

Bulletin No.: 21-NA-060

Subject: Information on TLC/SPS2 Module Programming Requirements for Vehicles Using GM's New Vehicle Intelligence Platform (VIP) Module Architecture

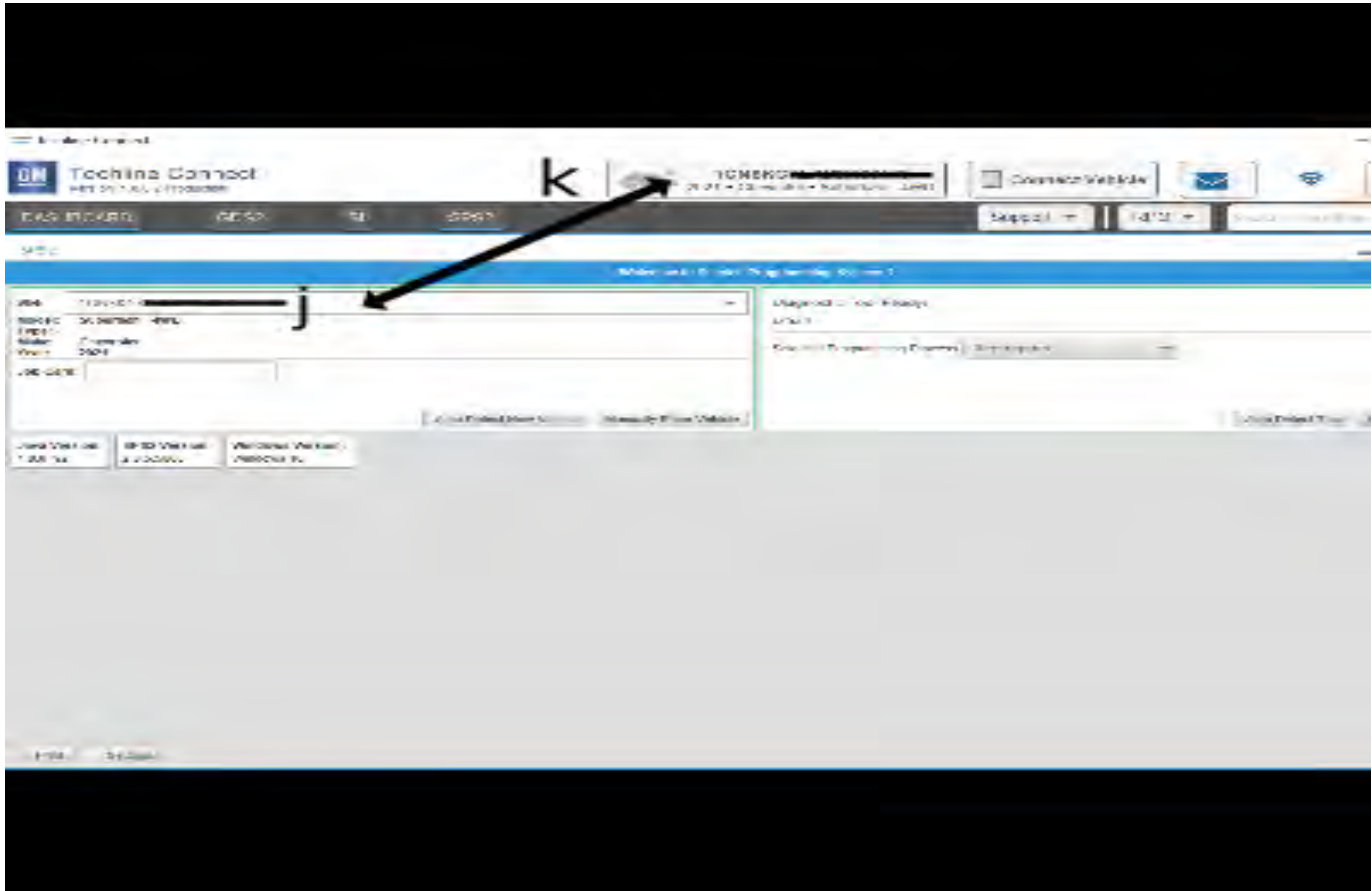
5743643

Caution: Be sure the VIN selected in the drop down menu (1) and the VIN connected (2) match the VIN plate of the vehicle to be programmed to ensure the correct software and/or calibration is loaded onto the module of the vehicle intended to be programmed.

Important: The service technician always needs to verify that the VIN displayed in the TLC left side drop down menu and the top center window match the VIN plate of the vehicle to be programmed prior to using Service Programming System 2 (SPS2) for programming or reprogramming a module.

- If the VIN that shows up in the TLC top center window after correctly reading the VIN from the vehicle does not match the VIN plate of the vehicle, manually type in the VIN characters from the vehicle VIN plate into the TLC top center window and use these for programming or reprogramming the subject module with the correct vehicle VIN and software and/or calibrations.
- The Engine Control Module (ECM) is the master module that TLC reads to determine the VIN of the vehicle. If the VIN read from the vehicle by TLC does not match the VIN plate of the vehicle, the ECM also needs to be reprogrammed with the correct VIN, software and calibrations that match the vehicle's VIN plate.
