EL12-070

## 2011-2013 QX56; WATER DROPS IN REAR COMBINATION LAMP

**APPLIED VEHICLES:** 2011-2013 QX56 (Z62)

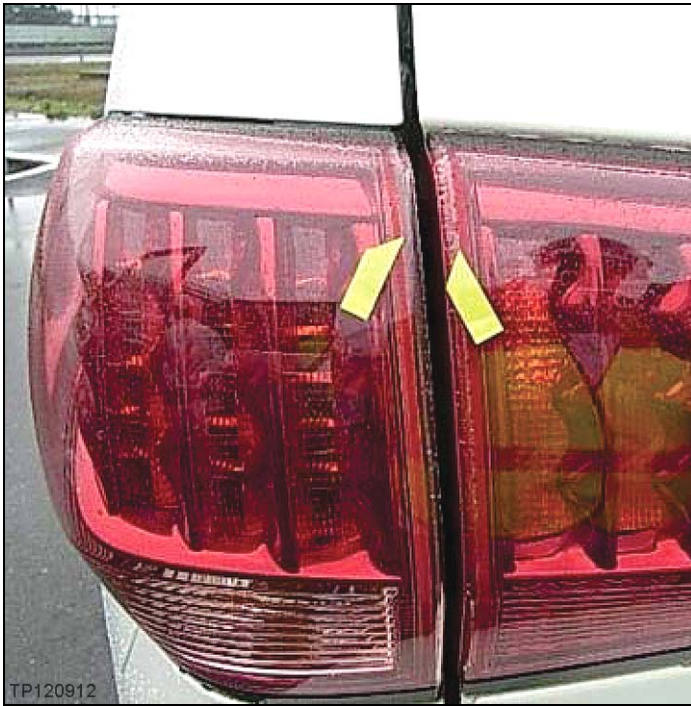
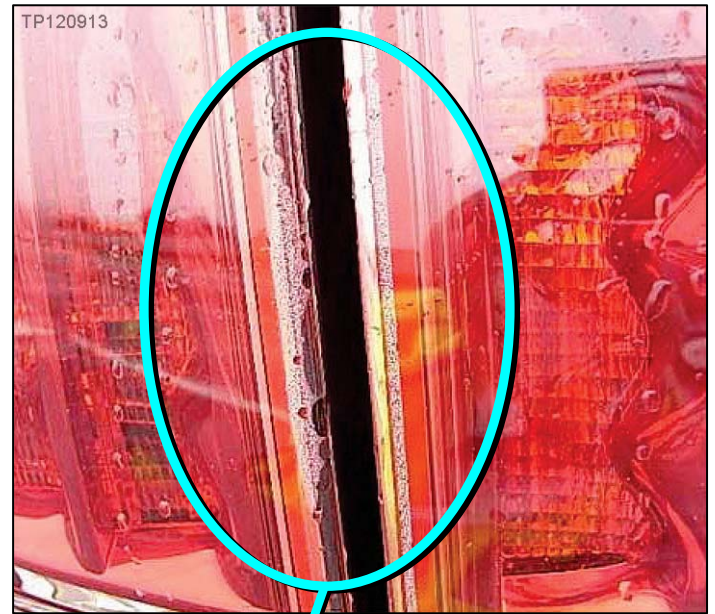
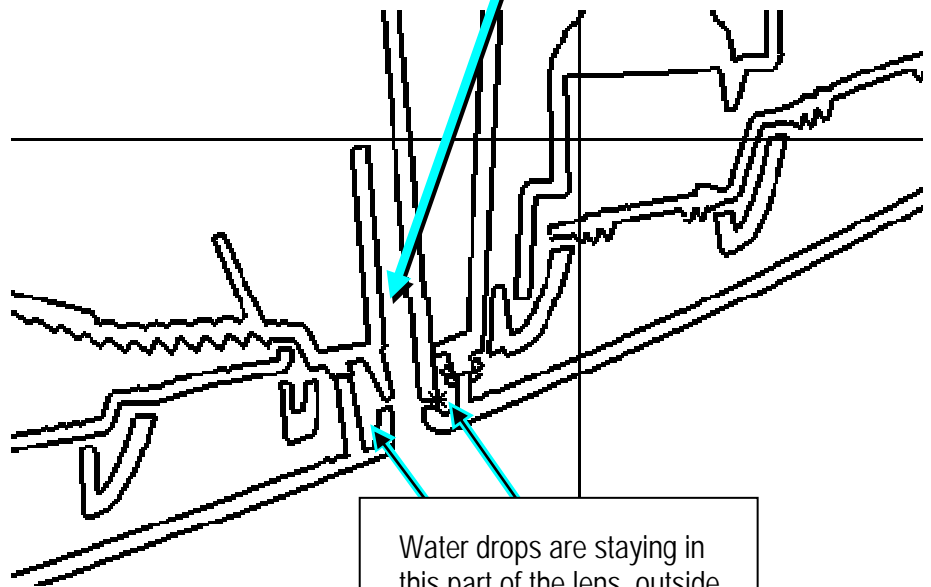
Occasionally, after a rain or a car wash, customers may notice water drops in the overhanging part of the rear combination lamp lens.

- This is a normal condition.
- The water drops should disappear over time when the lamp is in a dry environment.
- Refer to the images on page 2 for examples of a normal water drop condition.
- **Do not** replace any parts for this condition.

Example of normal water drop condition – rear combination lamp

Water drops are staying in this part of the lens, outside of the weld.
