EC11-024a

ITB11-054a

January 2, 2013

## 2011- 2013 QX56 AND 2011- 2012 M56; MIL ON WITH A/F SENSOR RELATED DTC STORED

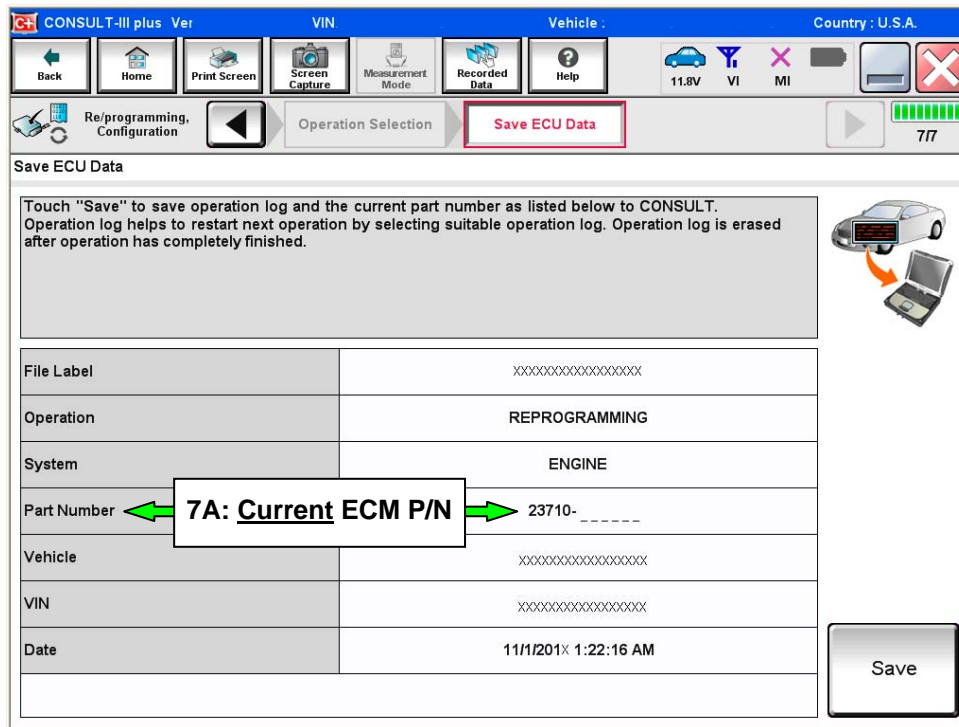
Figure 2

7. When you get to the screen shown in Figure 2, confirm ECM reprogramming applies as follows.
  - A. Find the ECM **Part Number** and write it on the repair order.

**NOTE:** This is the current ECM Part Number (P/N).

- B. Compare the P/N you wrote down to the numbers in the **Current ECM Part Number** column in **Table A** on the next page.
  - If there is a match, the ECM needs to be reprogrammed. Continue with the reprogramming procedure.
  - If there is not a match, the ECM does not need to be reprogrammed. Close C-III plus – repairs are completed.

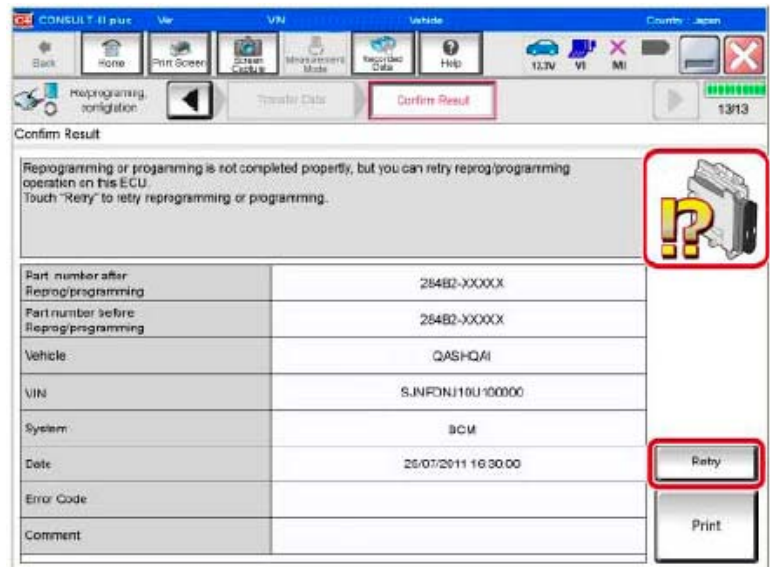
Figure 5

If reprogramming does not complete and the “!?” icon displays as shown in Figure 5:

- Check battery voltage (12.0–15.5 V).
- Ignition is ON, engine OFF.
- External Bluetooth® devices are OFF.
- All electrical loads are OFF.
- **Select retry and follow the on screen instructions.**
- “Retry” may not go through on first attempt and can be selected more than once.

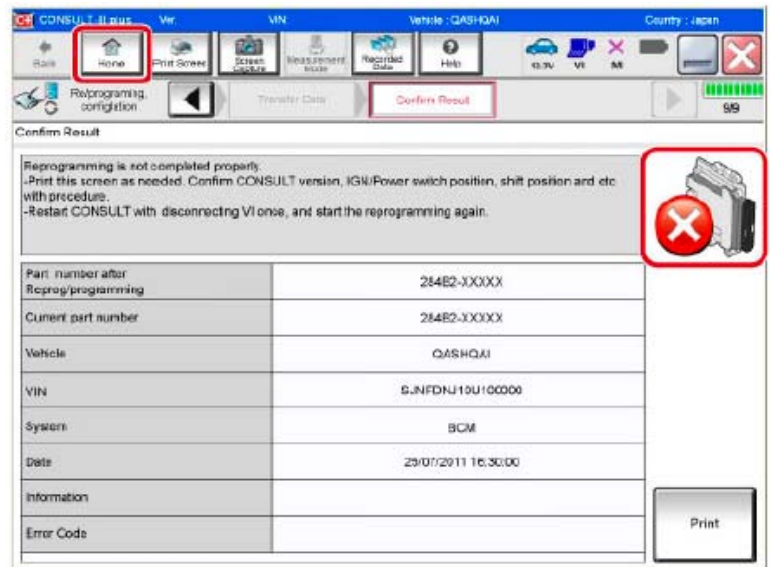
Figure 6

If reprogramming does not complete and the “X” icon displays as shown in Figure 6:

- Check battery voltage (12.0 – 15.5 V).
- CONSULT A/C adapter is plugged in.
- Ignition is ON, engine OFF.
- Transmission is in Park.
- All C-III plus / VI cables are securely connected.
- All C-III plus updates are installed.
- **Select Home, and restart the reprogram procedure from the beginning.**
