# SERVICE CAMPAIGN BULLETIN

NTB10-068e

January 28, 2013

## VOLUNTARY SERVICE CAMPAIGN NISSAN NAVIGATION SOFTWARE UPDATE

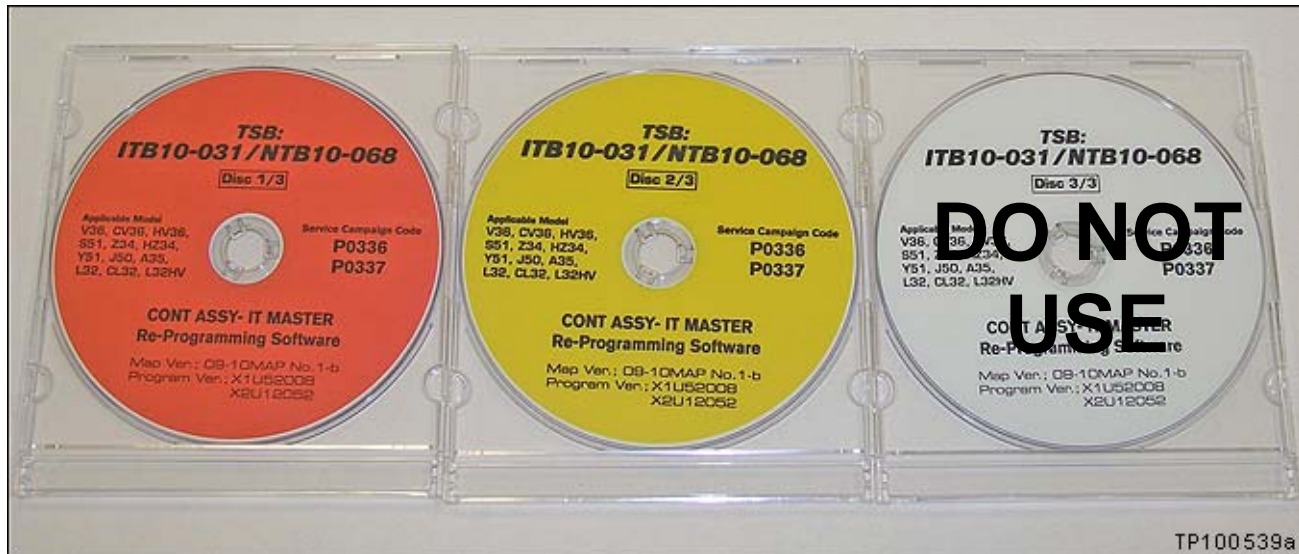
- Discs 1/3 and 2/3 of the set shown in Figure A are used for all applied models in this campaign except GT-R.
- Do not use disc 3/3.

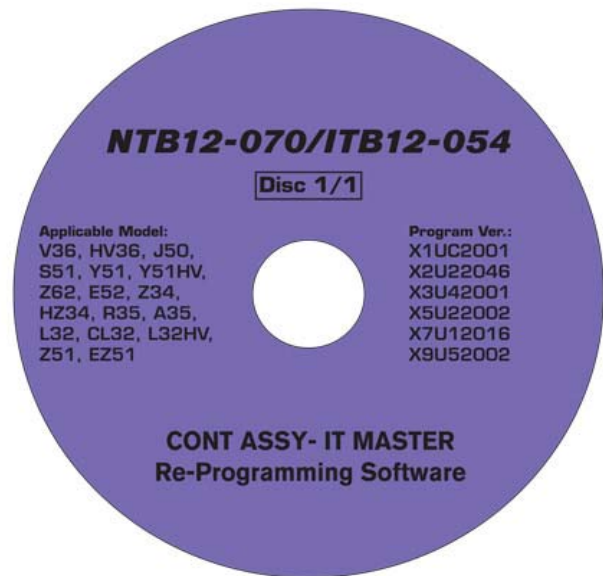
Figure B

- This **NEW** disc (Figure B) is required for all applied models in this campaign.
- This disc replaces disc 3/3 above.
- This disc also replaces disc NTB10-125b/ITB10-066b (disc 1/1) and disc NTB10-068 (disc1/1) for GT-R.

**NOTE:** Numbers on these discs do not match this bulletin's reference number or the campaign ID #.

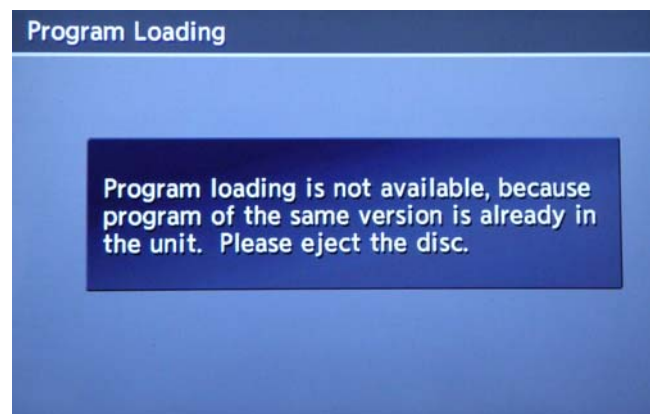
Figure13

- If the screen in Figure 13 is displayed, this disc is not needed.
  - Remove/eject the DVD from the CD slot.
  - Go to **C: Check Bluetooth® Setting** on page 12.

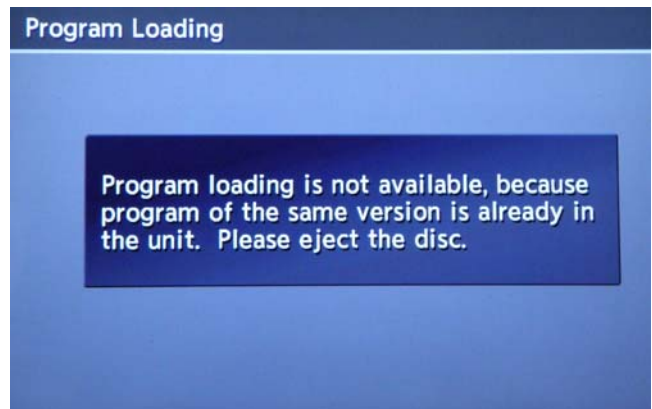
- If Figure 23 is displayed, it indicates that the reprogram has been completed.
  - If complete, go to step 26.

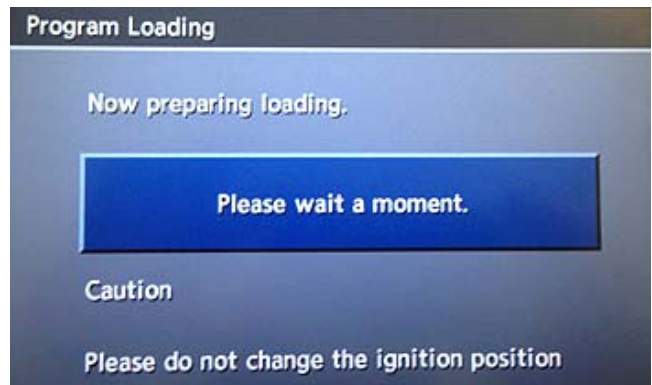
- If Figure 24 is displayed, the update did not complete. Allow the update to complete:
  - Go back to step 18 on page 8.
  - Follow steps 18 through 25 again.

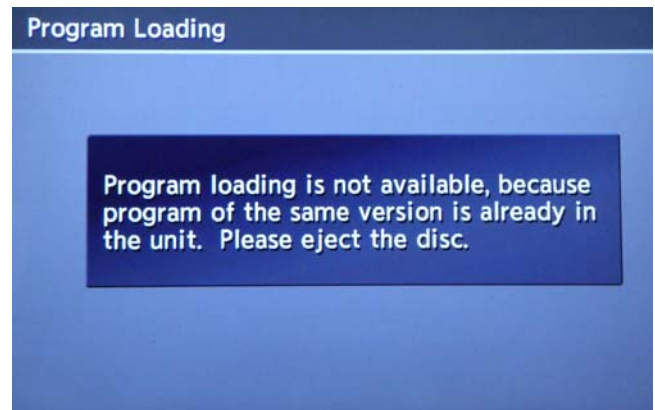
FigureA1

- If the screen in Figure A1 is displayed, this disc is not needed.
  - Remove/eject the DVD from the CD slot.
  - Go to **Check Bluetooth® Setting for GT-R** on page 17.

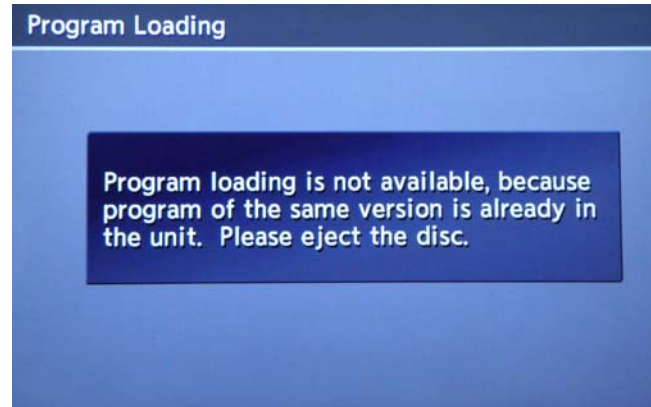
- If Figure A11 is displayed it, indicates that the reprogram has been completed.
  - If complete go to step 13.

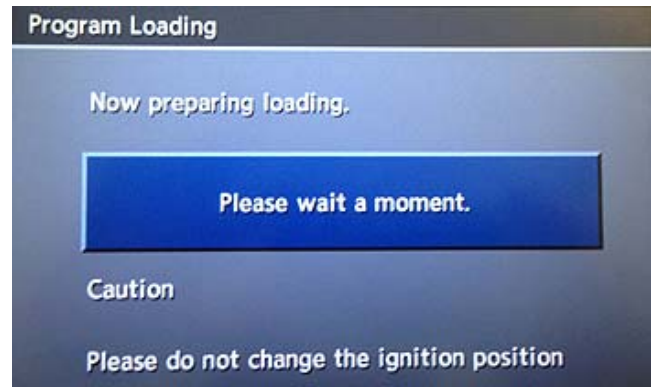
- If Figure A12 is displayed, the update did not complete. Allow the update to complete:
  - Go back to step 5 on page 13.
  - Follow steps 6 through 12 again.
