SERVICE CAMPAIGN BULLETIN

NTB11-073a

VOLUNTARY SERVICE CAMPAIGN CALL WAITING FUNCTION NAVIGATION UPDATE

CAMPAIGN ID #: P1234

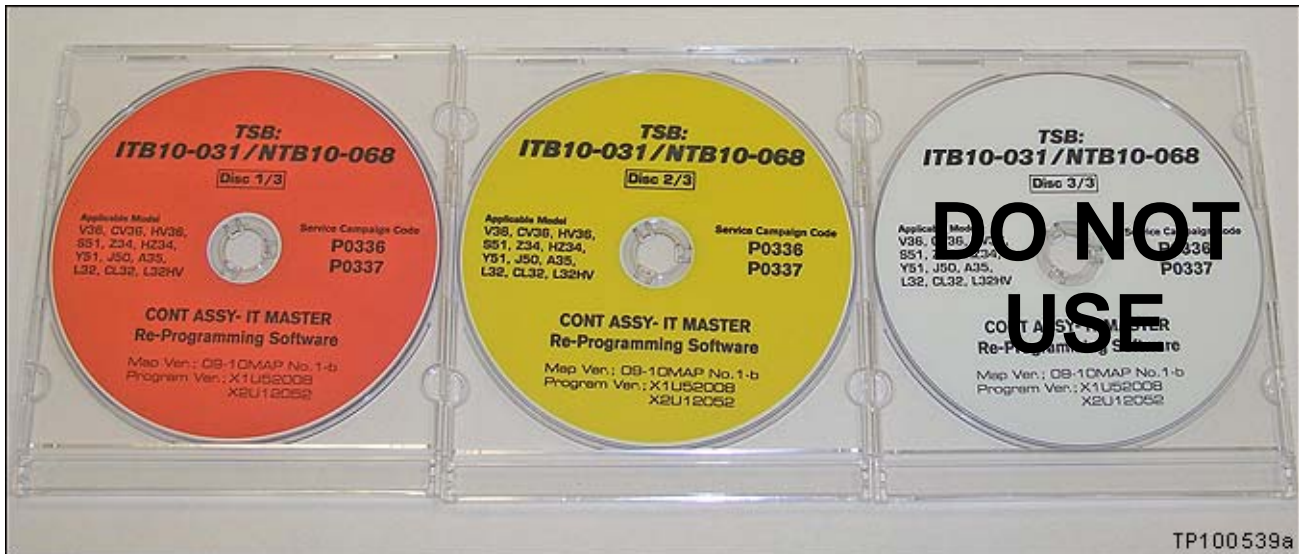
- Discs 1/3 and 2/3 of the set shown in Figure A are used for 2010 models in this campaign.
- Do not use disc 3/3.

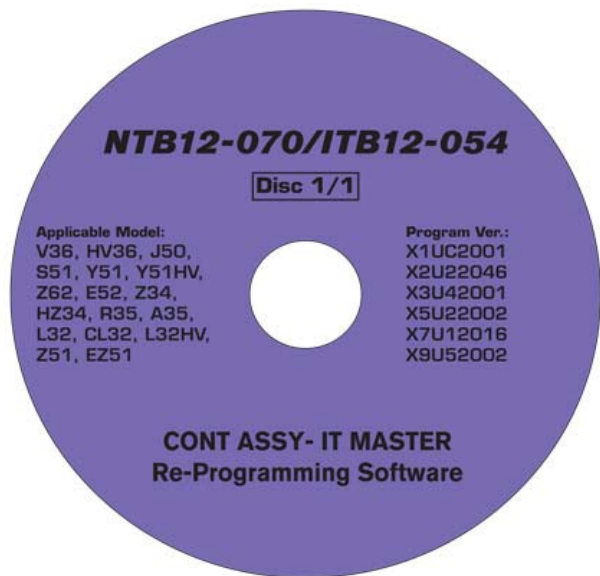
Figure B

- This NEW disc (Figure B) is required for all applied models in this campaign.
- This disc replaces disc 3/3 above.
- This disc also replaces disc NTB10-125b/ITB10-066b (disc 1/1) and disc NTB10-068 (disc1/1) for GT-R.

NOTE: Numbers on these discs do not match this bulletin's reference number or the campaign ID #.

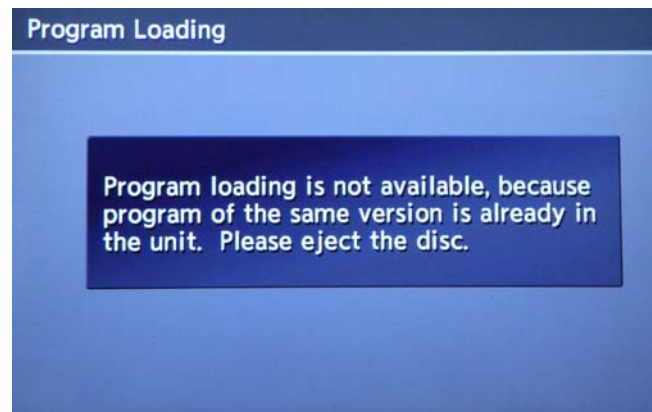
Figure13

- If the screen in Figure 13 is displayed, this disc is not needed.
 - Remove/eject the DVD from the CD slot.
 - Go to **C: Check Bluetooth® Setting** on page 12.

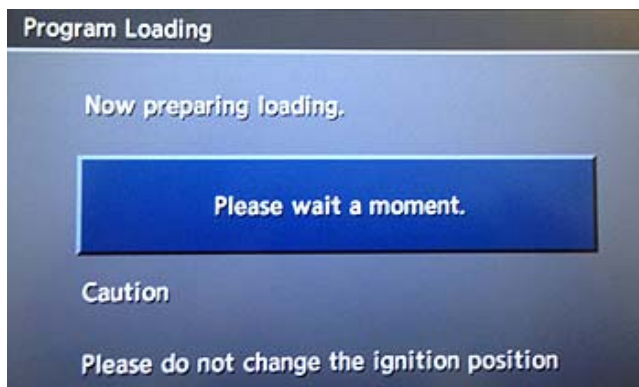
- If Figure 24 is displayed, the update did not complete. Allow the update to complete:
 - Go back to step 18 on page 8.
 - Follow steps 18 through 25 again.

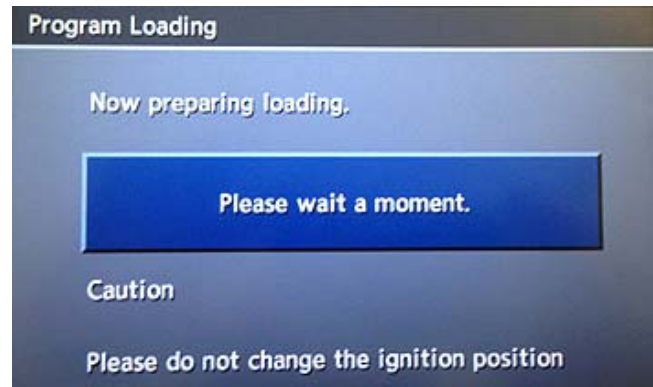
- If Figure A12 is displayed, the update did not complete. Allow the update to complete:
 - Go back to step 5 on page 13.
 - Follow steps 5 through 12 again.
