Dealer Inventory Inspection

May 9, 2013

2013 Nissan Altima and Maxima Rear Member

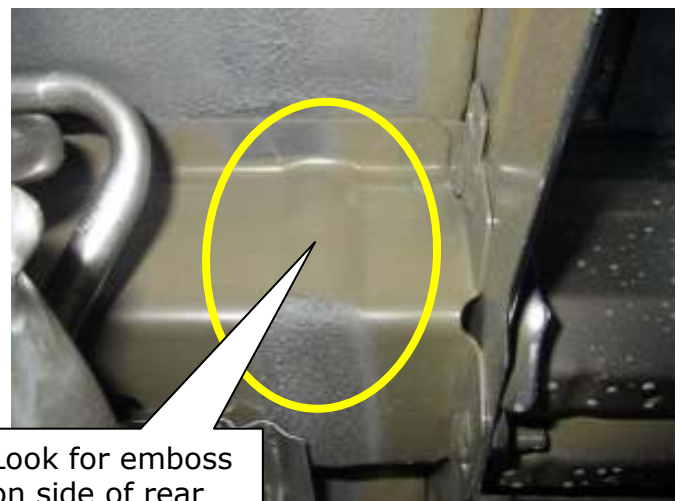
Figure 3

1. Locate drivers' side rear member shown in figure 1 and figure 2.
2. Inspect for a raised emboss on the outside of drivers' side rear member shown in figure 3.
 - If emboss is present on the outside of rear member, shown in figure 3. Go to step 3.
 - If emboss is not present take a picture of driver side rear member, then go to step 3.
3. Repeat instructions for passenger side.
 - **If emboss is present** on the drivers' and passenger side rear members shown in figure 3. No further action is needed and use warranty Op Code **PC2311**.
 - **If emboss is not present** on either drivers' or passenger side rear member, please send a picture with the following information to below email address for further instructions.
nafgasupport@nissan-usa.com
 - Send the following information.
 - Picture
 - VIN #
 - Which side rear member
 - Dealer Name
 - Dealer Code
 - Contact person
 - Phone number

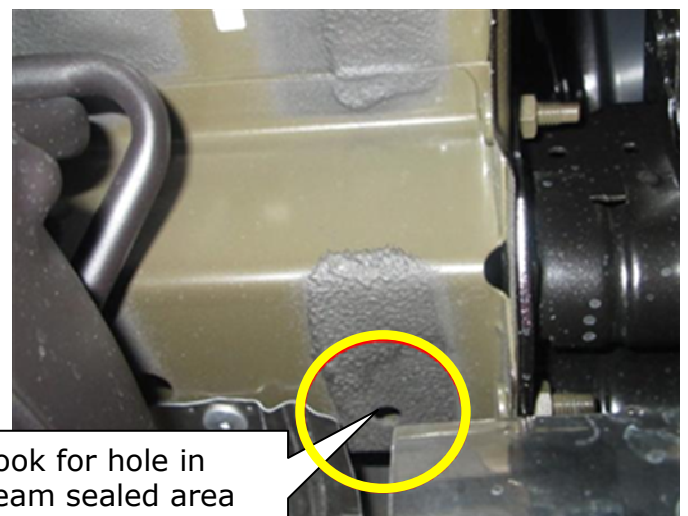
Figure 3

1. Locate drivers' side rear member shown in figure 1 and figure 2.
2. Inspect for a hole on the bottom of drivers' side rear member in the **seam-sealed area** shown in figure 3.

- If a hole is present on the bottom of rear member, shown in figure 3. Go to step 3.
 - If a hole is not present take a picture of drivers' side rear member, then go to step 3.

3. Repeat instructions for passenger side.
 - **If a hole is present** on the drivers' and passenger side rear members shown in figure 3. No further action is needed and use warranty Op Code **PC2311**.

- **If a hole is not present** on either drivers' or passenger side rear member, please send a picture with the following information to below email address for further instructions.
nnaqgasupport@nissan-usa.com
